INTERSTATE COMMERCE COMMISSION

REPORT OF THE DIRECTOR OF THE BUREAU OF SAFETY CONCERNING AN
ACCIDENT ON THE CLEVELAND, CINCINNATI, CHICAGO & ST. LOUIS
RAILWAY AT LAWRENCEVILLE, ILL. ON SEPTEMBER 18, 1934.

November 14, 1934.

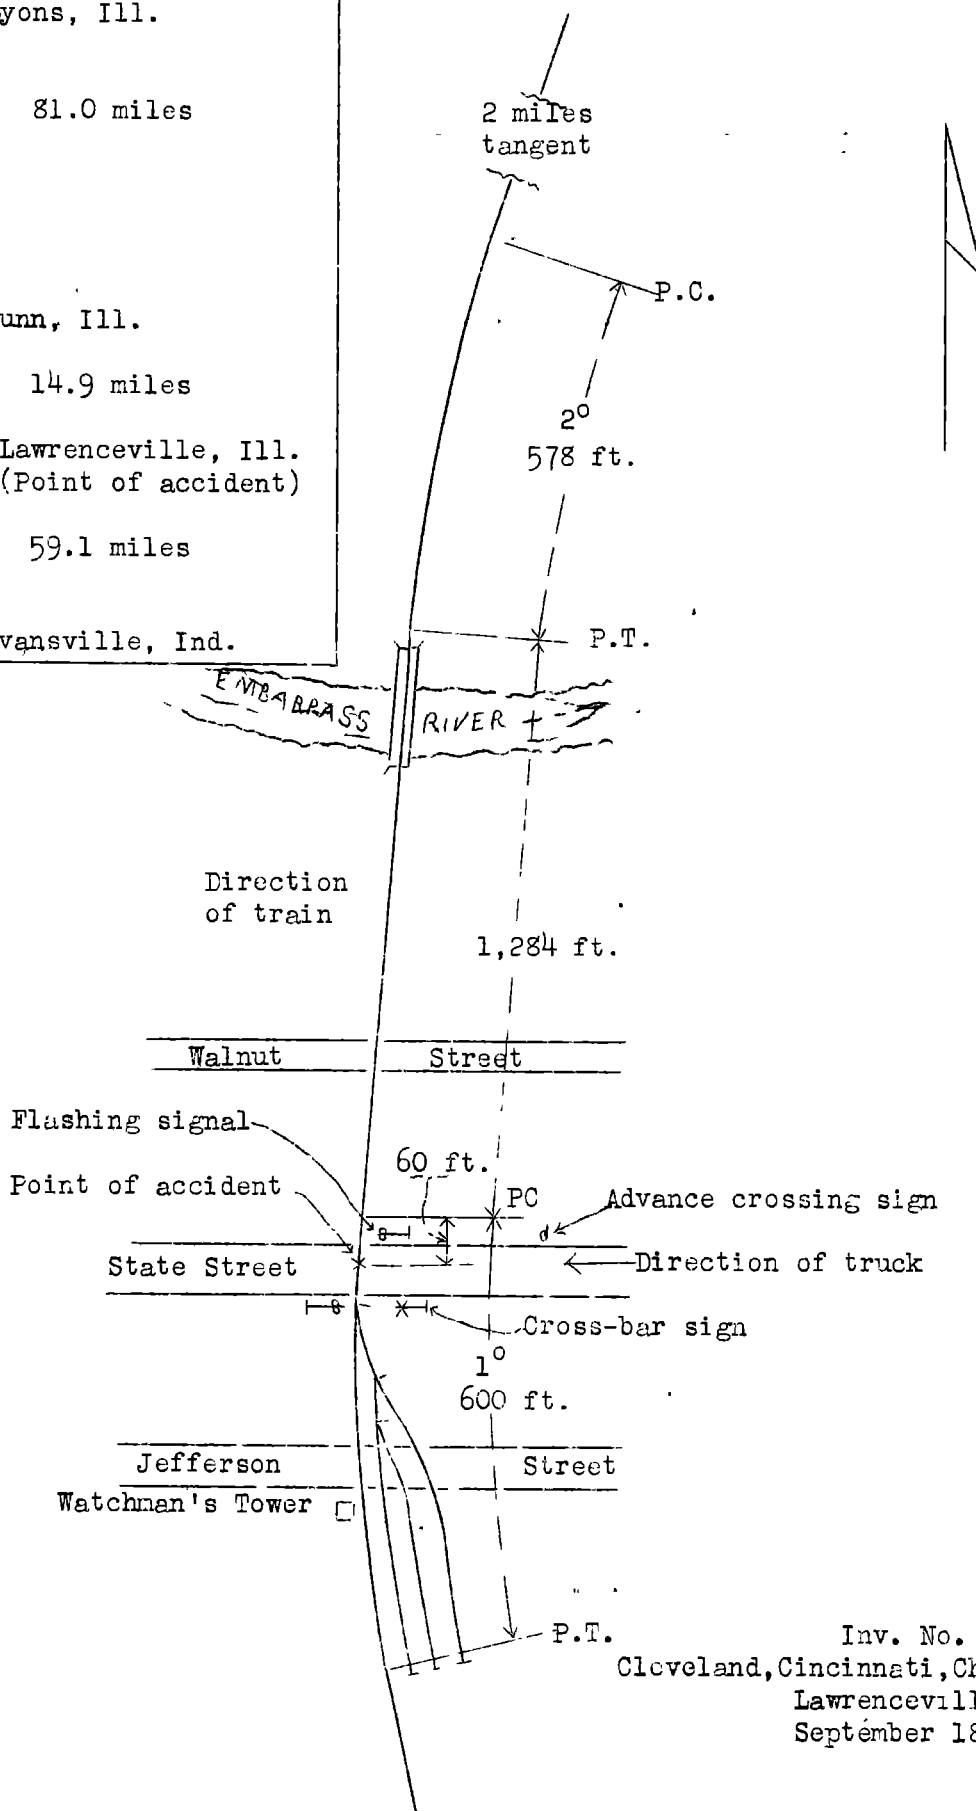
Inv. No. 1933
Cleveland, Cincinnati, Chicago & St. Louis Ry
Lawrenceville, Ill.
September 18, 1934.

From the driver's seat of a west-bound vehicle, the view of a train approaching from the north is materially restricted because of the angle of the crossing and by dwellings, trees, and a garage, making it necessary to approach close to the track before a south-bound train can be seen for any material distance. At a point 20 feet east of the center line of the track a south-bound train can be seen for a distance of 338 feet, but at a point 10 feet from the center line of the track it can be seen for a distance of 1,500 feet.

The tractor was thrown to the west of the track and the trailer to the east, both being demolished. Engine 6485, its tender and the first three cars were derailed; the engine followed the main track and was partly overturned, stopping with its front end about 300 feet south of the crossing; the cars followed the first of the stub-end sidings on the left or east side of the main track. The employee killed was the fireman.

The investigation and the results of this accident demonstrate the need for additional protection at this crossing and it is therefore recommended that provision be made for continuous protection which will be adequate to warn users of the highway of the approach of trains.
