INTERSTATE COMMERCE COMMISSION  
WASHINGTON

-----  
REPORT OF THE DIRECTOR  
BUREAU OF SAFETY  
-----

ACCIDENT ON THE  
CLEVELAND, CINCINNATI, CHICAGO & ST. LOUIS  
RAILWAY

-----  
McCOY, IND.  
-----

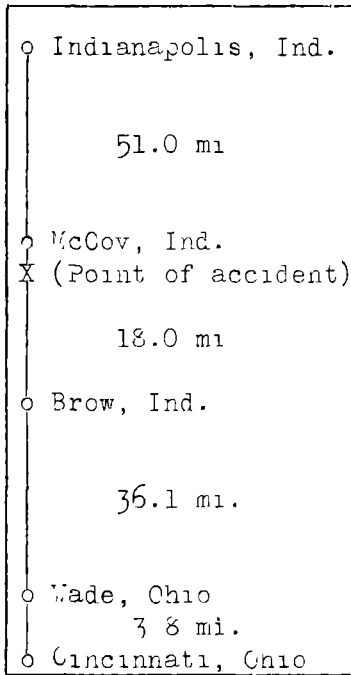
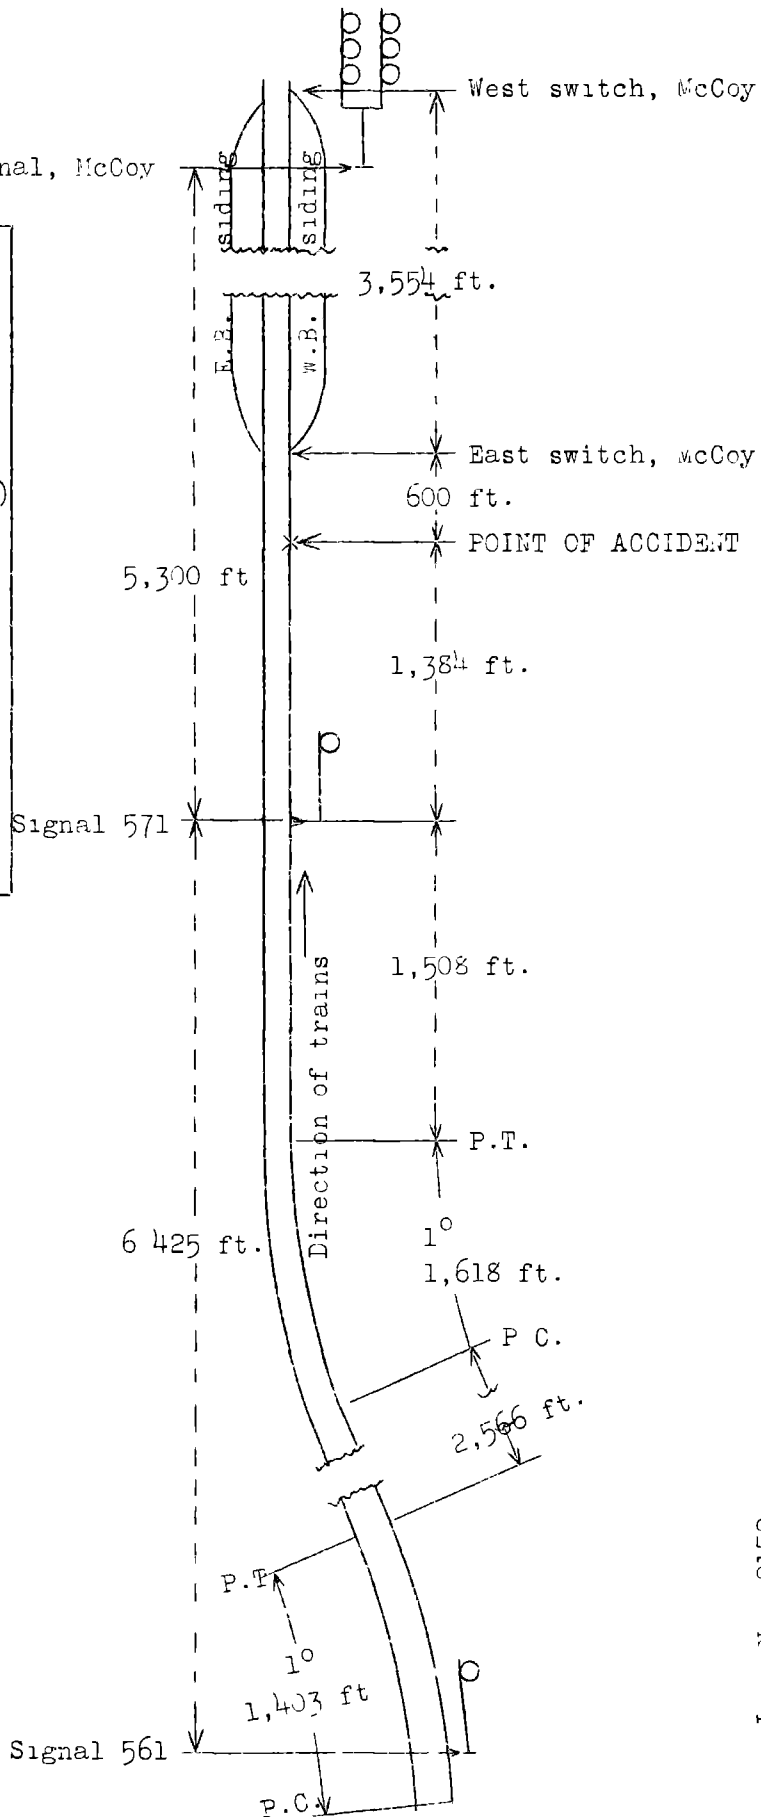
Inv. No. 2152  
 C.C.C. & St. L. Ry.  
 McCoy, Indiana  
 Feb. 22, 1937

The automatic signals involved in this accident are signals 531, 551, 561, and 571, located 4 miles, 2.6 miles, 7,809 feet and 1,384 feet, respectively, east of the point of accident. These signals are of the approach lighted, color-light, single-unit type, displaying the following indications: Green, proceed; Yellow, proceed at speed not to exceed one-half the maximum authorized speed at point involved (not exceeding 30 miles per hour) prepared to stop at next signal; Red, stop then proceed at restricted speed.
