INVESTIGATION NO. 2535

THE CLEVELAND, CINCINNATI, CHICAGO & ST. LOUIS
RAILWAY COMPANY

REPORT IN RE ACCIDENT
NEAR MORGANTOWN, IND., ON
OCTOBER 9, 1941

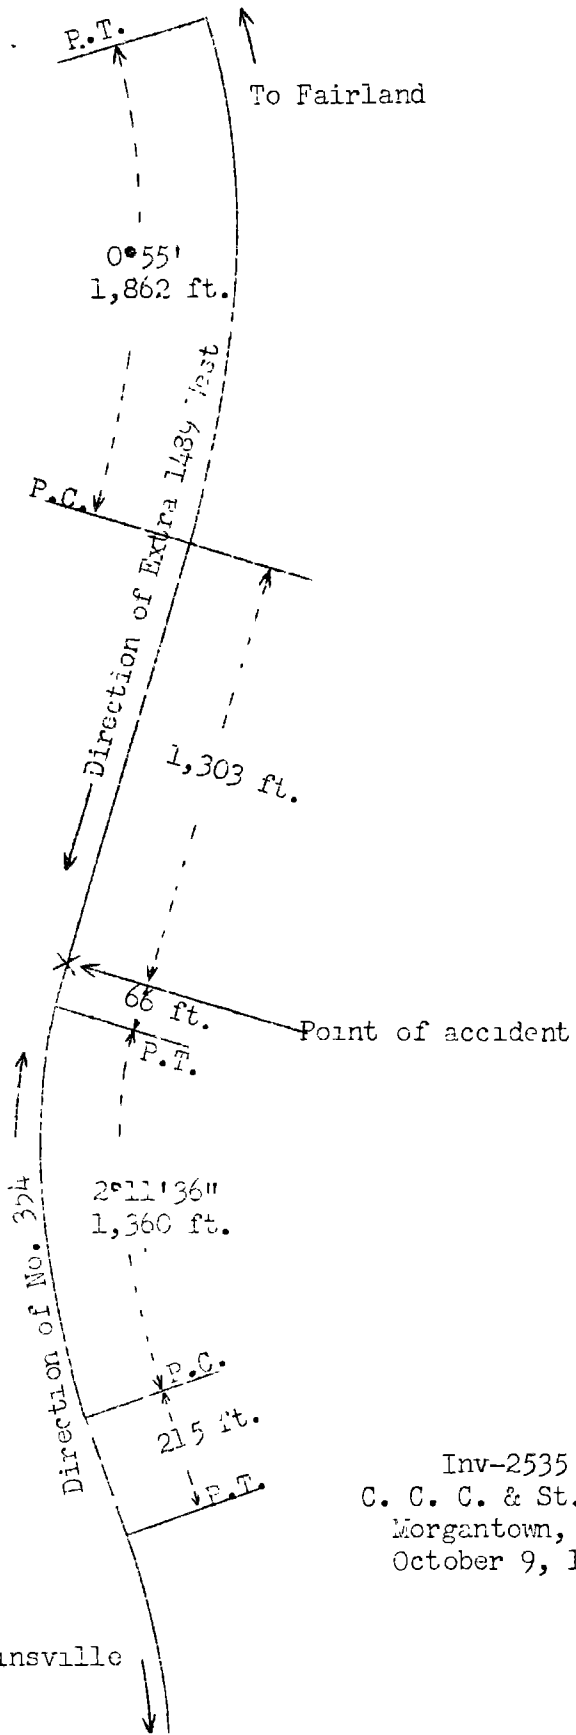
Inv-2535
 C. C. C. & St. L. Ry.
 Morgantown, Ind.
 October 9, 1941.

- o Fairland, Ind. 12.5 mi.
- o Franklin 7.2 mi.
- o Trafalgar 5.11 mi.
- X Point of accident 1.59 mi.
- o Morgantown 11.6 mi.
- o Martinsville, Ind.
