INTERSTATE COMMERCE COMMISSION

REPORT OF THE DIRECTOR OF THE BUREAU OF SAFETY CONCERNING AN
ACCIDENT ON THE CLEVELAND, CINCINNATI, CHICAGO & ST. LOUIS
RAILWAY AT WORTHINGTON, OHIO, ON NOVEMBER 16, 1933.

January 29, 1934.

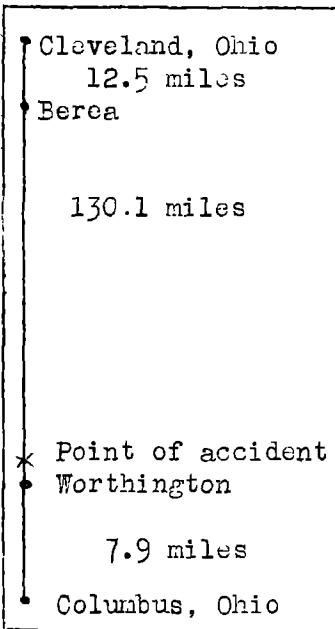
Inv. No. 1866
 Cleveland, Cincinnati,
 Chicago & St. Louis Ry.
 Worthington, Ohio
 November 16, 1933.

Point of accident

57 ft.

The rail involved was on the left or south side of the track, breaking at a point about 57 feet east of the center line of the first of the Pennsylvania tracks; this rail broke into many pieces, some of it being shattered, and about 7 feet of it could not be found. The breaks ran in various directions, some
