INTERSTATE COMMERCE COMMISSION

INVESTIGATION NO. 2582

THE CLEVELAND, CINCINNATI, CHICAGO &
ST. LOUIS RAILWAY COMPANY

REPORT IN RE ACCIDENT

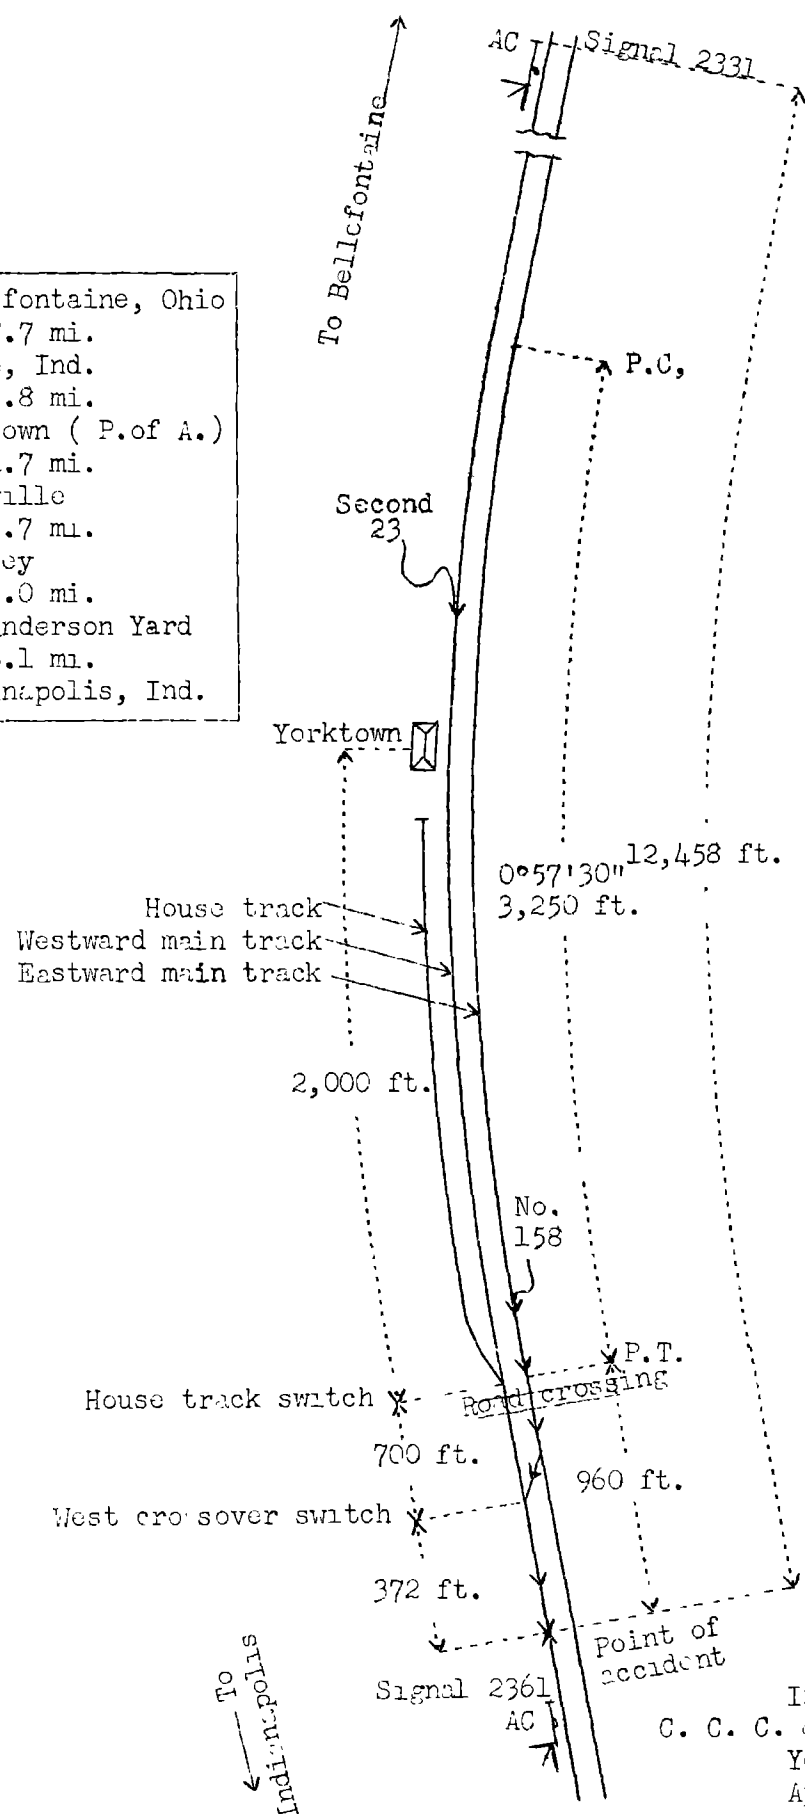
Location of Accident and Method of Operation

This accident occurred on that part of the Ohio Division which extends between Bellefontaine, Ohio, and Indianapolis, Ind., a distance of 143 miles. In the vicinity of the point of accident this is a double-track line over which trains are operated with the current of traffic by an automatic block-signal system, the indications of which supersede time-table superiority. At Yorktown a trailing-point crossover for movements with the current of traffic connects the eastward and the westward main tracks. The west switch of this crossover is located 2,700 feet west of the station. A spur track, designated as the house track, parallels the westward main track on the north. Entry to this track is provided by a trailing-point switch located 2,000 feet west of the station. The accident occurred on the westward main track at a point 372 feet west of the west crossover switch. As the point of accident is approached from the east there are, in succession, a tangent approximately 6 miles in length, a 0°57'30" curve to the left 3,250 feet, and a tangent 960 feet to the point of accident and several miles beyond. The grade for west-bound trains is 0.06 percent ascending a distance of 1,300 feet to the point of accident and about 1,500 feet beyond.

Automatic signals 2331 and 2361, governing west-bound movements on the westward main track, are located, respectively, 12,458 feet east and 342 feet west of the point of accident. These signals are of the 3-indication, color-light type, and are approach lighted. The aspects and corresponding indications of these signals are as follows:

The circuits are so arranged that when the house-track switch or either switch of the crossover is open, or if the westward main track between signals 2331 and 2361 is occupied, signal 2331 displays a red-over-red aspect.

The switches involved are not bolt-locked. The house-track switch and the west switch of the crossover are provided with intermediate switch stands and double-vaned targets. When the house-track switch is lined for movement to the house track, a red target is displayed.

Because of track curvature, the view of the point of accident from the right side of a west-bound engine is restricted to about 300 feet, and from the left side to 3,000 feet.
