REPORT NO. 1972

INTERSTATE COMMERCE COMMISSION

REPORT OF THE DIRECTOR OF THE BUREAU OF SAFETY CONCERNING AN
ACCIDENT ON THE CLINCHFIELD RAILROAD NEAR TOECANE, N.C.,
ON MARCH 20, 1935.

May 7, 1935.

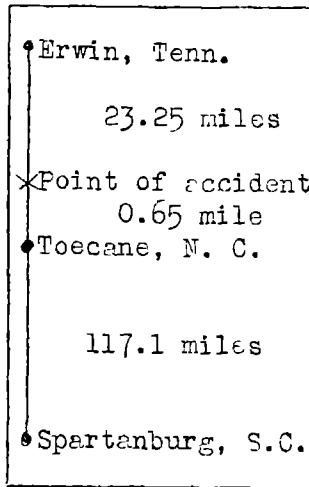
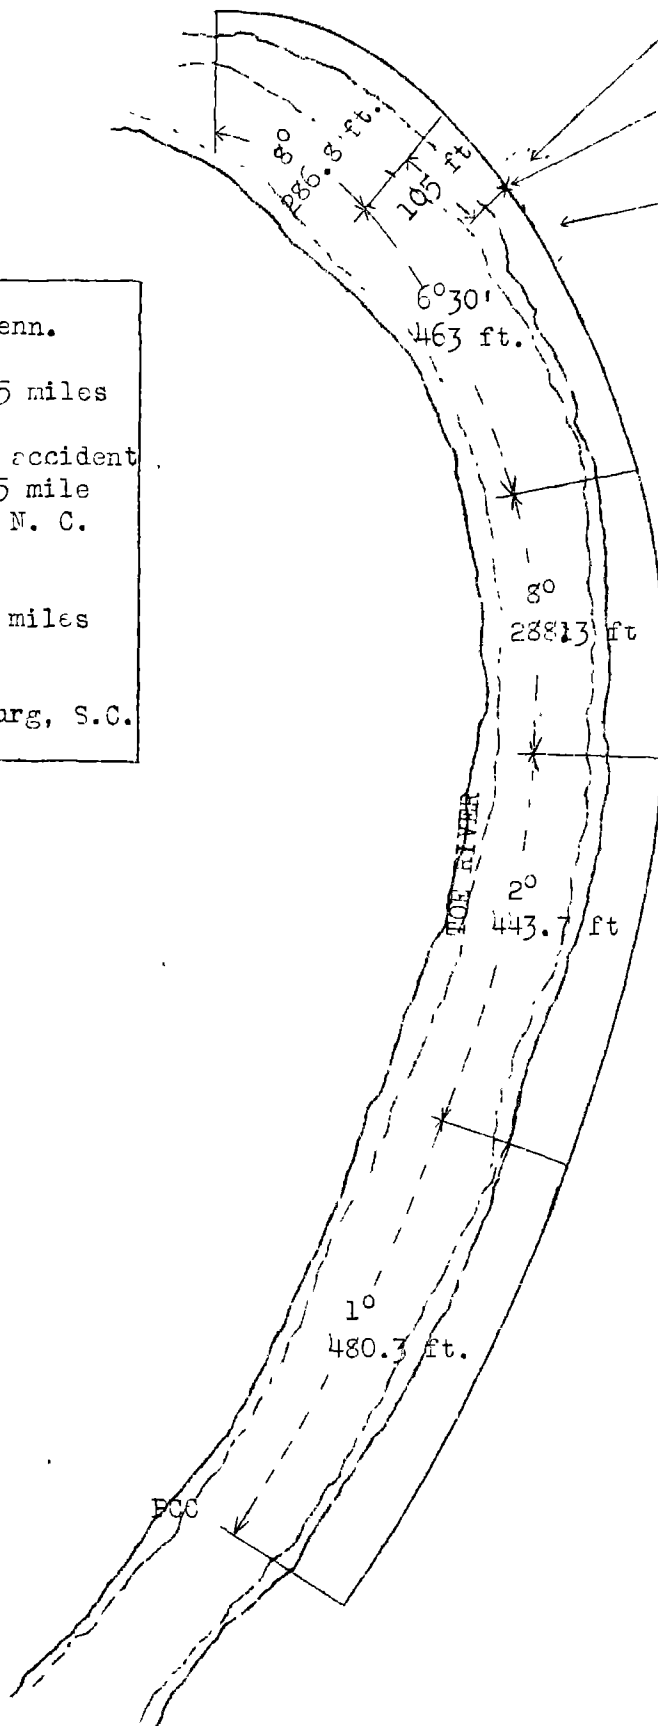
Inv. No. 1972
Clinchfield Railroad
Toecane, N. C.
March 20, 1935

Area of slide starting
41 feet above track

Point of accident

Portion of slope scaled
on March 18, 19 and 20.

The slide consisted of from 40 to 50 cubic yards of earth and rock which was dislodged from an irregular cavity about 5 feet deep, 20 feet wide at the base and about 10 feet wide at the top, the top portion being about 40 feet above the track. The indications were that the track had been pushed out of line and that the east or right rail was covered to a depth of about $3\frac{1}{2}$ feet. A north-bound train had passed through this territory about $1\frac{1}{2}$ hours prior to the occurrence of the accident, at which time there was no evidence of anything wrong.

This accident was caused by a land and rock slide.

It is recommended that immediate consideration be given by this carrier to patrol of tracks by watchmen, the installation of slide detector fences or some other means of protecting trains against the danger of slides in this vicinity.
