NATIONAL TRANSPORTATION SAFETY BOARD

RAILROAD ACCIDENT REPORT

COLLISION AND DERAILMENT
OF AMTRAK TRAIN 6
ON THE BURLINGTON NORTHERN RAILROAD
RUSSELL, IOWA
OCTOBER 12, 1987

NTSB/RAR-88/04

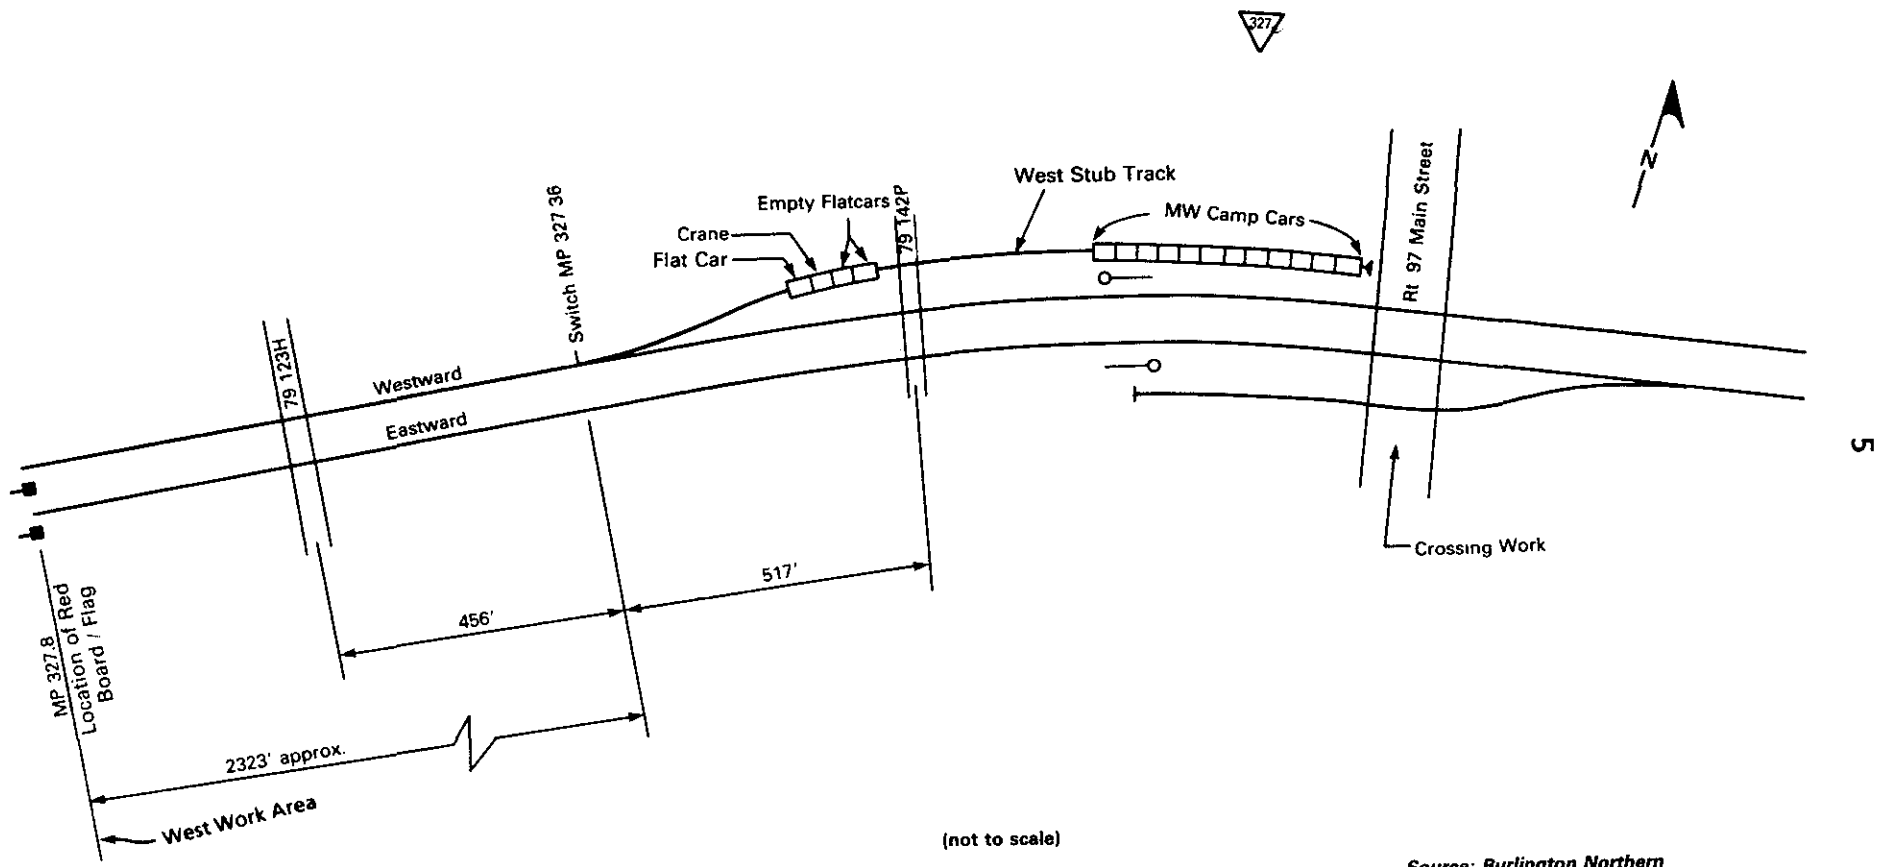
Figure 3.--Russell west stub track - October 12, 1987

The pilot and engineer observed the yellow board and red board as they continued eastbound toward Russell. As they came into Russell, they simultaneously observed that the switch points of the stub track switch were aligned for the stub track instead of for the main track. They also observed that a crane with a flat car was on the stub track. The crew estimated that they were about 1,000 to 1,500 feet west of the switch when they saw the equipment. (See figure 3.) They could not remember seeing the switch banner position on the switch stand mast. The engineer said he immediately initiated an emergency application of the train brakes and shouted to the fireman and pilot to get on the floor. The engineer, fireman, and pilot then braced themselves for the collision. About 1130, train 6 struck the maintenance-of-way work equipment on the west stub track at Russell. (See figure 4.)

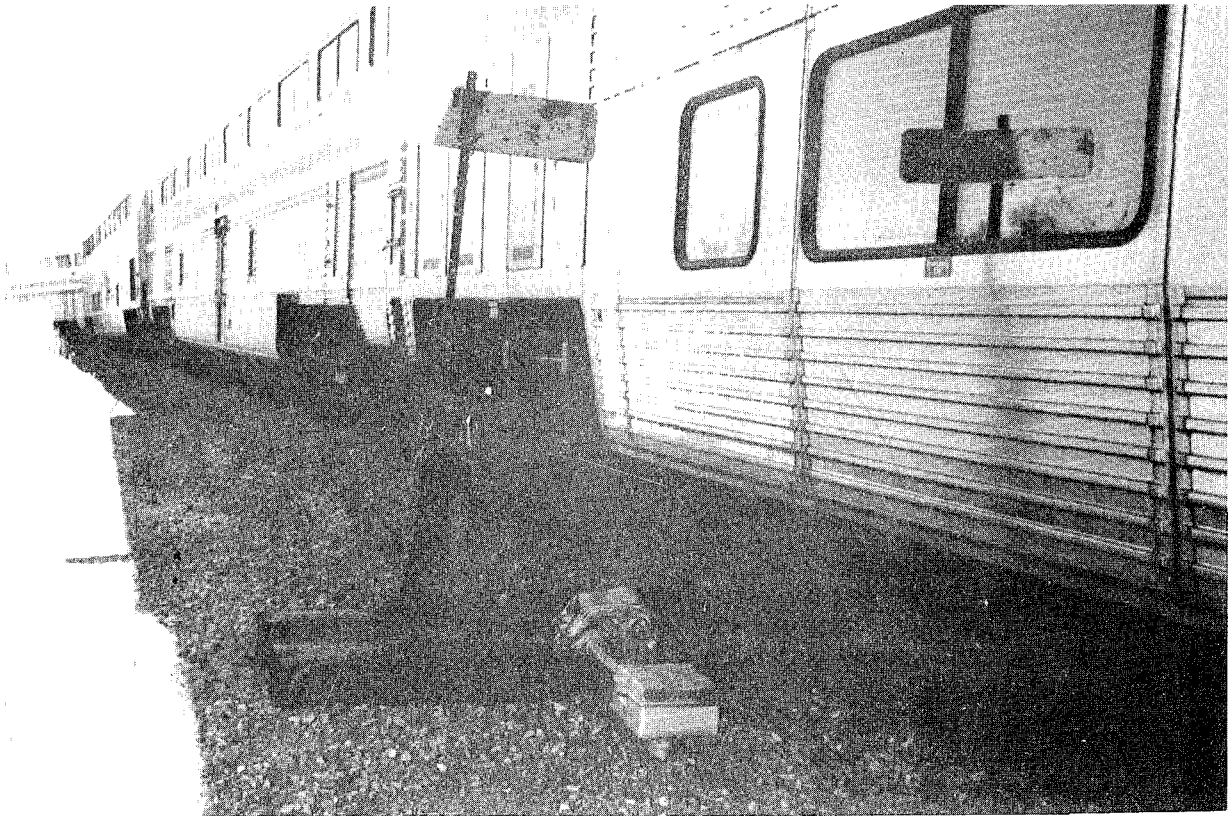
Figure 5 --AMT 34076 on turnout switch point rails
(north side view)

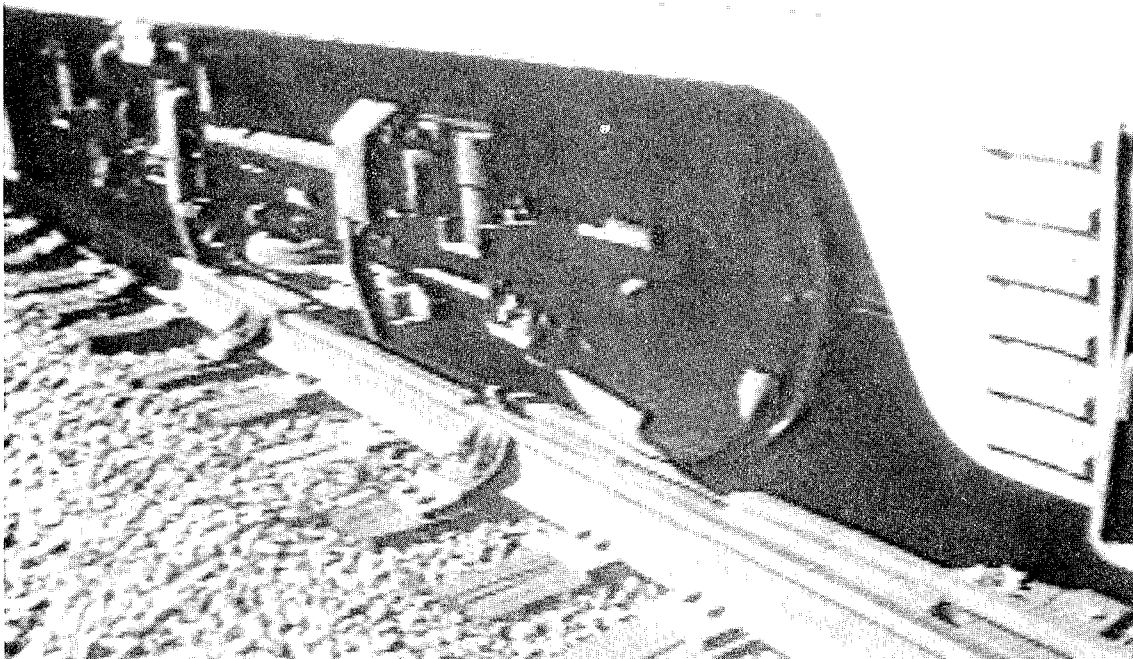
Figure 6.--AMT 34076 on turnout switch point rails
(south side view).

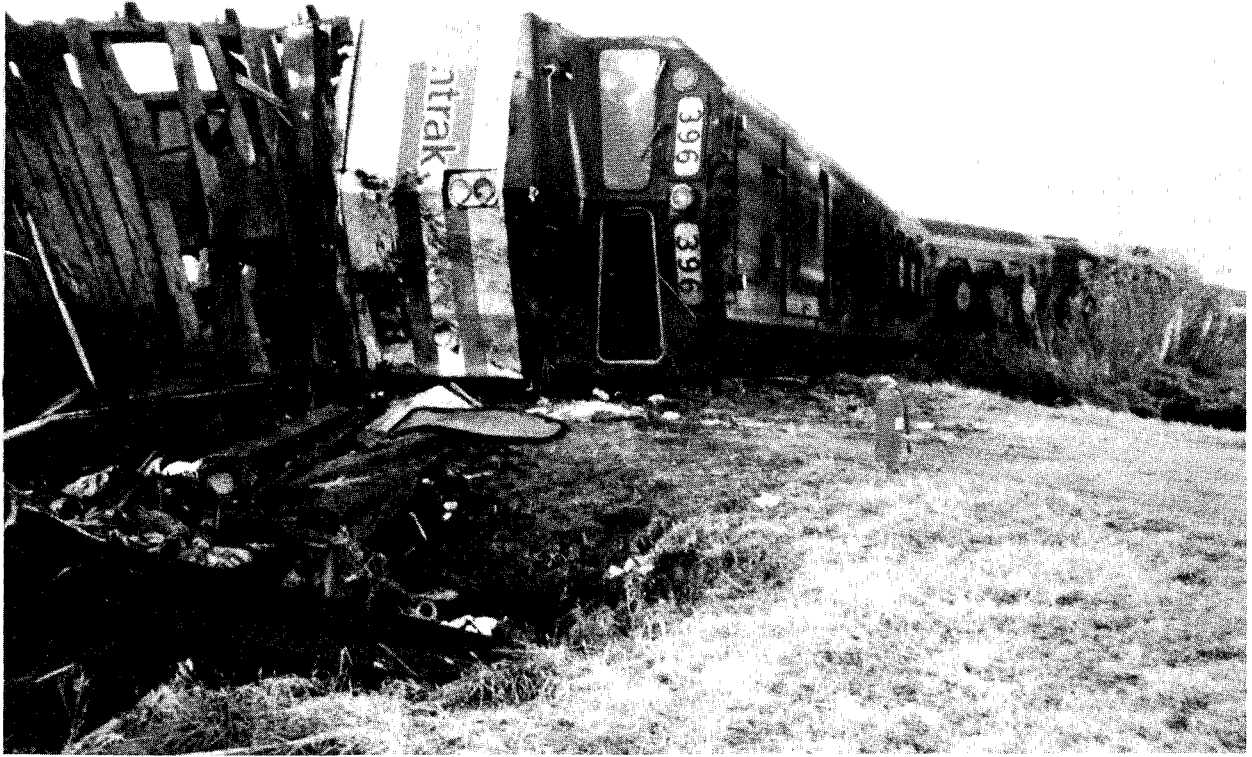
The two locomotive units of train 6 received extensive damage. Unit 396, the lead unit, was facing forward, in the direction of travel, and unit 357, the trailing unit, was facing rear. Both units turned on their sides (See figure 7). The nose and electrical connections of unit 396 were damaged on the pilot end, while the airbrake system and sheet metal were damaged on the left (fireman) side. The sheet metal of unit 357 was damaged on the right (engineer) side, as were the fuel tank and trucks. The sheet metal of the sides and ends of the baggage and passenger cars were damaged, and the derailed trucks and wheel sets were damaged.

Figure 7 --Locomotive of train 6 after the collision

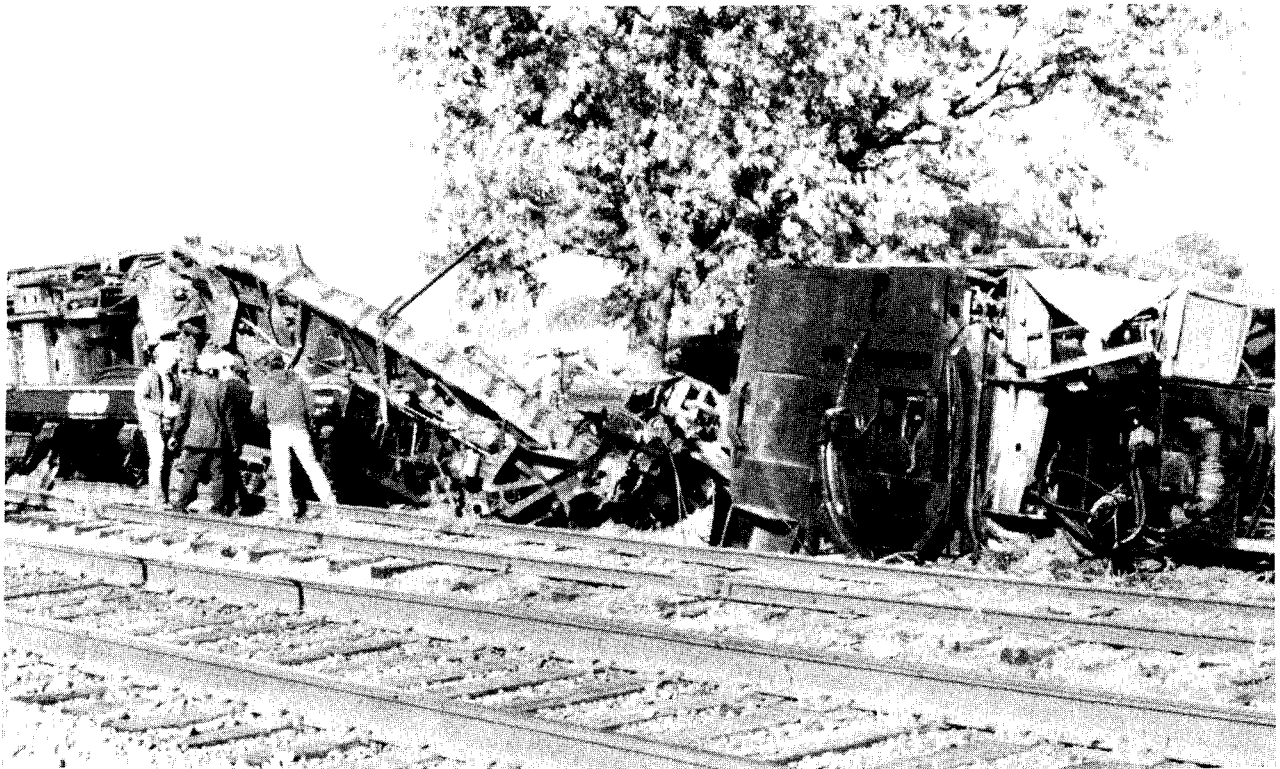
The BN reported that its three flat cars were destroyed. In addition, the crane was extensively damaged. The cab compartment of the crane was separated from its supporting car underframe and the boom separated from the cab and buckled (See figure 8).

Figure 8 --Locomotive, flat car, and crane after the collision.

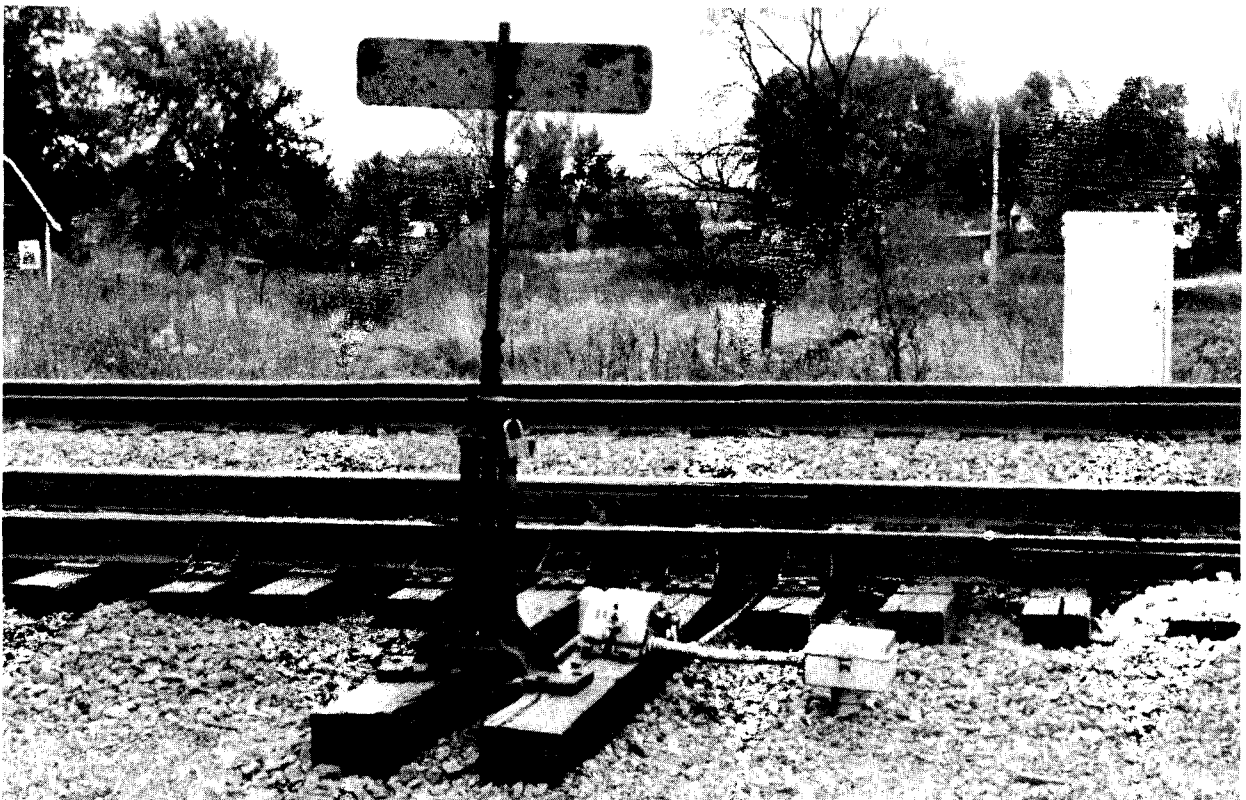
From the track switch located at about MP 327 36, the west stub track extends eastward for about 3/4 mile on the north side of the double main track. The track switch was part of a No. 11 turnout.⁷ The switch points, 19 feet 6 inches in length, were mated to undercut stock rails. The switch stand was a Racor column-throw high stand, without a switch-point locking mechanism. It was equipped with a partially rusted, red-painted banner measuring 8 inches by 36 inches and located approximately 5 feet above the top of the rail. (See figure 11.)

Figure 11.--West stub track switch banner.

Because the switch banner was partially rusted, it was difficult to see against the background, including the track crane. As a result, the crew of train 6 had little opportunity to take advantage of this warning of the track switch position. The traincrew testimony indicated that the switch point position was the first visible sign they had that the switch was open to the stub track. The use of reflective material on the switch banner would have enhanced the visibility of the banner.

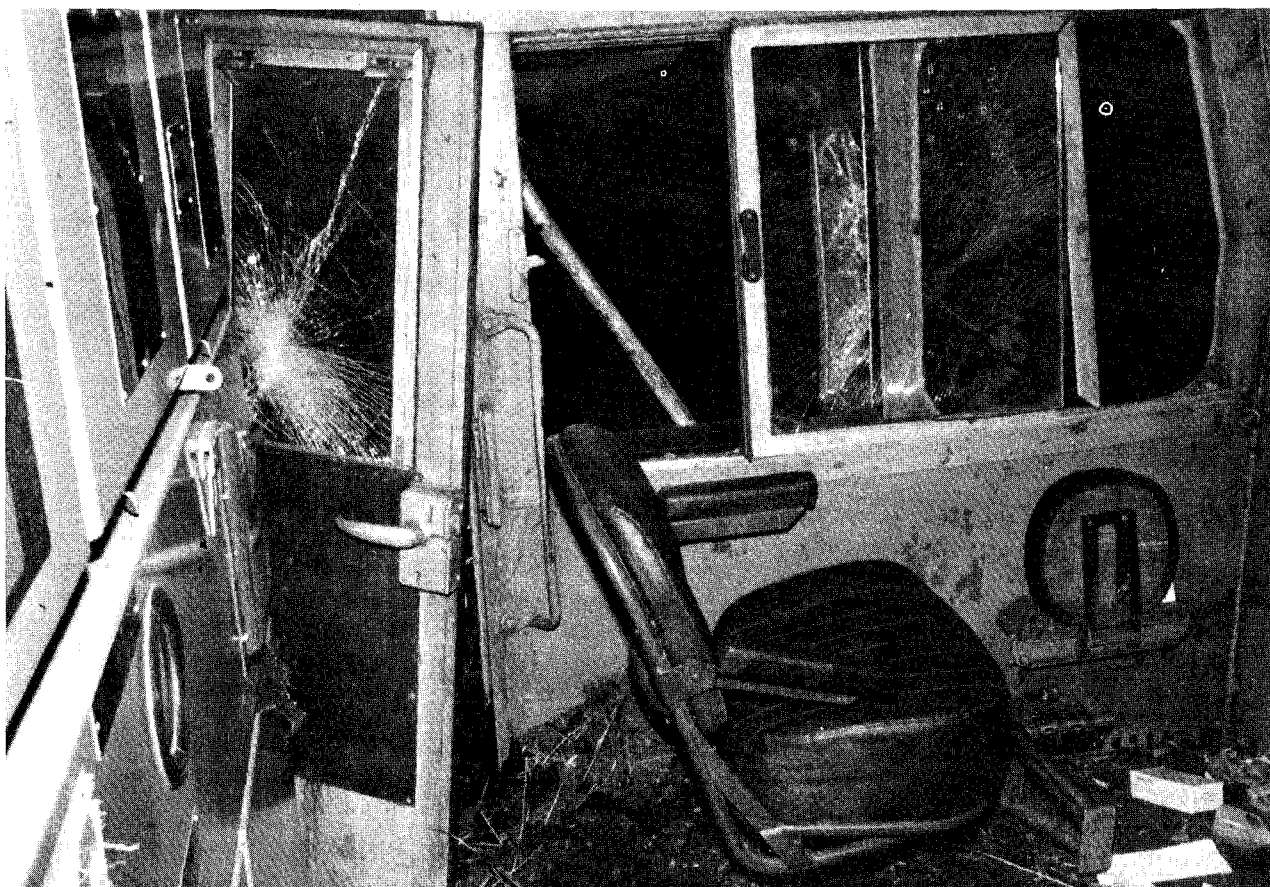
Most of the interior damage sustained by the lead unit 396 was on the fireman's side. The sidewall was displaced inward from the rear of the fireman's door opening to the windshield post with a maximum displacement of about 2 inches at the post between the front and rear windows on the fireman's side. (See figure 12.) The top hinge of the fireman's door was broken and the door window was crazed. The rear sliding window was crazed and the front sliding window was missing because it had been broken out in the accident. The fireman's windshield was removed when the crew evacuated the locomotive. There was a "spider web" crack at the bottom center of the engineer's windshield.

Figure 12 --Interior of the fireman's side of locomotive.

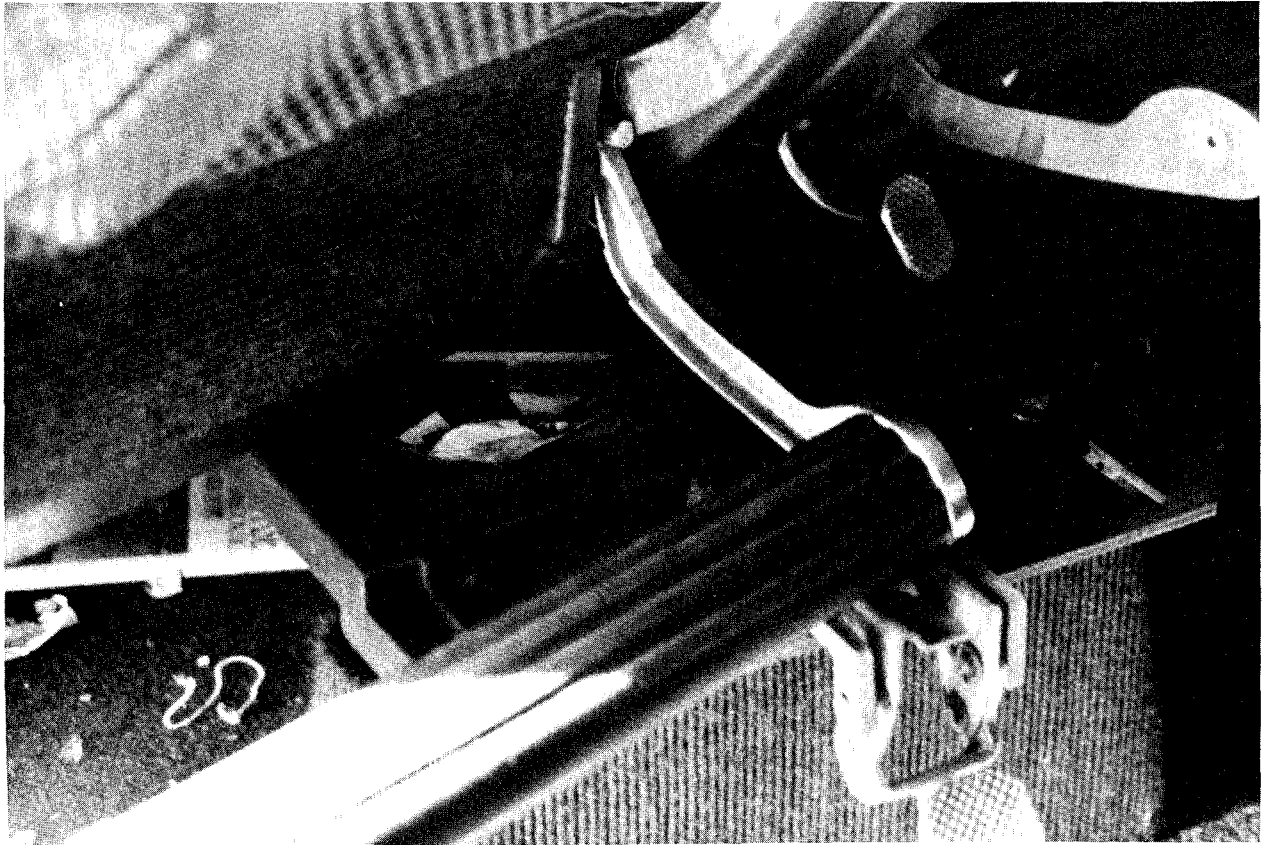
In the coach/dorm car, the seat locks were broken at seats 5/6 and 21/22. Five other seats were turned, but the locks were not broken. The upper door glass was not present on one end. In the coach cars, the seats were turned without damage to seat locks and several cars had damaged and inoperative seat locks. Coach 39957 had six turned seats. Coach 34076 had six turned seats. In addition, seats 7/8, 13/14, 15/16, 25/26, 45/46, and 47/48 had damaged and inoperative seat locks. (See figure 13.) The tops of the seat cushions were dislodged from the frame and the sheet metal supports were exposed at seats 3, 18, 52, 55, and 61. (See figure 14.) Coach 34065 had 10 turned seats. Seats 43/44 and 65/66 had damaged and inoperative seat locks; the tops of the seat cushions were dislodged from the frames and the sheet metal supports were exposed at seats 4, 26, 44, and 54. Coach 34014 had six turned seats. Seats 5/6, 25/26, 49/50, and 63/64 had damaged and inoperative seat locks. Coach 34027 had two seats turned and seats 75/76 and 77/78 had damaged and inoperative seat locks on the upper level. The top seat cushion on seat 80 was dislodged, exposing the sheet metal support; the lower level had 11 seat pairs turned, and seat 3/4 had a damaged and inoperative seat lock.

Figure 13.--Typical damage, inoperative seat lock.

In early 1981, a seat lock was developed by AMI Corporation. . after a period of time, it was determined that these AMI locks were unsatisfactory. Coach and Car Corporation developed a lock that had more positive securement . .Amtrak specified the lock when making the purchase of Amfleet II cars. . delivered through 1983. .in addition seats were purchased. .to replace deteriorated seats in Amfleet I cars . .these additions have been made throughout the period when the six-year overhaul program began in late 1984 Trison Company [second source of supply] developed a lock mechanism similar to the Coach and Car device. .delivery will commence June 1988.

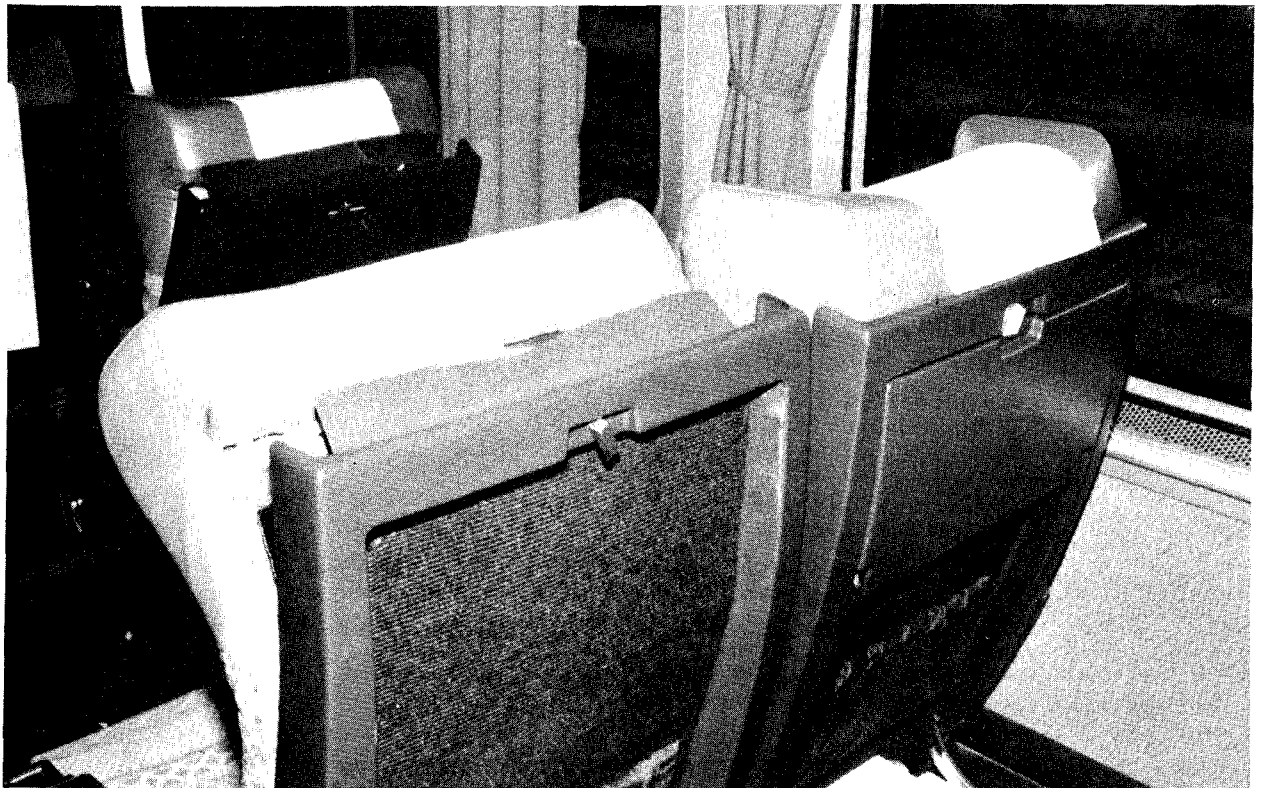
Figure 14.--Typical damage, top seat cushion support with exposed sheet metal strip..

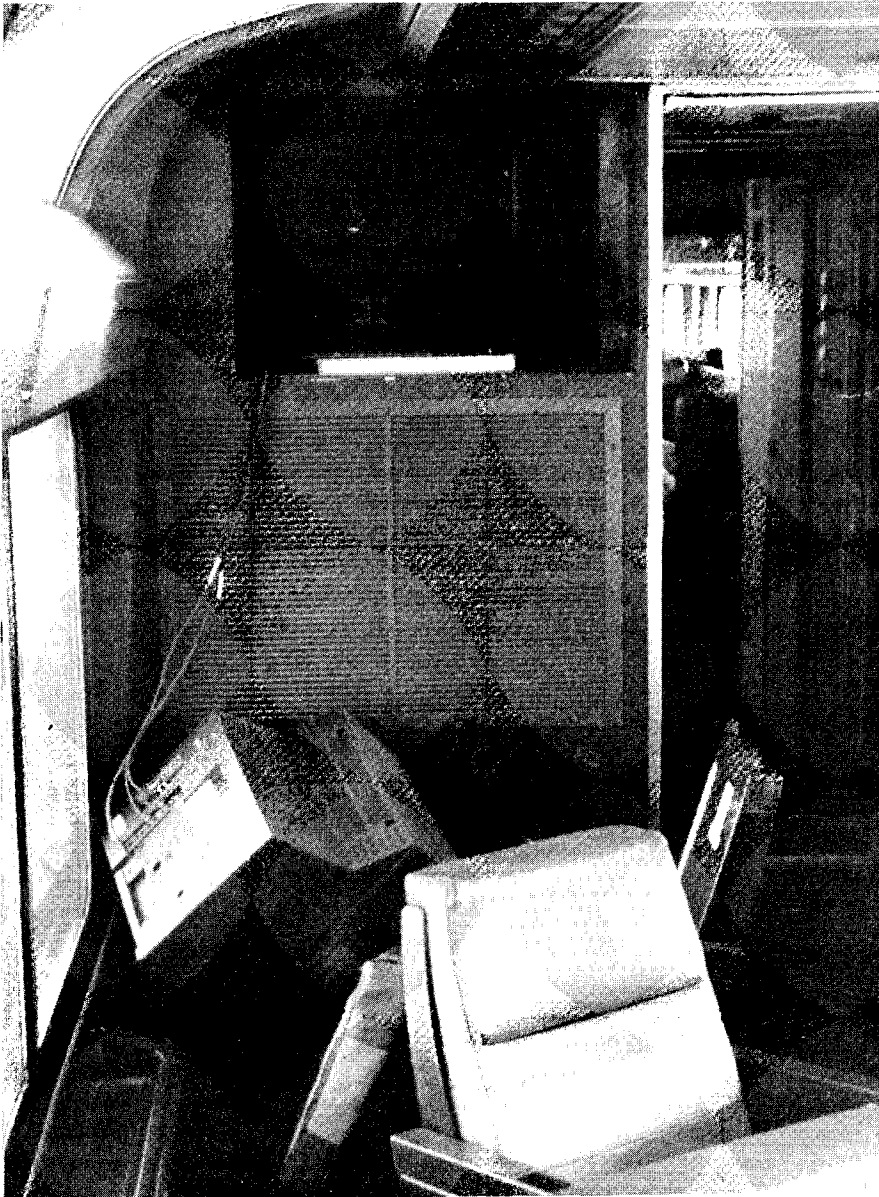
The lower level of lounge/cafe car 33004 had two microwave ovens without restraining straps, but both were still in place. Three rear refrigerator doors were loose and the hinges were broken at the upper pivot. The upper level of the lounge/cafe car had television sets at both ends of the car. The television sets were mounted in a recessed area on short pedestals. At the top of each pedestal was a metal plate to which the television was attached by four sheet metal screws, which passed through drilled holes in the plate and screwed into raised molded plastic bosses (enlarged part of base) on the bottom of the television. All four bosses were broken off and both televisions were

found on the floor of the car. (See figure 15) In addition, three coffeemakers were found on the floor of dining car 38023.

Figure 15.--Interior of AMT 33004 lounge/cafe car.
