ACCIDENT ON THE
COLORADO & SOUTHERN RAILWAY

FOLSOM, N. MEX.

FEBRUARY 16, 1938

INVESTIGATION NO. 2252

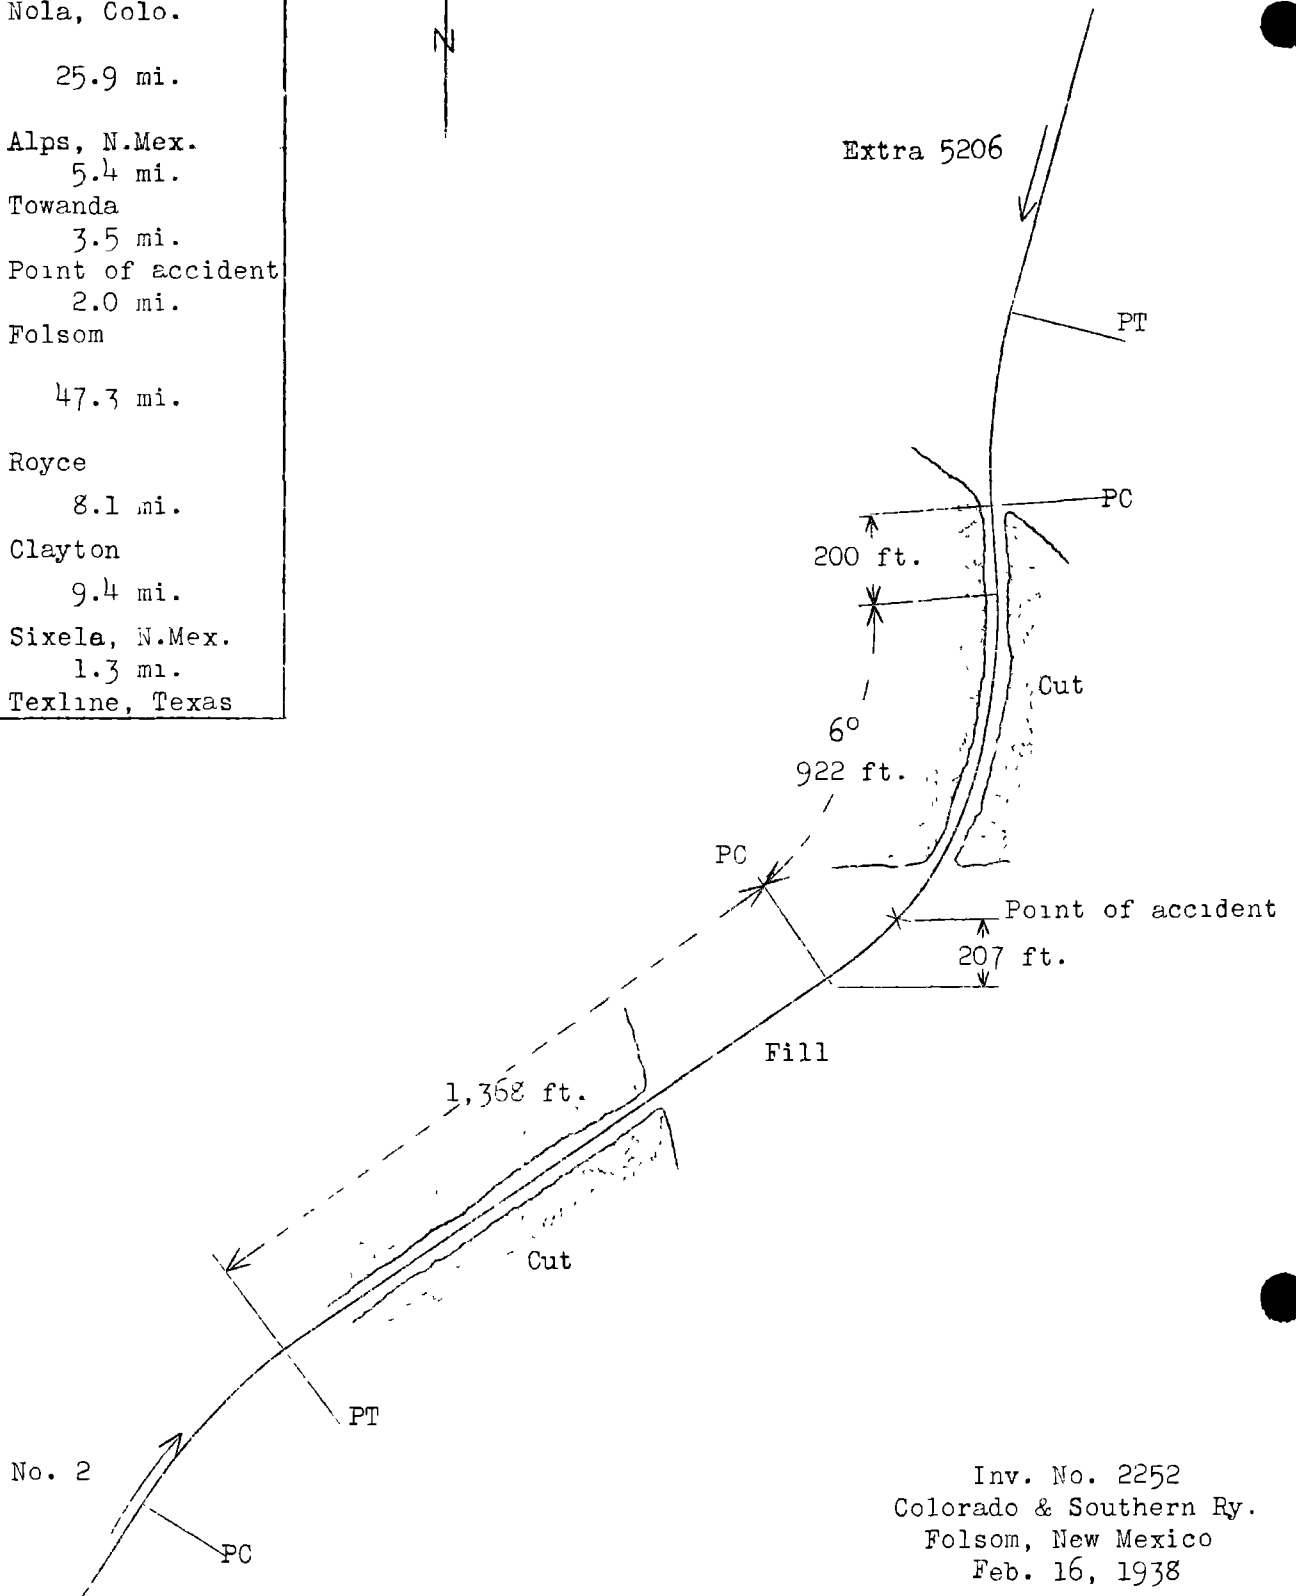
Inv. No. 2252
 Colorado & Southern Ry.
 Folsom, New Mexico
 Feb. 16, 1938

○	Trinidad, Colo.
	32.9 mi.
○	Nola, Colo.
	25.9 mi.
○	Alps, N.Mex.
	5.4 mi.
○	Towanda
	3.5 mi.
X	Point of accident
	2.0 mi.
○	Folsom
	47.3 mi.
○	Royce
	8.1 mi.
○	Clayton
	9.4 mi.
○	Sixela, N.Mex.
	1.3 mi.
○	Texline, Texas
