INTERSTATE COMMERCE COMMISSION

ACCIDENT ON THE

COLORADO & SOUTHERN RAILWAY

MARCH 26, 1937

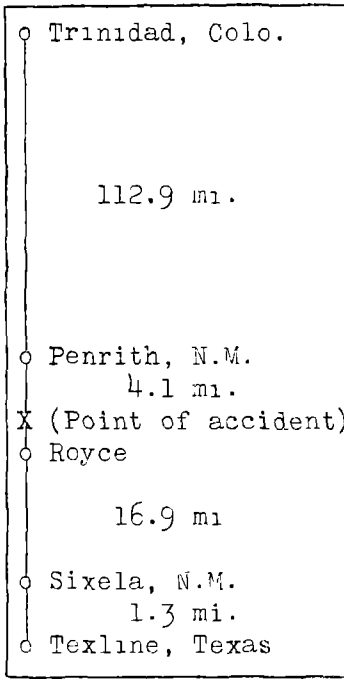
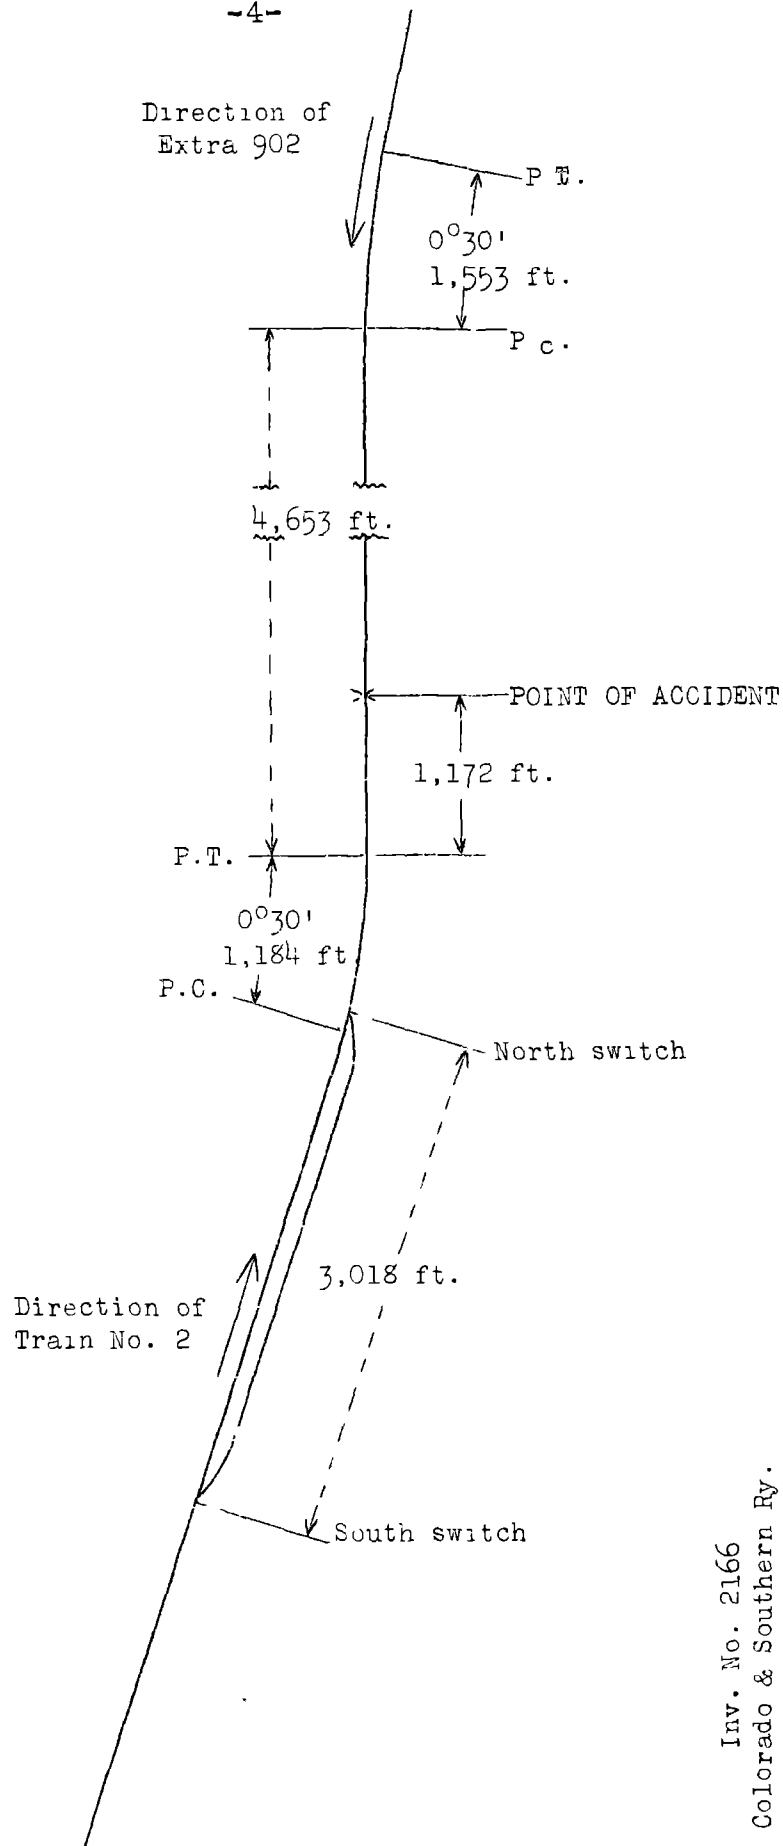
Inv. No. 2166
Colorado & Southern Ry.
Royce, New Mexico
March 26, 1937

at 10:38 p.m., according to the train sheet 11 minutes late, and while running at a speed of 60 miles per hour, as shown by the recording tape on engine 2959, collided with Extra 902 at a point about 2,297 feet north of the north passing-track switch at Royce, at 10:52 p.m.

Both engines were derailed but remained upright close to and parallel with the rails, with the smoke box of engine 902 telescoped nearly its entire length. The trucks and underframe of the tender of engine 2959 were demolished, and the front end of the cistern telescoped the engine cab, while the rear end telescoped the baggage car. The remaining cars of train No. 2 remained on the track and were undamaged. The tender of engine 902 partially telescoped the cab of the engine but remained upright and parallel with the track. The head car stopped with the head end on top of the tender of engine 902, and the rear end off the truck and some distance to the west of the track; the second car stopped with the head end on top of the first car, and the rear end in line with the track; the third car lay on its side to the west of the roadbed. The fourth car was thrown off its trucks, and the head truck of the fifth car was derailed. The employee killed was the engineman of train No. 2. The employees injured were the conductor and fireman of train No. 2, and the fireman, head brakeman and engineman of Extra 902.
