INVESTIGATION NO. 7021

THE COLORADO AND SOUTHERN RAILWAY COMPANY

REPORT IN RE ACCIDENT

Accident near Walsenburg, Colo., on September 5, 1946,
caused by failure to provide adequate protection
for the preceding train.

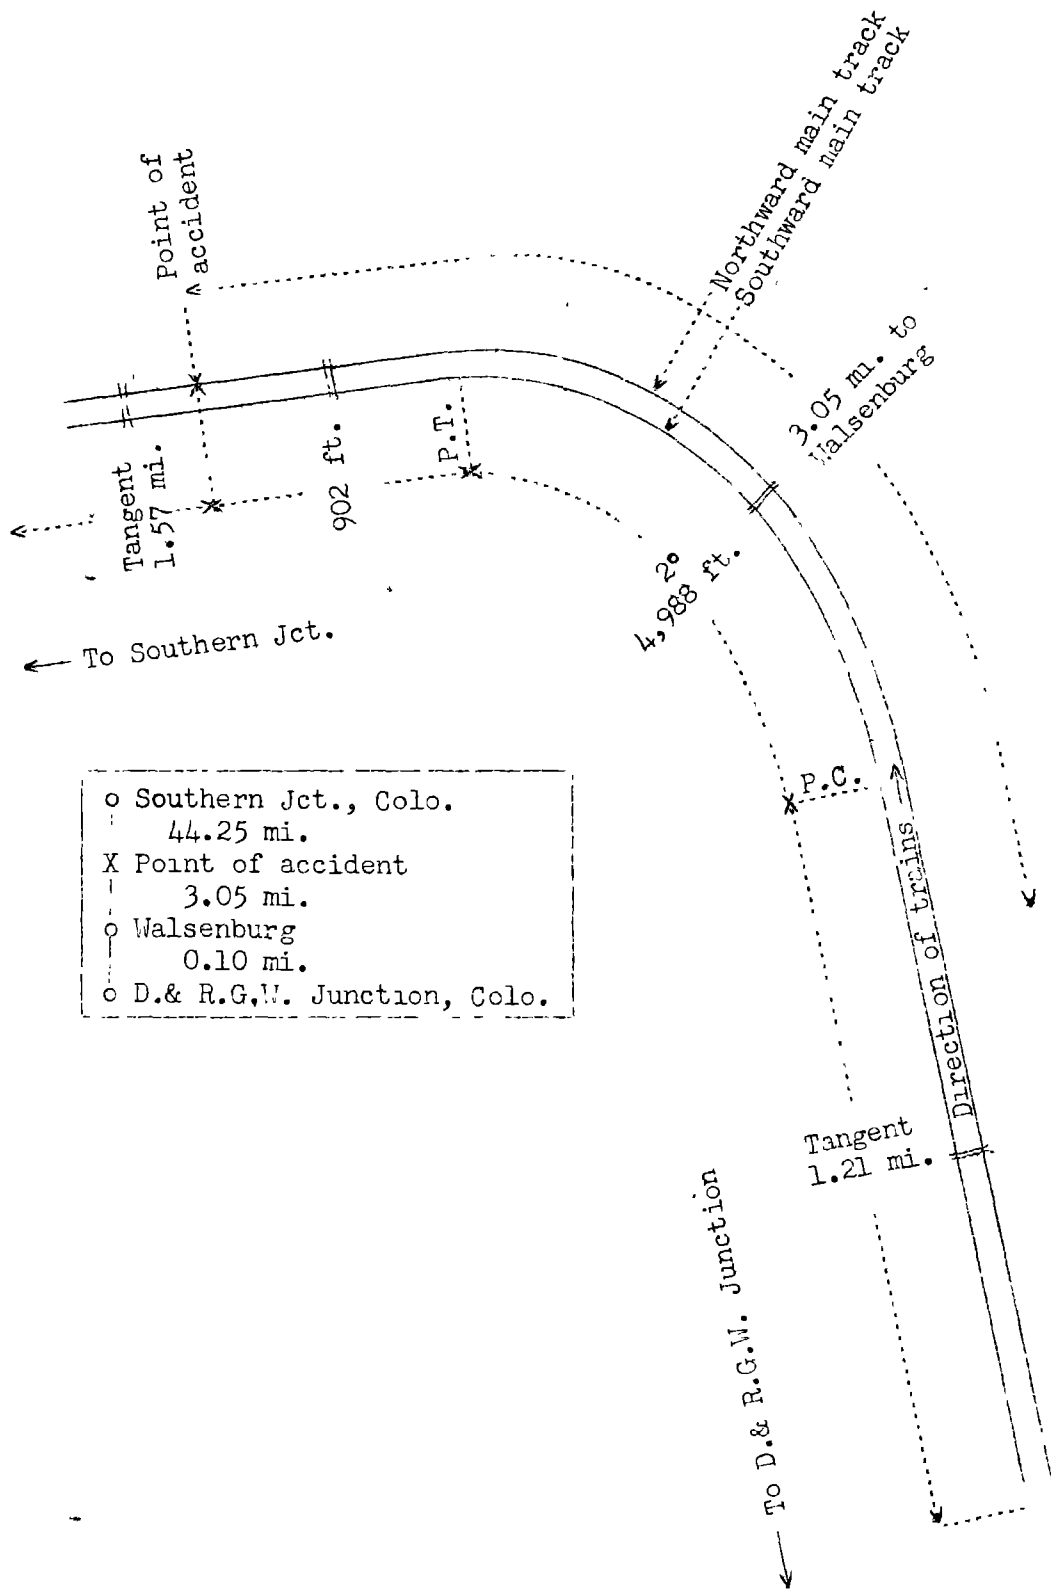
Inv. No. 3021
 Colorado and Southern Railway
 Walsenburg, Colo.
 September 5, 1946

| o | Southern Jct., Colo. | 44.25 mi. |
| X | Point of accident | 3.05 mi. |
| o | Walsenburg | 0.10 mi. |
| o | D. & R.G.W. Junction, Colo. | |
