INTERSTATE COMMERCE COMMISSION:

INVESTIGATION NO. 3022

COLUMBUS AND GREENVILLE RAILWAY COMPANY

REPORT IN RE ACCIDENT

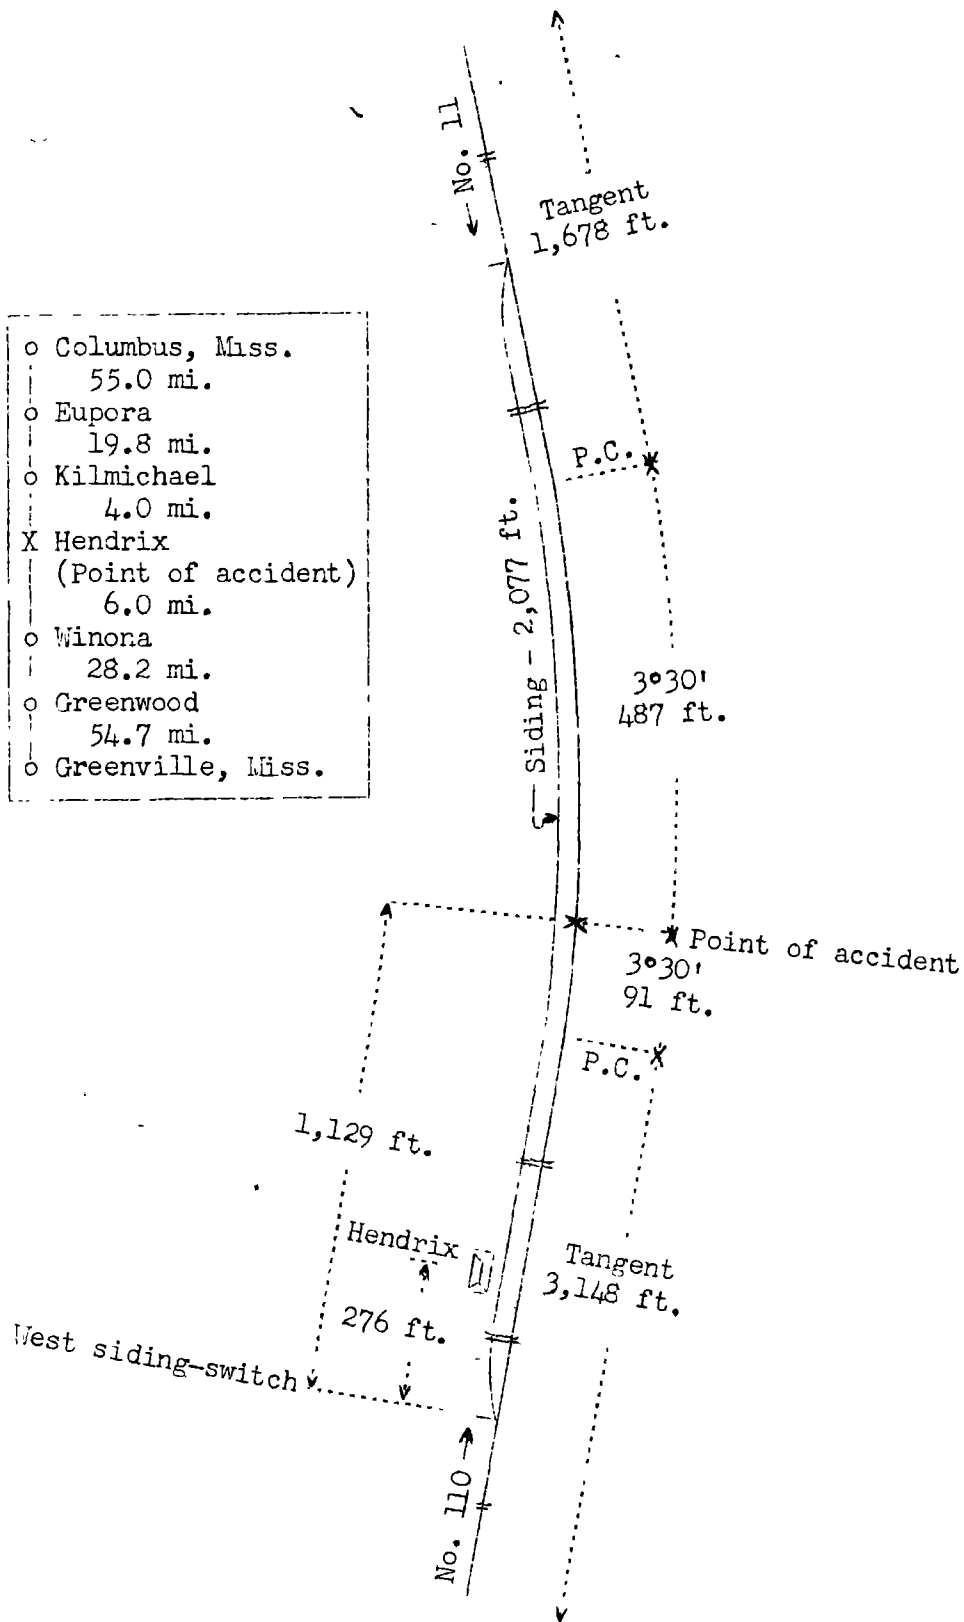
Inv. No. 3022
 Columbus and Greenville Railway
 Hendrix, Miss.
 September 14, 1946

Location of Accident and Method of Operation

The Columbus and Greenville Railway is a single-track line extending between Columbus and Greenville, Miss., 167.7 miles, over which trains are operated by timetable and train orders. There is no block system in use. At Hendrix, 78.8 miles west of Columbus, a siding 2,077 feet in length parallels the main track on the north. The west switch of this siding is 276 feet west of the station. The accident occurred on the main track 1,129 feet east of the west siding-switch. From the east there is a tangent 1,678 feet in length, which is followed by a 3°30' curve to the right 487 feet to the point of accident and 91 feet westward. From the west there is a tangent 3,148 feet in length, which is followed by the curve on which the accident occurred. The grade is 0.10 percent ascending westward.

Because of vegetation on the inside of the curve on which the accident occurred, the view of the point where the accident occurred from an engine moving in either direction is restricted to a distance of about 500 feet.
