INVESTIGATION NO. 3055
COLUMBUS AND GREENVILLE RAILWAY COMPANY
REPORT IN RE ACCIDENT
NEAR MEANS, MISS., ON
DECEMBER 30, 1946

Railroad: Columbus and Greenville
Date: December 30, 1946
Location: Means, Miss.
Kind of accident: Derailment
Train involved: Mixed
Train number: 110
Engine number: 506
Consist: 17 cars
Estimated speed: 30 m. p. h.
Operation: Timetable and train orders
Track: Single; tangent; 0.041 percent
descending grade eastward
Weather: Cloudy
Time: 5:10 p. m.
Casualties: 1 killed; 6 injured
Cause: Broken angle bars

Accident near Means, Miss., on December 30, 1946, caused
by broken angle bars.

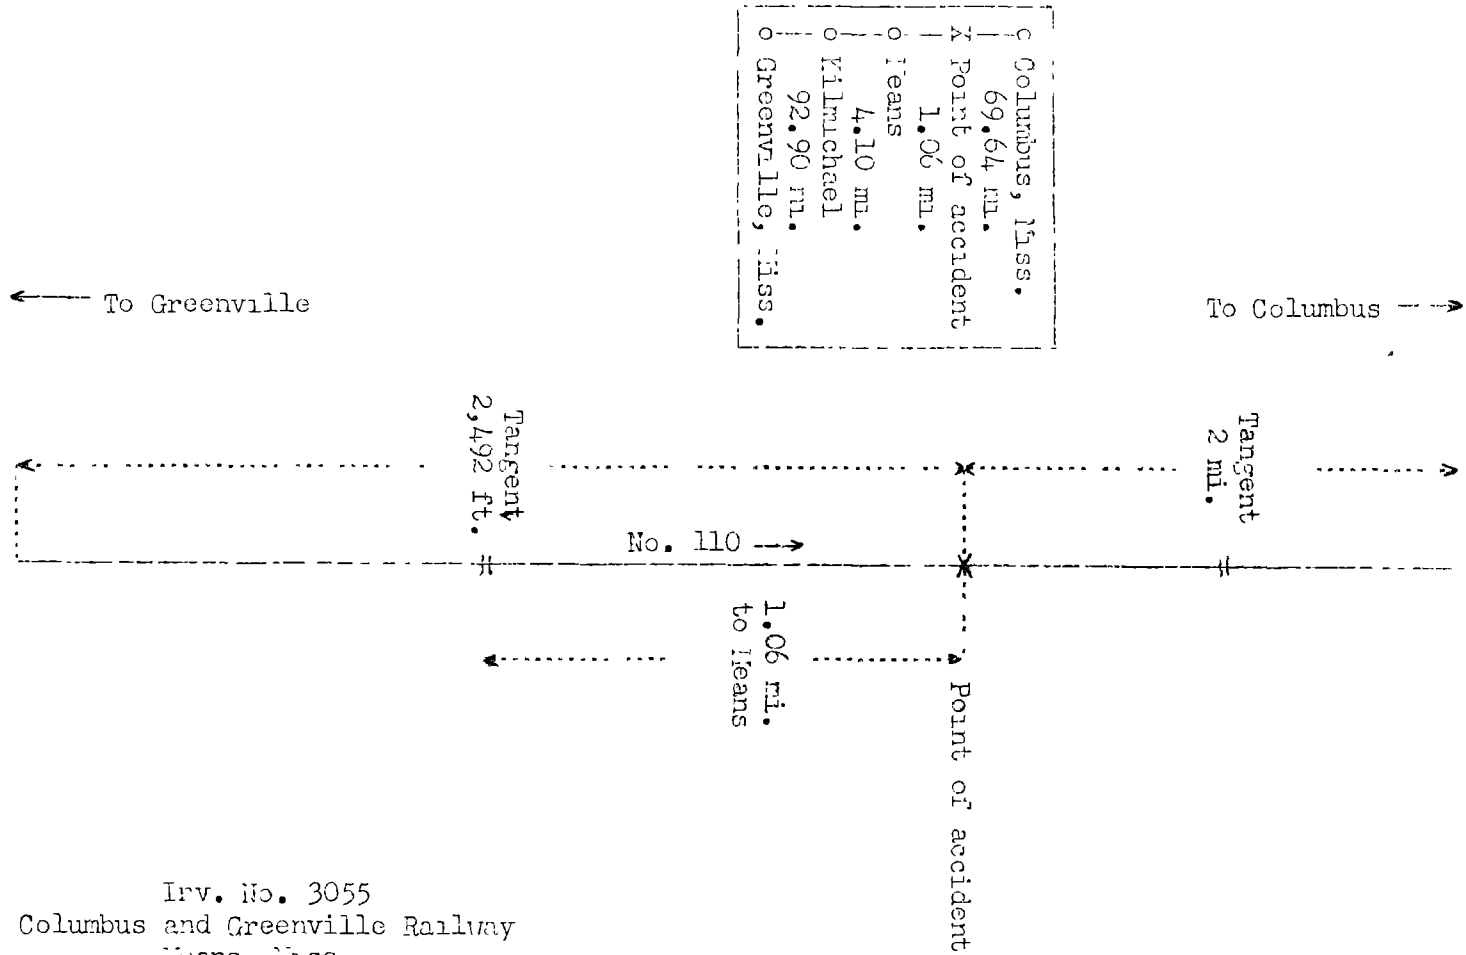
Irv. No. 3055
 Columbus and Greenville Railway
 Means, Miss.
 December 30, 1946

The engine overturned to the right and stopped on its right side down the embankment and at an angle of about 15 degrees to the track, with the front end 228 feet east of the point of derailment. The cab was demolished, steam pipes within the cab were broken, and the engine was otherwise badly damaged. The tender stopped on its right side, off its trucks, at the rear of the engine and at an angle of about 45 degrees to it. The derailed cars stopped in various positions and were considerably damaged.

After the accident the west ends of two broken angle bars were found attached to the leaving end of a rail on the south side of the track. These angle bars were broken squarely at the rail-end location. The east end of the rail was battered downward about 1/8-inch and horizontally on the gage side about 3/8-inch. Eastward from this point the track was destroyed throughout a distance of about 200 feet to the point where the engine overturned. At the break in the outside angle bar there was a progressive fracture extending downward about 1/4-inch and across the entire width of the bar. At the break in the inside bar there was a progressive fracture which covered about 50 percent of the cross-sectional area. The breaks other than the progressive fractures were new. A tie supported each rail near its end at the joint in question, but there was no tie immediately under the joint. The bolt holes of the bars were elongated considerably, which condition indicates that there had been excessive movement at this joint. In this vicinity the track is laid on an earthen fill extending across marshland. The centers of the cribs were filled with cinder ballast extending to the tops of the ties, but the ends of the ties were inadequately supported by ballast. The batter marks on the east end of the rail at the location of the broken angle bars indicate that the complete failure of these bars occurred some time before the derailment occurred, and that the batter marks were made prior to the derailment by the wheels of the equipment of a west-bound train being in contact with the east end of this rail. Examination of the engine of No. 110 disclosed that the pilot was bent inward, and the right side of the pilot bore marks indicating that it had been in contact with the end of a rail. Evidently the west end of the rail

immediately east of the broken angle bars extended upward, as the result of surface bending, sufficiently to be in contact with the pilot of the engine of No. 110, then the general displacement of the track structure followed.
