# NATIONAL TRANSPORTATION SAFETY BOARD

## RAILROAD ACCIDENT REPORT

REAR-END COLLISION OF  
CONRAIL COMMUTER TRAINS  
PHILADELPHIA, PENNSYLVANIA

NTSB-RAR-80-5

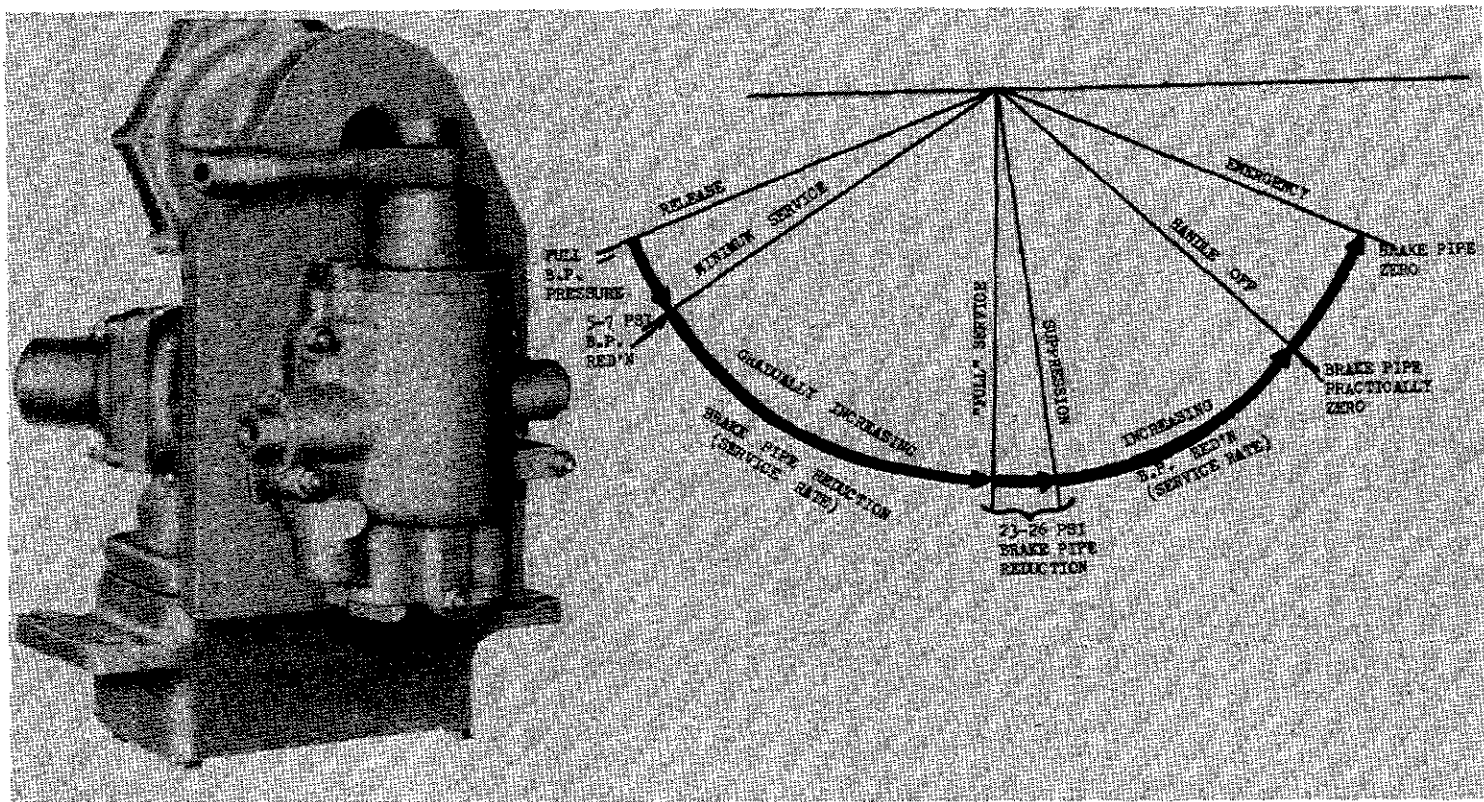
Figure 1.—26-B-1 automatic brake valve.

Following the accident, an inspection of the operating controls of train No. 1718 indicated that the brake valve was cut in, with the handle in the handle-off position. The master controller handle was missing but the handle receptacle indicated that the controller was in the center or emergency position. The control plug, which activates the car's controls, was inserted.

6. The condition of the railheads did not contribute to the failure to stop.
7. The engineer failed to operate the automatic brake valve handle correctly and, thus, failed to stop the train before it collided with the standing train.

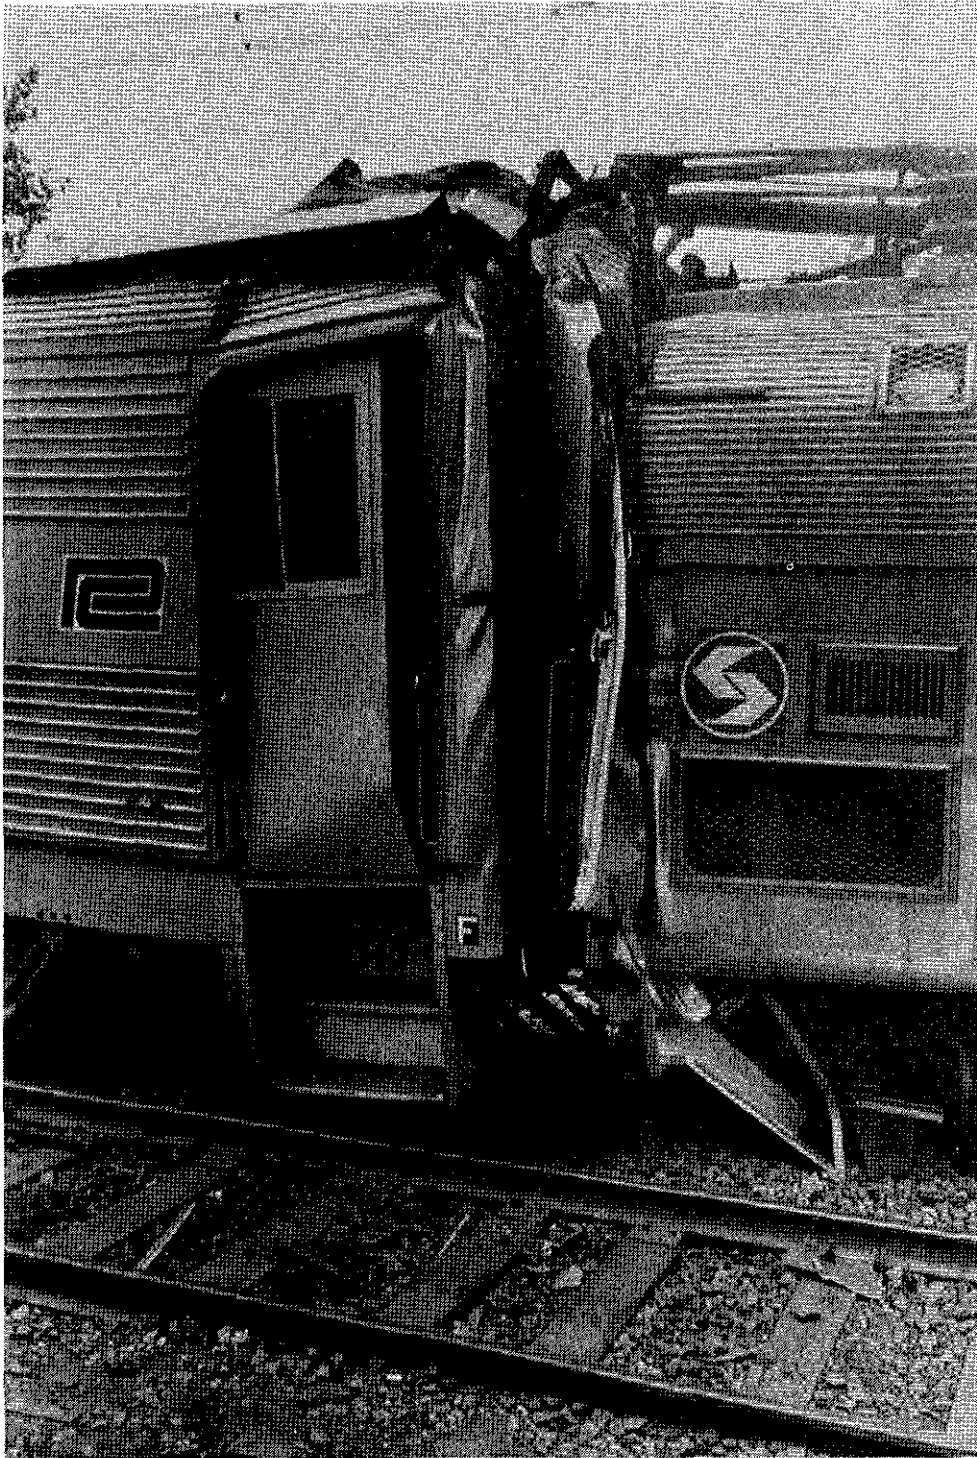
Figure 3.--Left-rear car No. 0714, right-lead car No. 1718.

The equipment in trains Nos. 716, 0714, and 1718 had damage that varied from slight to heavy. The damage consisted of broken piping to the emergency air reservoirs, broken couplers, bent end-posts and frames, buckled side skin, buckled buffer plates, and broken glass. The ends of the cars where impact occurred were damaged severely. On several cars, the end doors were inoperable because of the distortion of the underframe caused by high compressive forces.

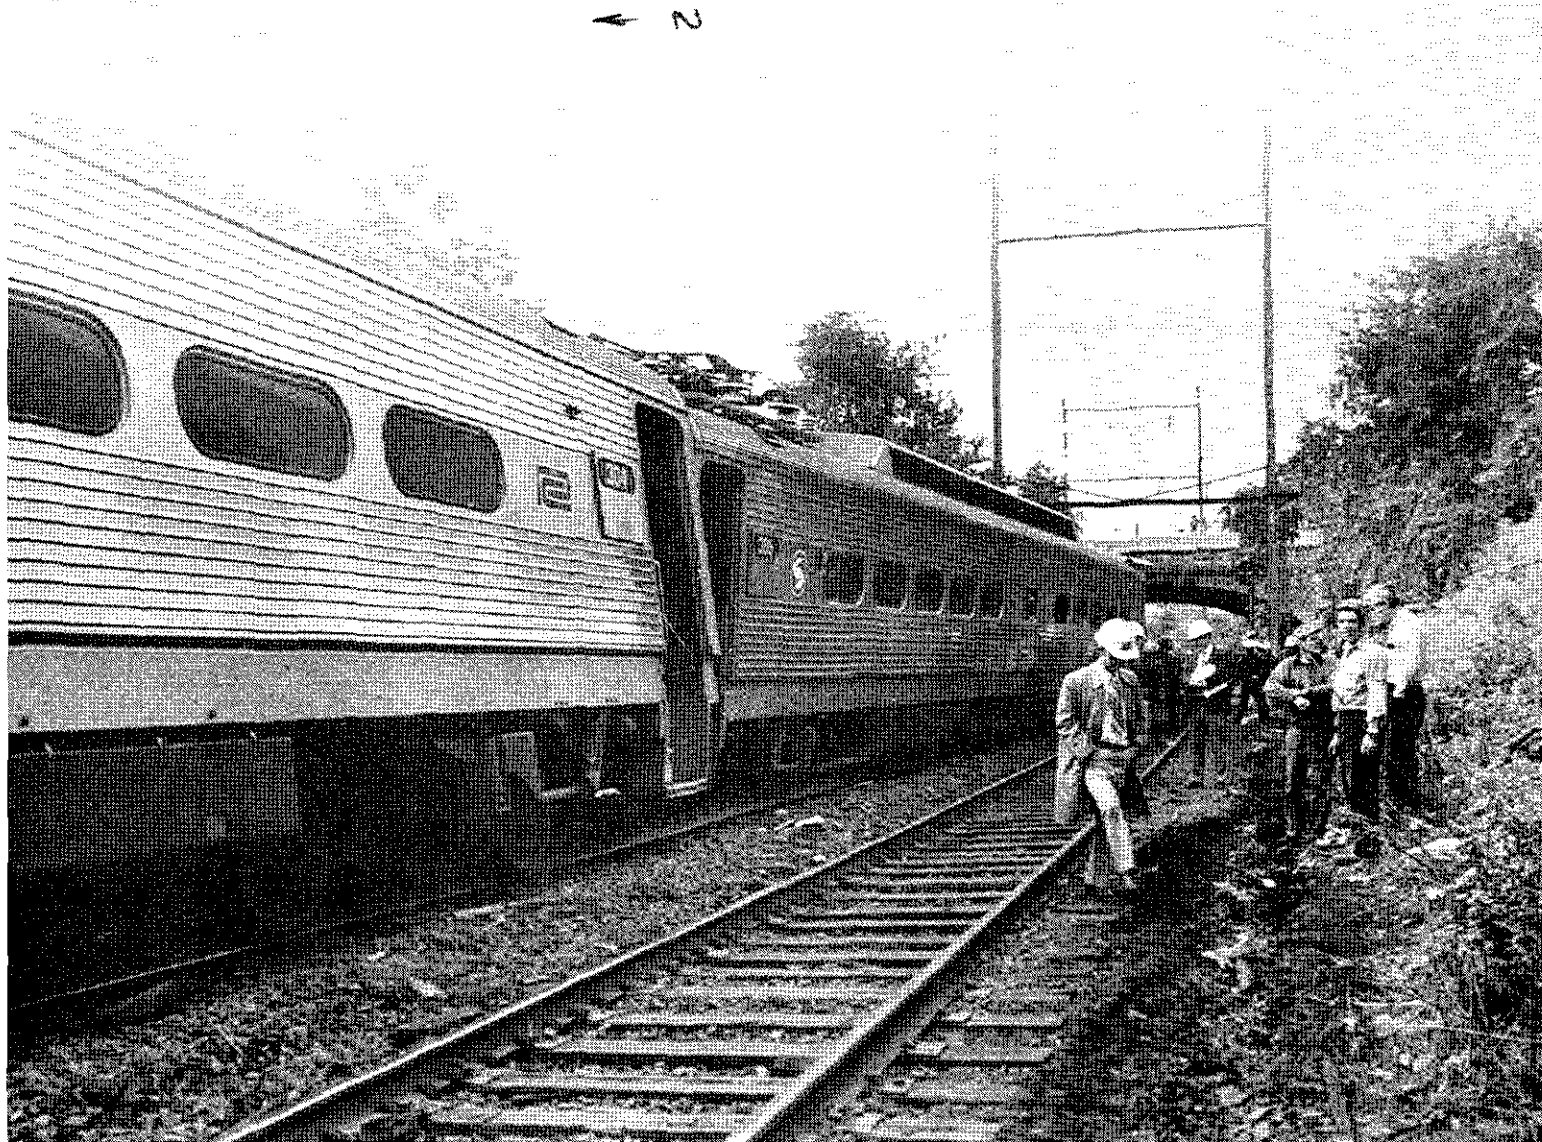
Cars Nos. 305 and 304 in train No. 0714 derailed and moved toward the west a sufficient distance to block track No. 2, but they remained upright and in line. Cars Nos. 265, 221, and 255 in train No. 1718 derailed but remained upright and in line with the track. Although the catenary structure was not damaged and power was not disrupted, power was cut off at 8:22 a.m., as a safety precaution. (See figures 3 and 4.)

Figure 4.--Train No. 0714; view is south.

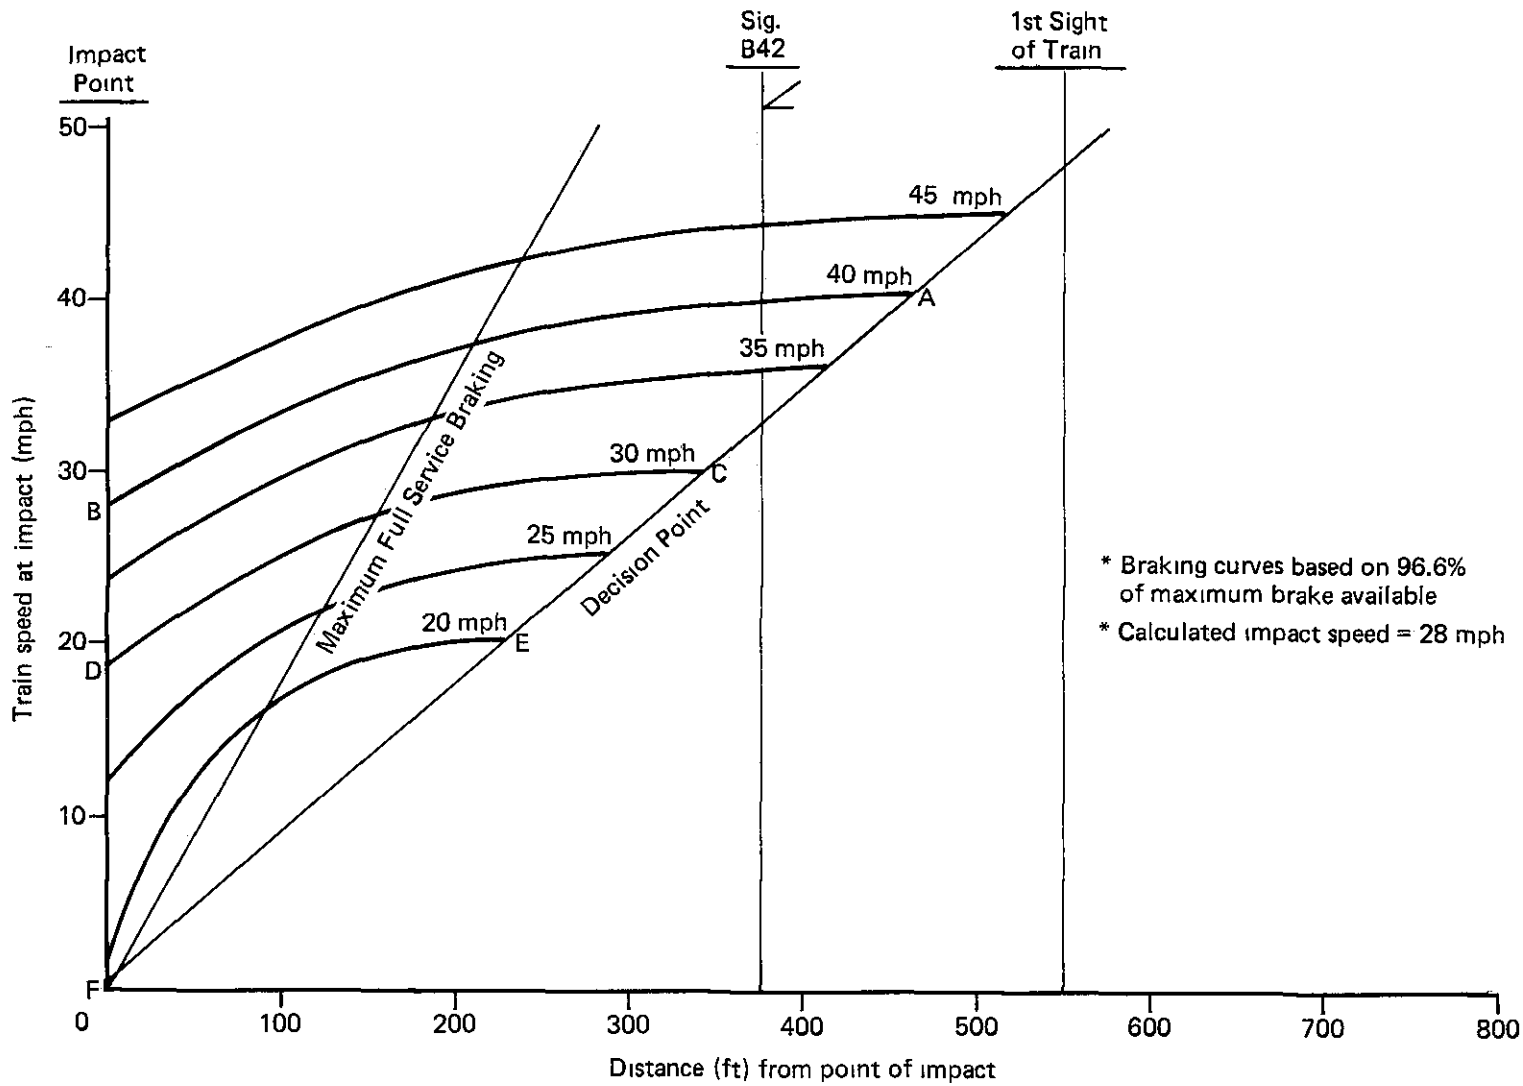
Test results indicate that the brakes were operable and effective. Therefore, the Safety Board must conclude that the train was being operated at a speed greater than the 20 mph estimated by the engineer for the resulting damage to have occurred.

- o The 40-mph curve indicates that, if a decision was made to stop and a full-service brake application was made, the train's speed would be reduced to the computed collision speed, 28 mph, in approximately 460 ft (points A to B).
- o Allowing time for a decision to stop and make a full-service brake application; the 30-mph curve indicates that impact would have occurred at a lower speed, 18 mph, after traveling approximately 350 ft (points C to D).
- o Under the same conditions for the 20-mph curve, the 20-mph curve indicates that train No. 1718 would have stopped before hitting train No. 0714 (points E to F).

Figure 5.—Impact speed vs. train speed (mph).
