# NATIONAL TRANSPORTATION SAFETY BOARD

## RAILROAD ACCIDENT REPORT

**REAR END COLLISION OF  
CONRAIL COMMUTER TRAIN NO. 400  
AND AMTRAK PASSENGER TRAIN NO. 60  
SEABROOK, MARYLAND  
JUNE 9, 1978**

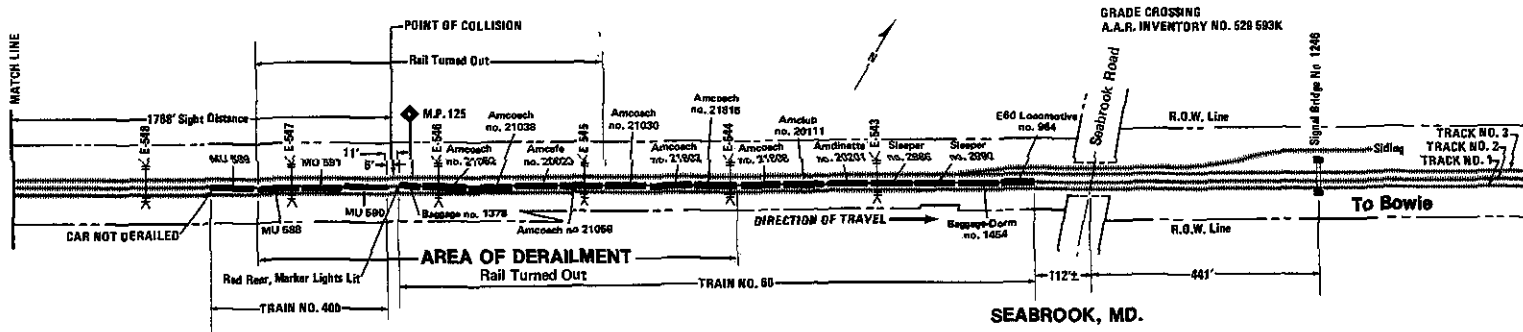
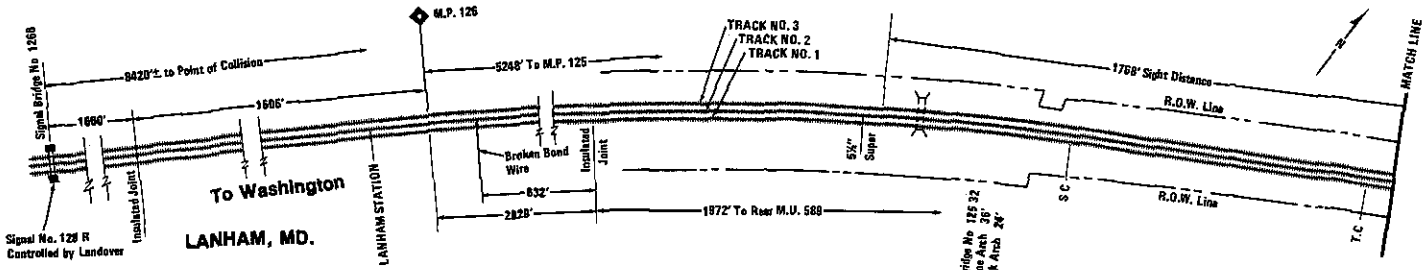
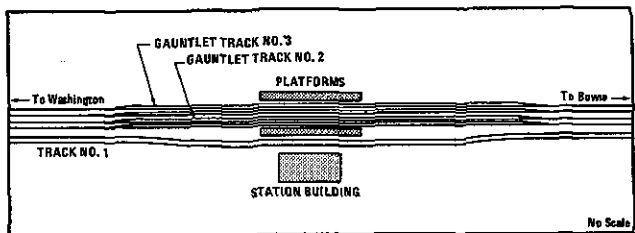
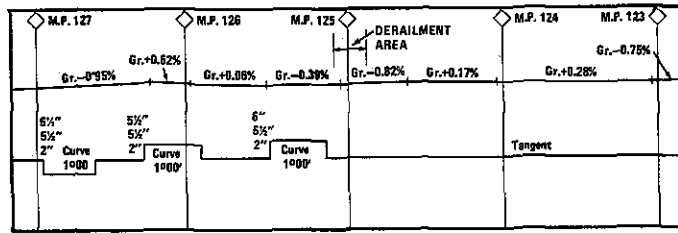
Figure 1. Plan view of accident site.

A northbound train on track No. 2 beginning at signal 128R moves around a 1° right curve for 1,760 feet; the grade ascends at the rate of 0.62 percent. At this point the train enters a 2,290-foot tangent section. It then enters a 1° right curve for 1,654 feet on a 0.39 percent descending grade. The track is then tangent with the same rate of descending grade for 191 feet to the point of the collision. The tracks are elevated about 5 feet above the terrain on each side. Visibility of the engineer of a train approaching the collision point is about 1,770 feet because of track curvature and vegetation along the track. (See figure 1.)

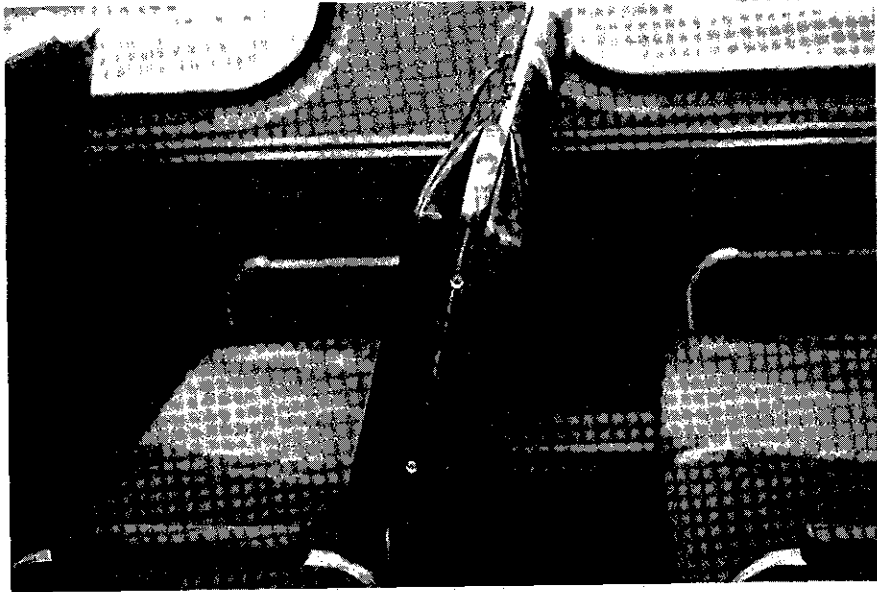
Figure 2. Seat with unpadded metal strip bordering top and side.

The injuries to persons aboard train No. 400 were caused by being propelled into seatbacks which collapsed and onto unpadded metal strips bordering the tops and sides of the seats. The Safety Board has discussed the injury-producing features of car interiors in previous reports. <sup>1/</sup> The Safety Board has made recommendations to the FRA regarding the unsafe design of these cars. Neither the FRA nor UMTA currently has any regulations for the interior design of passenger cars. Because of this lack of regulation, neither the FRA nor UMTA was involved with the design of the NJ DOT cars, even though their construction was funded by the Federal government. The Safety Board concludes that if the commuter cars on train No. 400 had been designed to eliminate injury-producing interior features, the number of injuries resulting from the collision would have been greatly reduced.

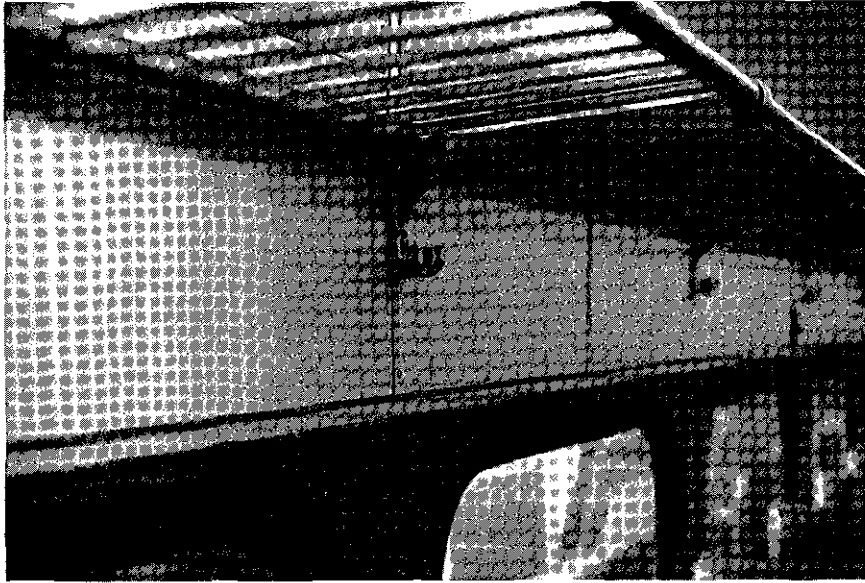
Figure 4. Large metal hooks for hats and coats.

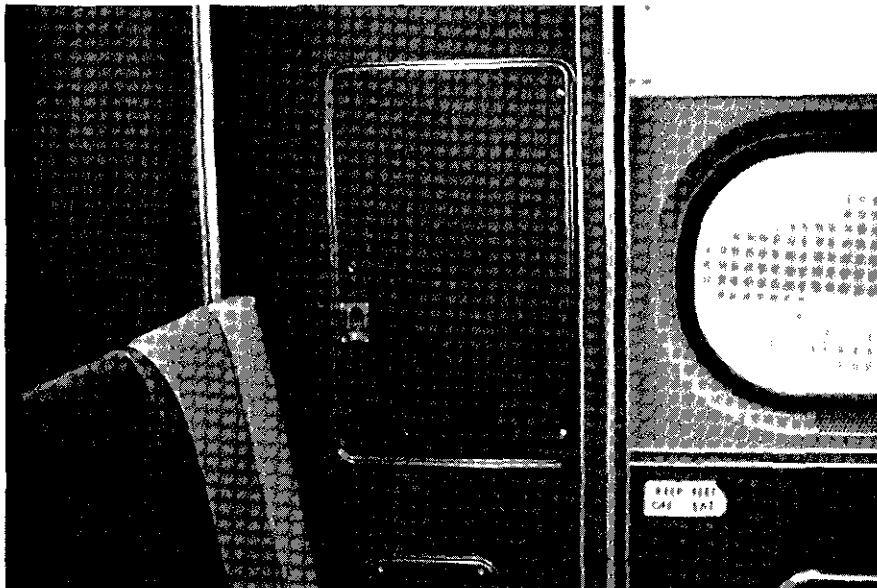
Figure 5. Cabinet door containing emergency operating door mechanism.

Emergency release mechanisms for doors and instructions for their operation should be clearly marked for use in case of derailment, collision, and fire. In this accident, the door operating instructions were locked inside the cabinet containing the operating device in the cars of train No. 400, and there was no sign on the cabinet to indicate the device was inside. The conductor of train No. 400 had not been trained to use the device. Amtrak and Conrail had not provided training and familiarization for railroad emergencies to local rescue organizations. The failure to provide identification of the emergency mechanism and Conrail's failure to train the crewmembers to use the device caused the removal of injured passengers to be delayed.

"Change the emergency release mechanism for the doors on all cars of the type involved in this accident so that the doors can be opened by passengers under emergency conditions, and properly identify the operating emergency equipment. (Class II, Priority Action)(R-79-29)

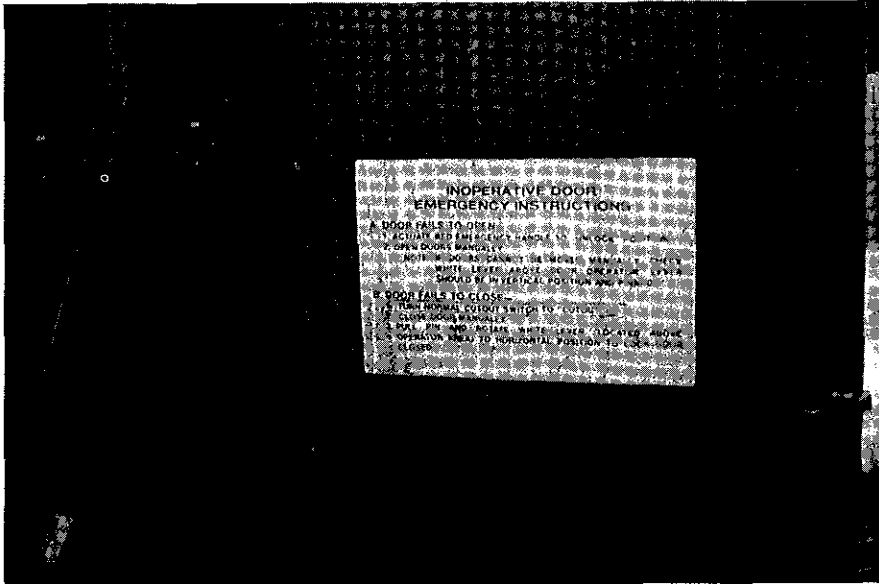
Figure 6. Operating instructions on inside of cabinet door.

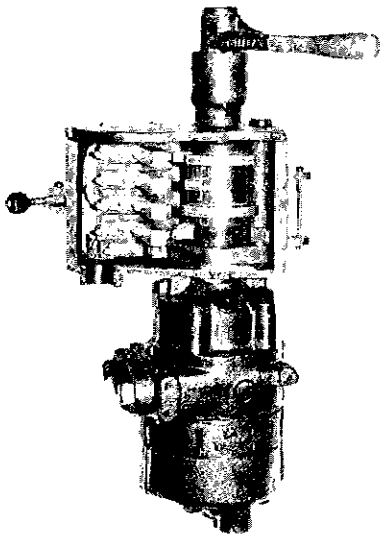
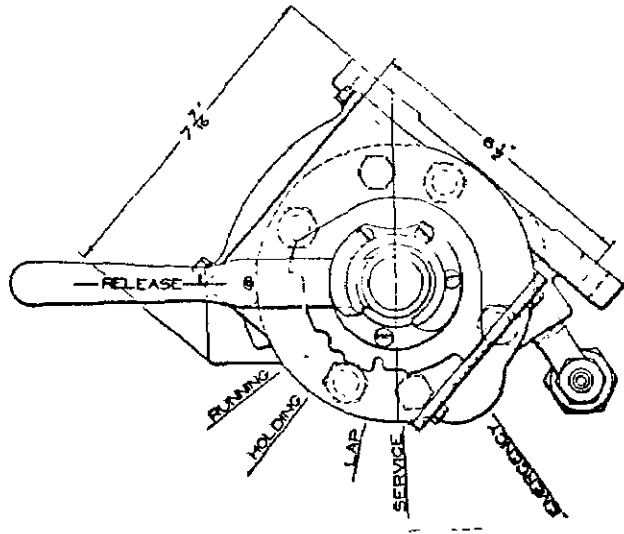
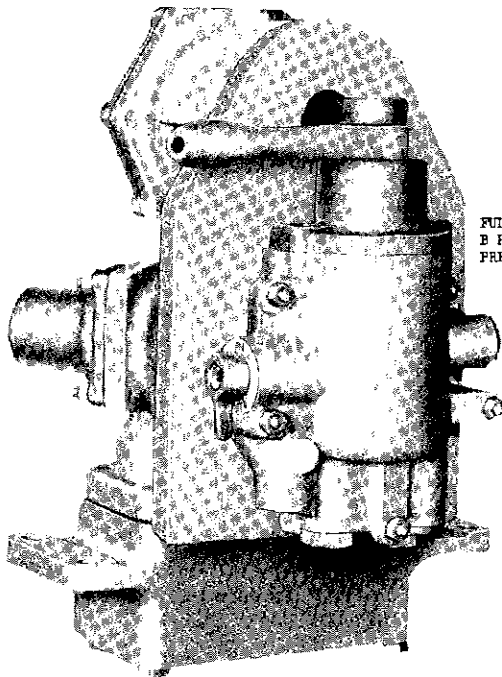
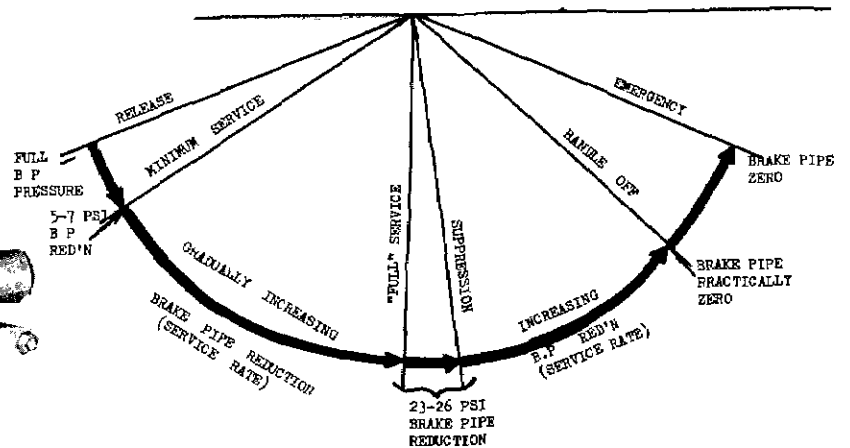
Figure 8. Brake valves and handle positions.

The NJ DOT cars had a type-26, fully pneumatic brake system; the commuter cars used before May 1, 1978, had an electropneumatic system. To apply the brakes on the older cars the brake valve handle is moved counterclockwise from its far left position to the "service" position. In the service position, the train line pressure is reduced. When the desired amount of reduction is obtained, the handle must be moved clockwise to either the "lap" or "holding" position to maintain the brake application. If the brake valve remains in the service position, the air pressure in the train line will be depleted. (See figure 8.)

To apply the brakes on the NJ DOT cars, the handle of the B-1 self-lapping brake valve is moved from its far left position counterclockwise to the service position. The position in which the brake valve is placed in the service position determines the amount of reduction of air pressure in the train line and the amount of braking effort. The left side of the service position produces the least braking pressure while the right side produces the most braking pressure. It is not necessary to move this handle to another position to hold the brakes applied. To increase or lessen the braking effort the handle need only be moved in the proper direction within the service position. (See figure 8.)

If the engineer operated the brake equipment on the NJ DOT car, in use at the time of the accident, in the same manner as he had operated the electropneumatic brake equipment on the older train, each movement to the left would have reduced or released the brake application. During the engineer's familiarization trip, he used this new brake valve improperly; he used it in the same manner as the older electropneumatic brake valve. Because of the lack of evidence of heavy braking on the wheels of train No. 400 or on the rails behind the train, and the position of the brake valve after the accident, the Safety Board concludes that the engineer did not apply the service brake properly and that an emergency brake application was not made.
