# NATIONAL TRANSPORTATION SAFETY BOARD

## RAILROAD ACCIDENT REPORT

REAR END COLLISION OF TWO  
CONRAIL FREIGHT TRAINS,  
STEMMERS RUN,  
BALTIMORE, MARYLAND

REPORT NUMBER: NTSB-RAR-78-1

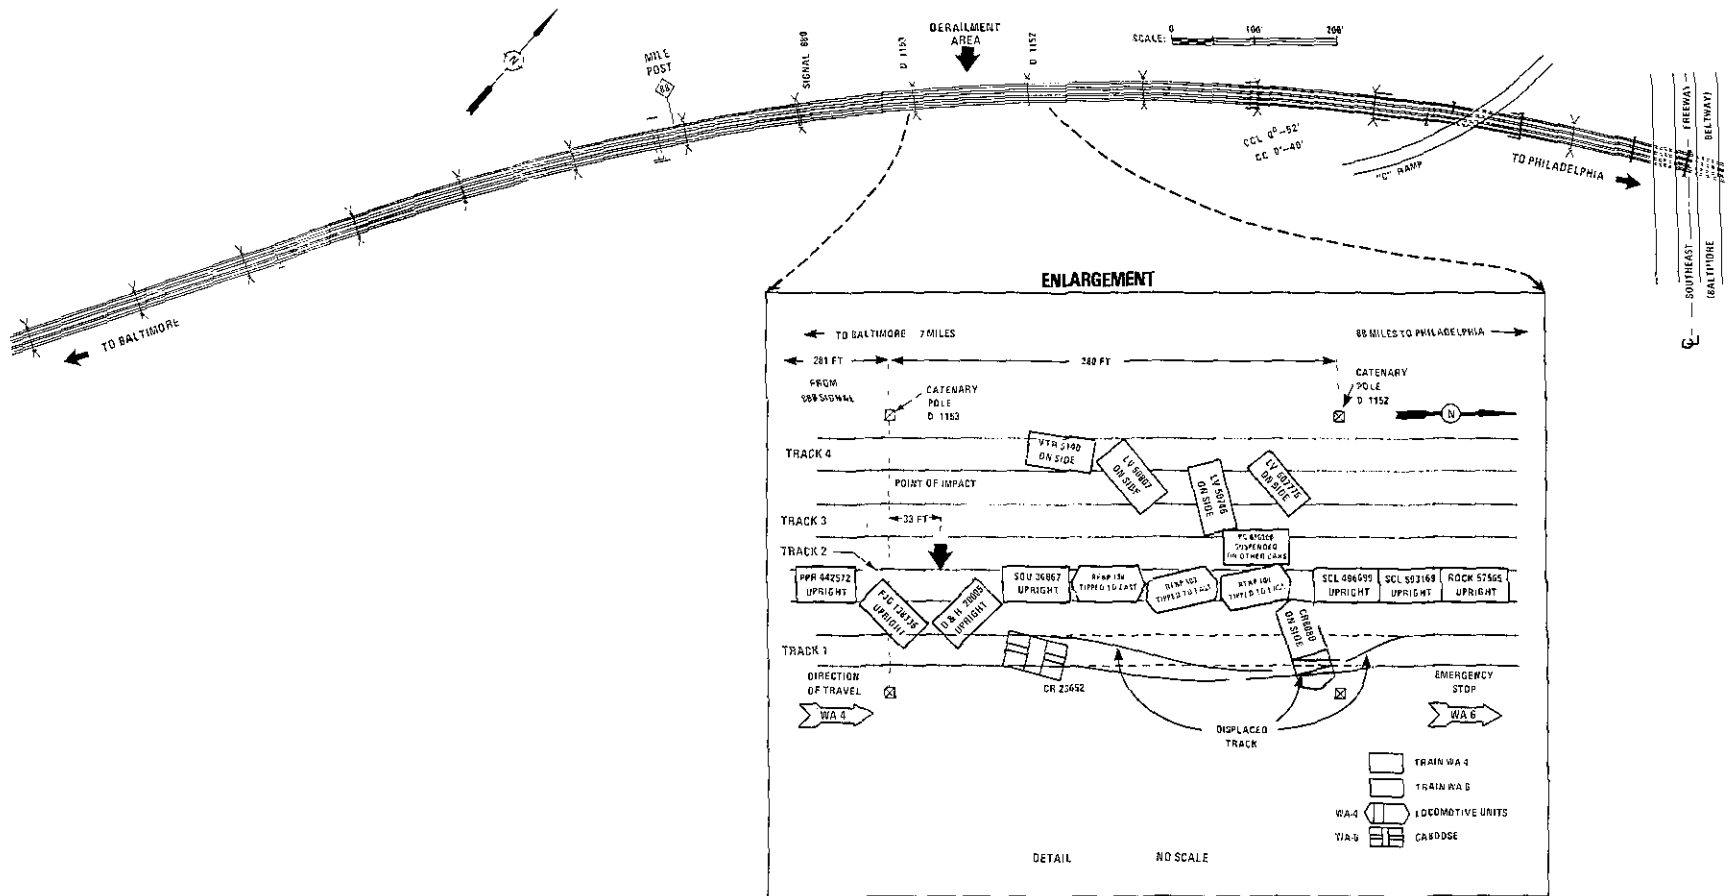
Figure 1. Plan of accident site.

The four main tracks at the accident site are provided with an overhead catenary system, which supplies 11,000-volt a.c. electric power for the propulsion of trains. Approaching the point of impact, a northbound train operates around a 0°30' curve to the right for 0.3 mile, and then around a compound curve of 0°25' to 0°52' to the left for 0.9 mile. The track is then straight for 0.3 mile where it enters a compound curve to the right of 0°57' to 0°40'. The accident occurred 1,394 feet from the south end of this curve. (See figure 1.)

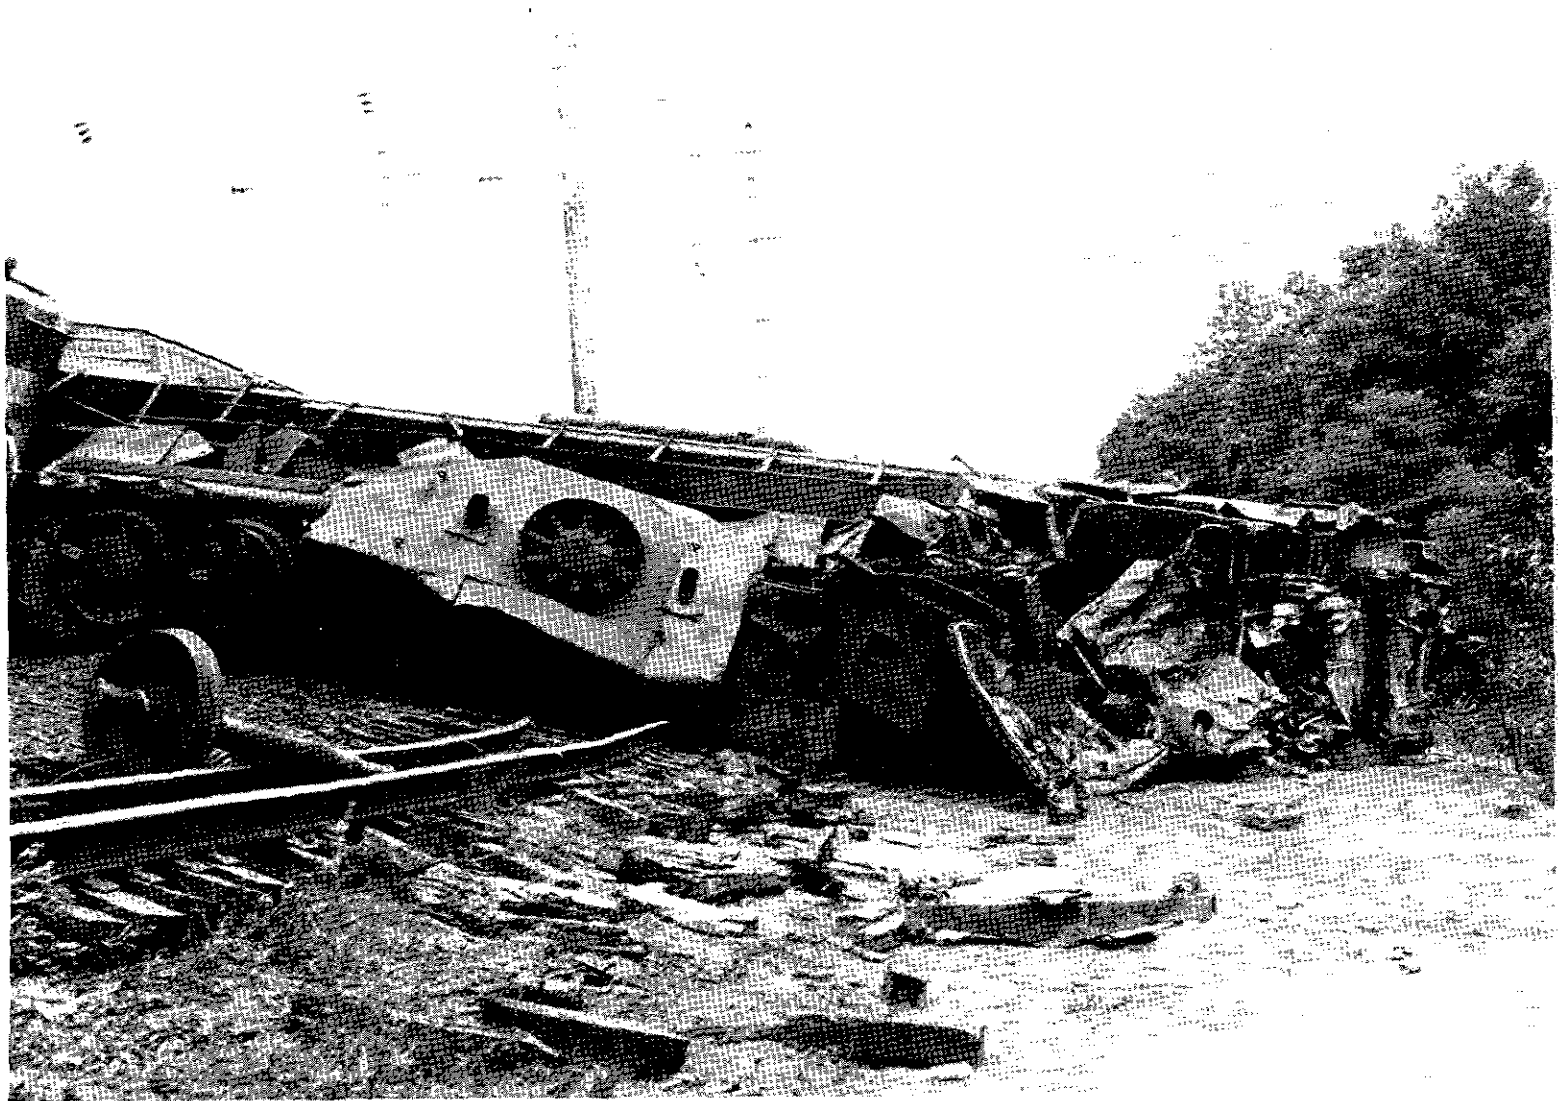
The collision occurred on a right-hand curve and the locomotive and caboose were deflected toward the right side of the track. The lead locomotive unit of train WA-4 turned over on its right side and came to rest perpendicular to the track. Although there was no override, both the caboose and the locomotive unit were extensively damaged. The five derailed cars of train WA-6 were driven across tracks Nos. 3 and 4 and were extensively damaged. The other derailed locomotive units and cars of train WA-4 were not extensively damaged. (See figure 2.)

Figure 2. Damaged lead locomotive unit of train WA-4.
