**REAR-END COLLISION OF
SEPTA-CONRAIL TRAINS
NOS. 406 AND 472
ON CONRAIL TRACK
NORTH WALES, PENNSYLVANIA
JULY 17, 1980**

NTSB-RAR-80-11

**REAR-END COLLISION OF
SOUTHEASTERN PENNSYLVANIA TRANSPORTATION AUTHORITY
AND CONSOLIDATED RAIL CORPORATION TRAINS
NOS. 406 AND 472
ON CONRAIL TRACK
NORTH WALES, PENNSYLVANIA
JULY 17, 1980**

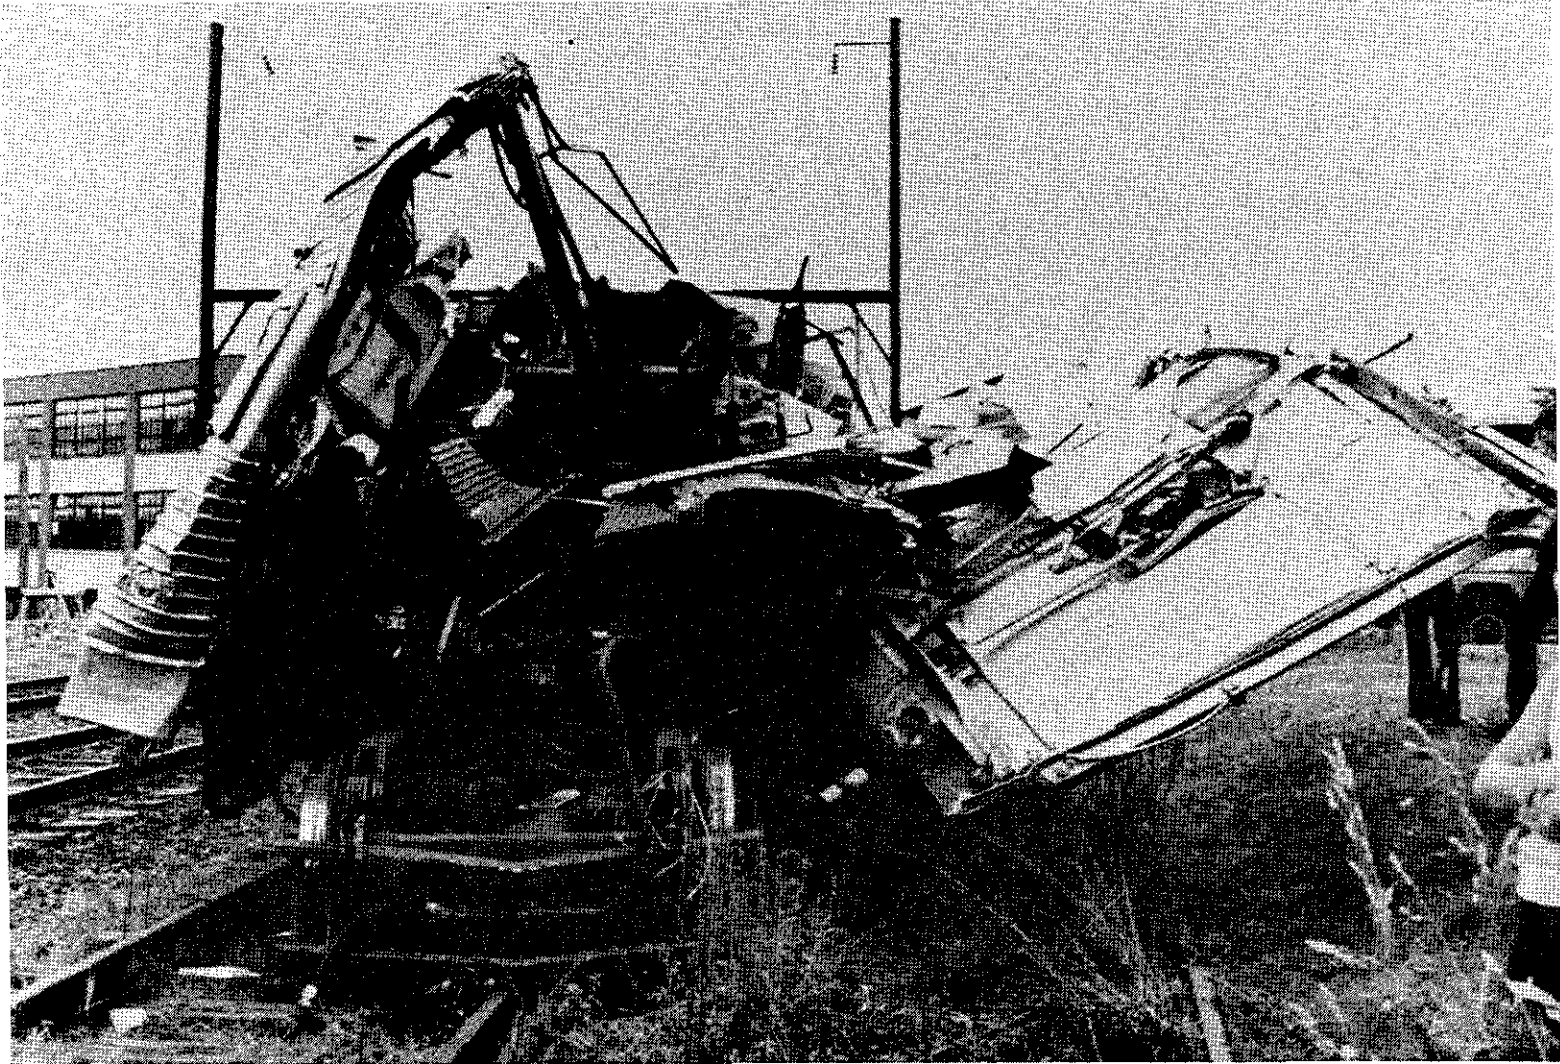
Figure 2.--Car No. 9020 of train No. 472.

Car No. 9020 of train No. 472 was derailed on the "A" end and was severely damaged by the overriding and penetration of the rear car of train No. 406. (See figure 2.) The roof structure of car No. 9020 containing the pantograph was completely destroyed. The collision posts were bent rearward from the vertical, but the base welds remained intact. The forward floor section, attached to the end frame assembly, separated from the frame when the center-welded box section of the end frame assembly failed about 25 inches forward of the body bolster centerline. About 30 feet of the forward portion of the car was completely destroyed. The couplers between the standing and striking cars coupled upon impact, but were subsequently destroyed during the override. The "B" end of car No. 9020 had only minor structural and interior damage.

The deformation of equipment was less than might be expected, which is probably due to the unusual overriding action of the rear car of train No. 406. The overriding was initiated by the failure of the underframe assembly on car No. 9020 at the minimum cross section area. Failure would be expected at this point since it was the minimum cross sectional area of the beam. When the end underframe assembly separated, it permitted car No. 133 to override and penetrate car No. 9020 because of the nature of the failure. The mass and momentum of the striking train then forced the rear car of train No. 406 up and over the lead car of train No. 472, which accounts for the destruction of car No. 9020. The dissipation of kinetic energy through this action undoubtedly reduced the severity and the number of injuries received by the passengers.

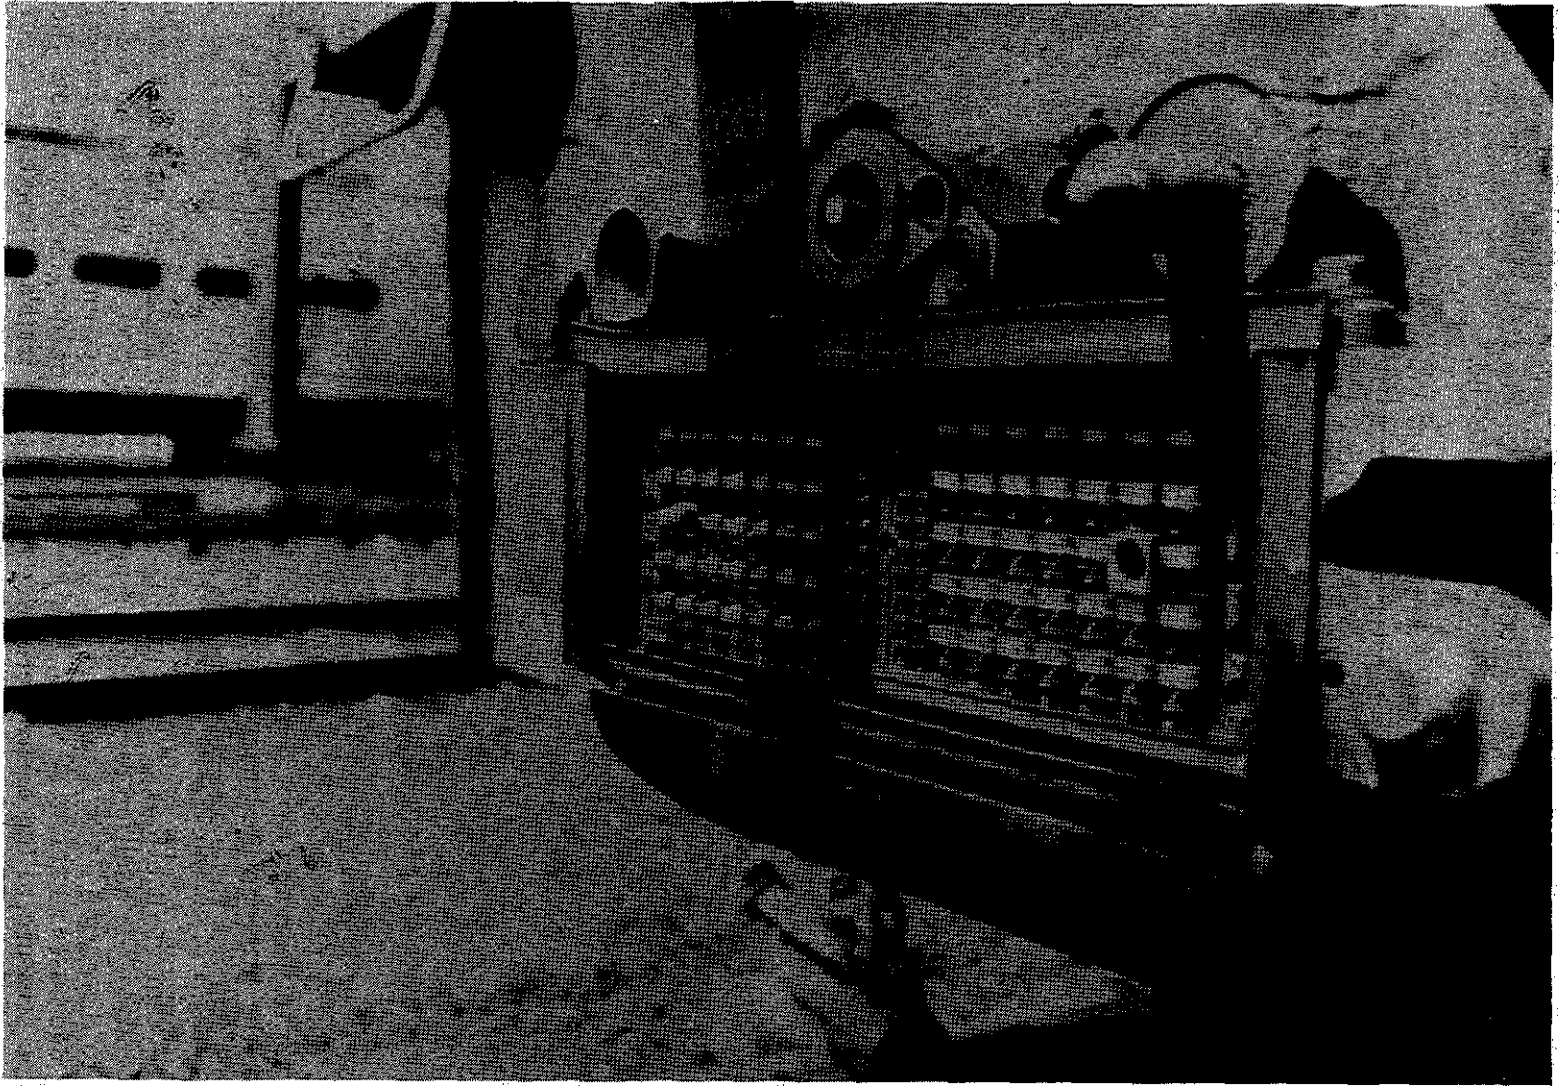
Figure 3.--A special electrical contactor which is part of the N-2 automatic coupler used on the type cars involved in this accident.

High resistance between mating contacts in the contactor boxes could have prevented the control voltage from passing through the trainline from cars Nos. 123 and 124 to cars Nos. 114 and 9020. However, it is very unlikely that a simultaneous failure would occur between two different cars on the same numbered contacts. Conrail supervisory personnel knew that car No. 9020 would be the lead car on its return trip to Reading Terminal unless it was switched to another position or to another train. Yet, no qualified electrician or car inspector was dispatched to Doylestown to check the car after the reported problem on the previous day. None of the supervisors to whom the trouble was reported took any action to have the car checked.
