# NATIONAL TRANSPORTATION SAFETY BOARD

REAR END COLLISION  
BETWEEN CONRAIL TRAINS  
OIPI-6 AND ENPI-6X  
NEAR SALTSBURG, PENNSYLVANIA  
FEBRUARY 26, 1984

✓  
NTSB/RAR-85/02.

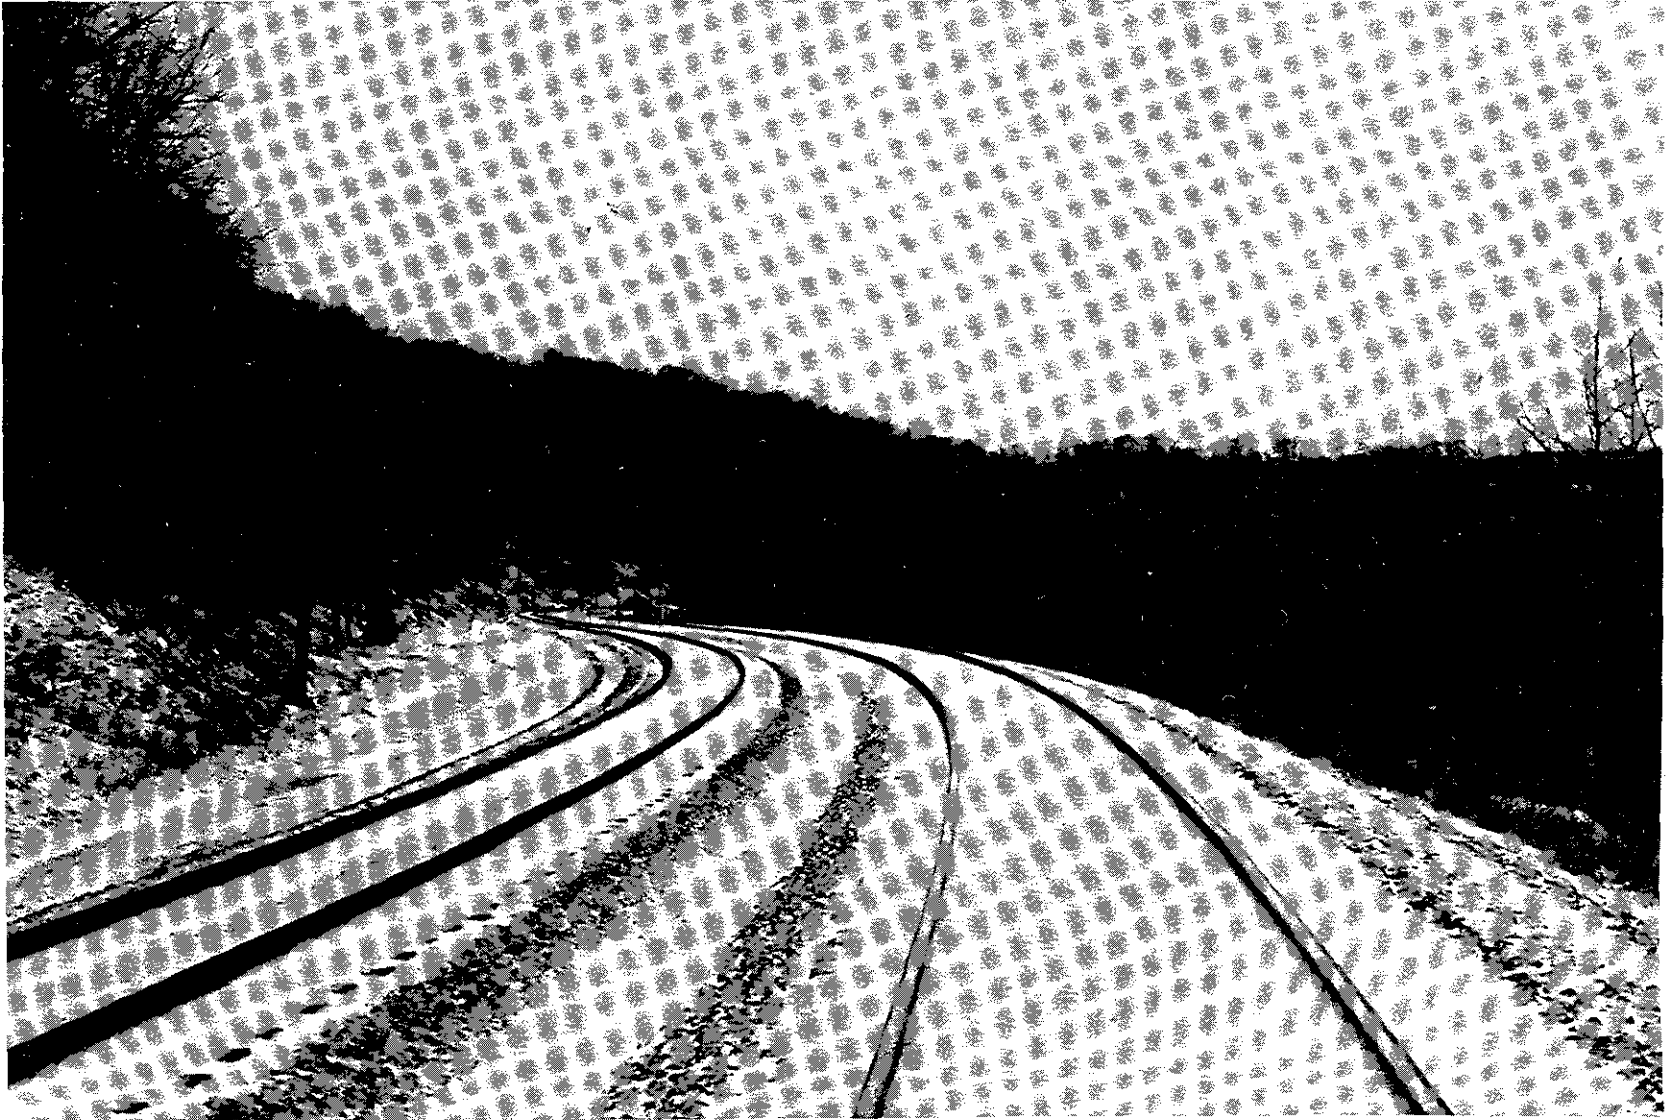
Figure 1.—No. 2 track on the right approaching the point of impact from the west.  
Point of impact is on short length of tangent track between curves.

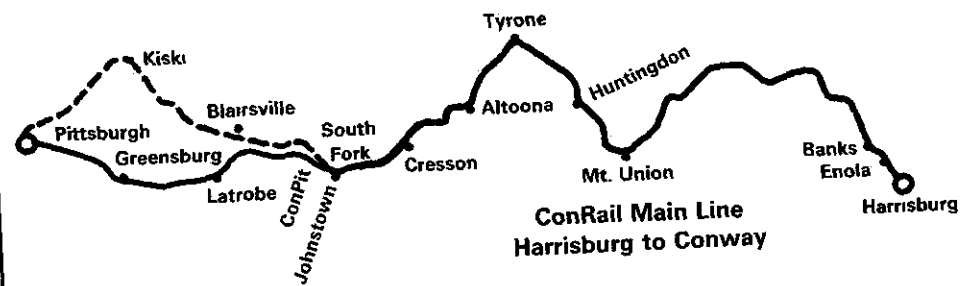
Figure 2.—Rear-end collision of Conrail trains OIPI-6 and ENPI-6X and involving train TV-12M at CP Salts.

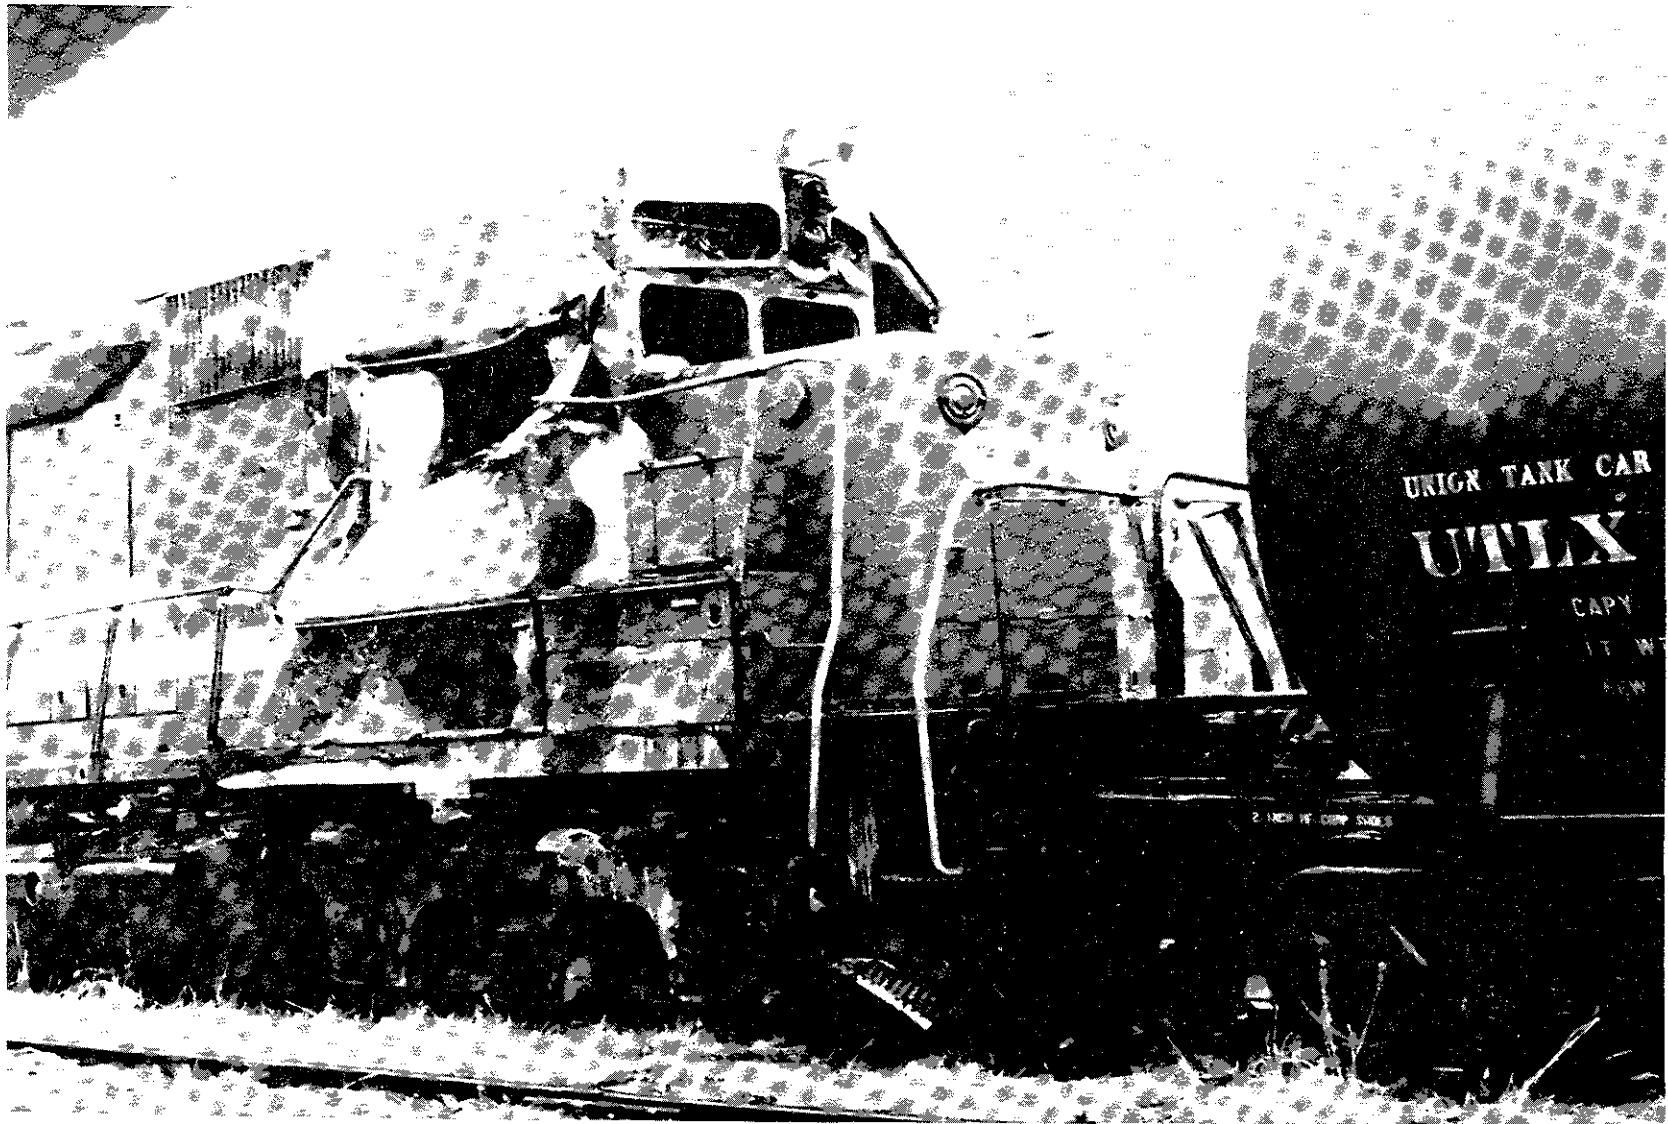
When the lead engine unit No. 3317 of train ENPI-6X overturned on its right side, some crush damage occurred to the unit. (See figure 3.) The left side panels of the operating compartment were pushed inward, caused either by heat from the fire or from impact damage. (See figure 4.) The fire following the accident burned and destroyed the interior of the operating compartment. The origin of the fire was not determined, but

Figure 3.—Right side of locomotive unit 3317 of train ENPI-6X.

it was fueled by diesel fuel and the flammable contents of the punctured tank car in train OIPI-6. (See figures 3 and 4.) The side panels and railing along the long nose of the lead locomotive unit on both sides and the undercarriage of the locomotive were damaged, and there was a small puncture to the fuel tank; there was only slight damage to the forward end of unit No. 3317. Unit No. 2730 did not overturn or derail. The primary damage to that unit was caused by the post-collision fire.

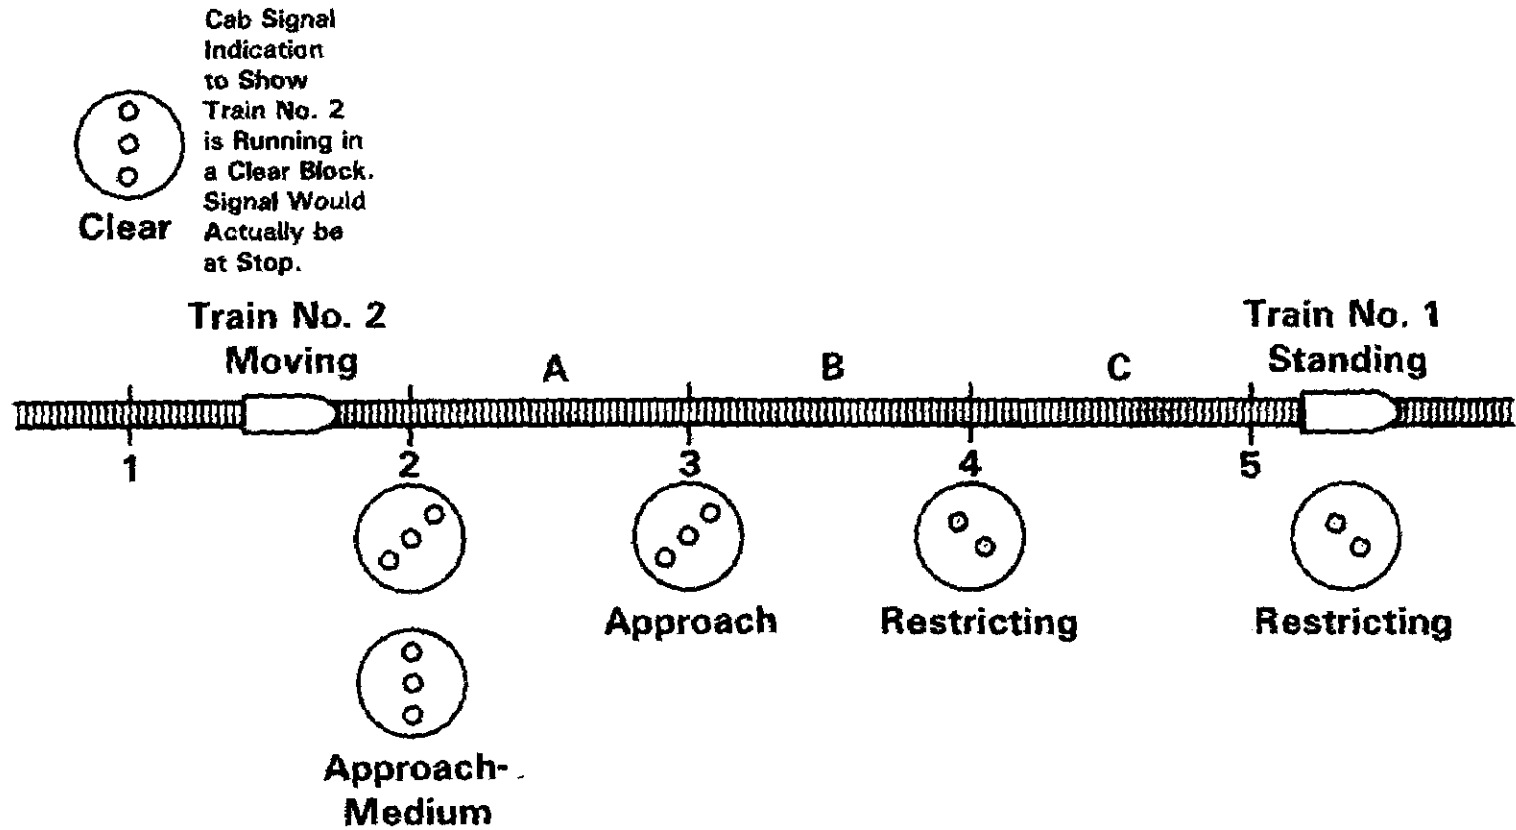
Figure 6.—Four aspect three block cab signalling system -  
 aspects displayed in locomotive operating compartment for condition shown.  
 (Not related to the track/signal conditions between CP Blair and CP Salts.)
