RAILROAD ACCIDENT REPORT

REAR-END COLLISION OF TWO
CONSOLIDATED RAIL CORPORATION
FREIGHT TRAINS
MUNCY, PENNSYLVANIA
JANUARY 31, 1979

NTSB-RAR-79-6

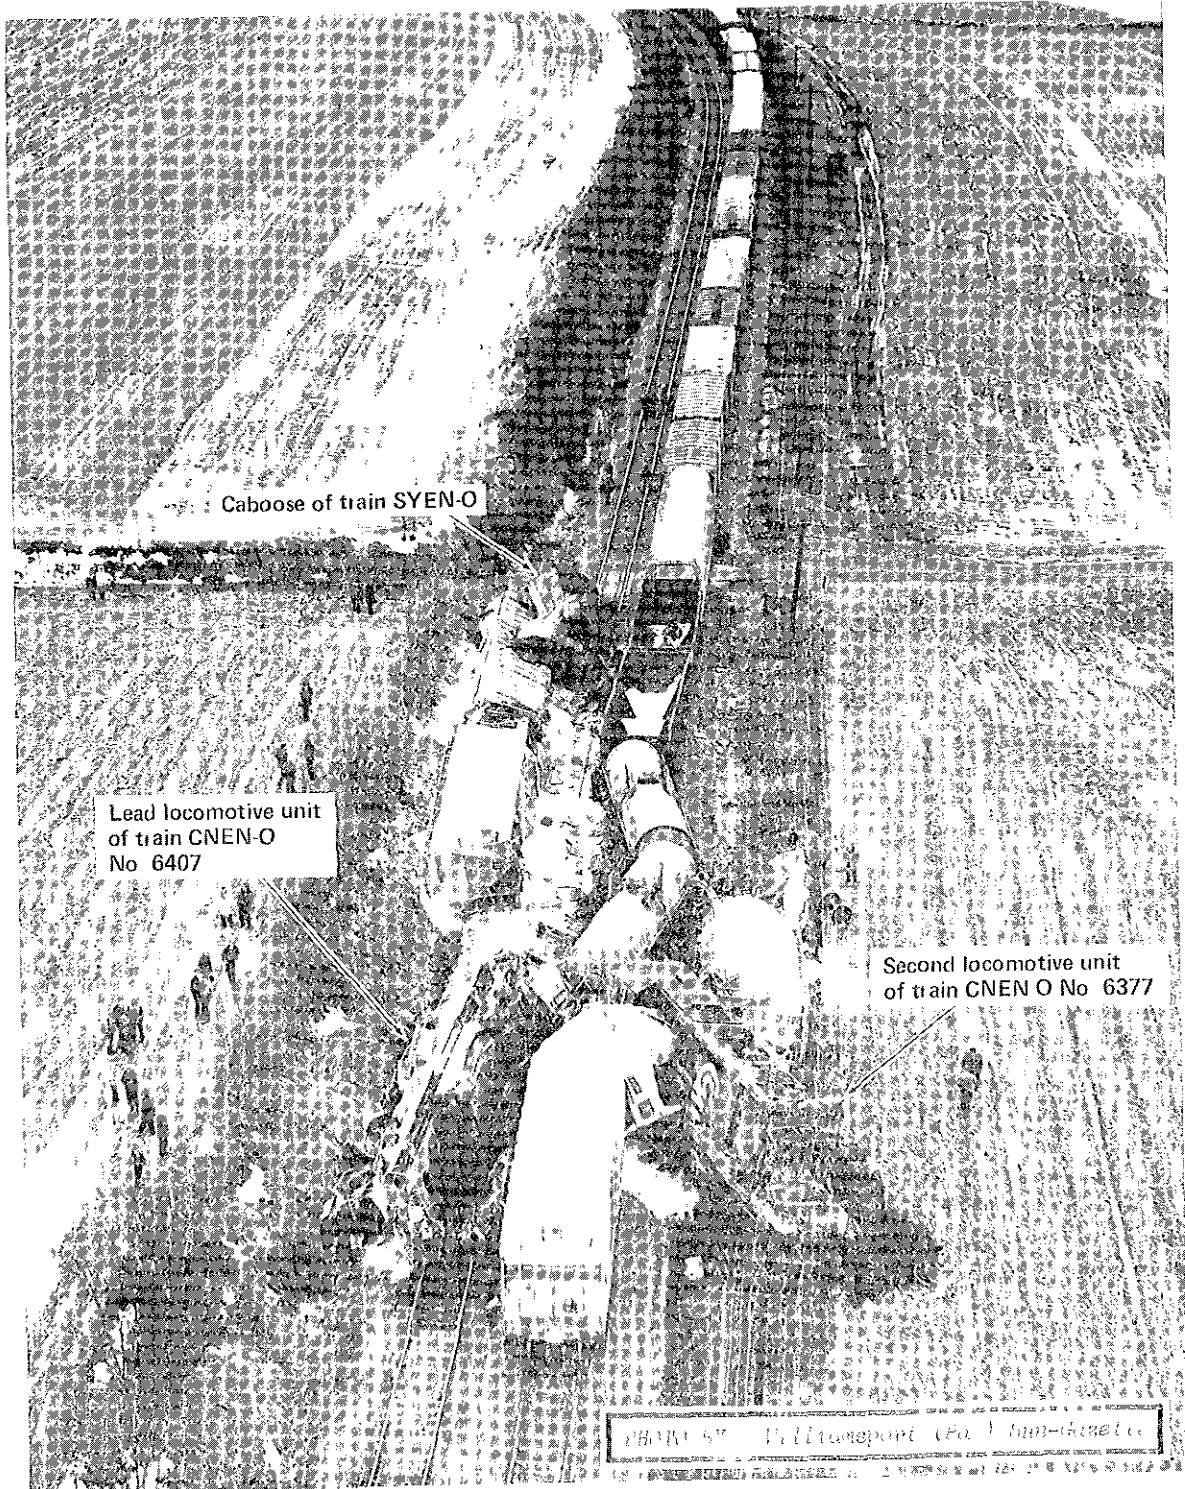
Figure 2. View of Accident site.

The lead locomotive unit of train CNEN-0 was destroyed and the second unit was heavily damaged. (See figure 2.) Fourteen cars in the train were damaged. Four cars of train SYEN-0 were destroyed, and one car was heavily damaged. The total estimated damage was:

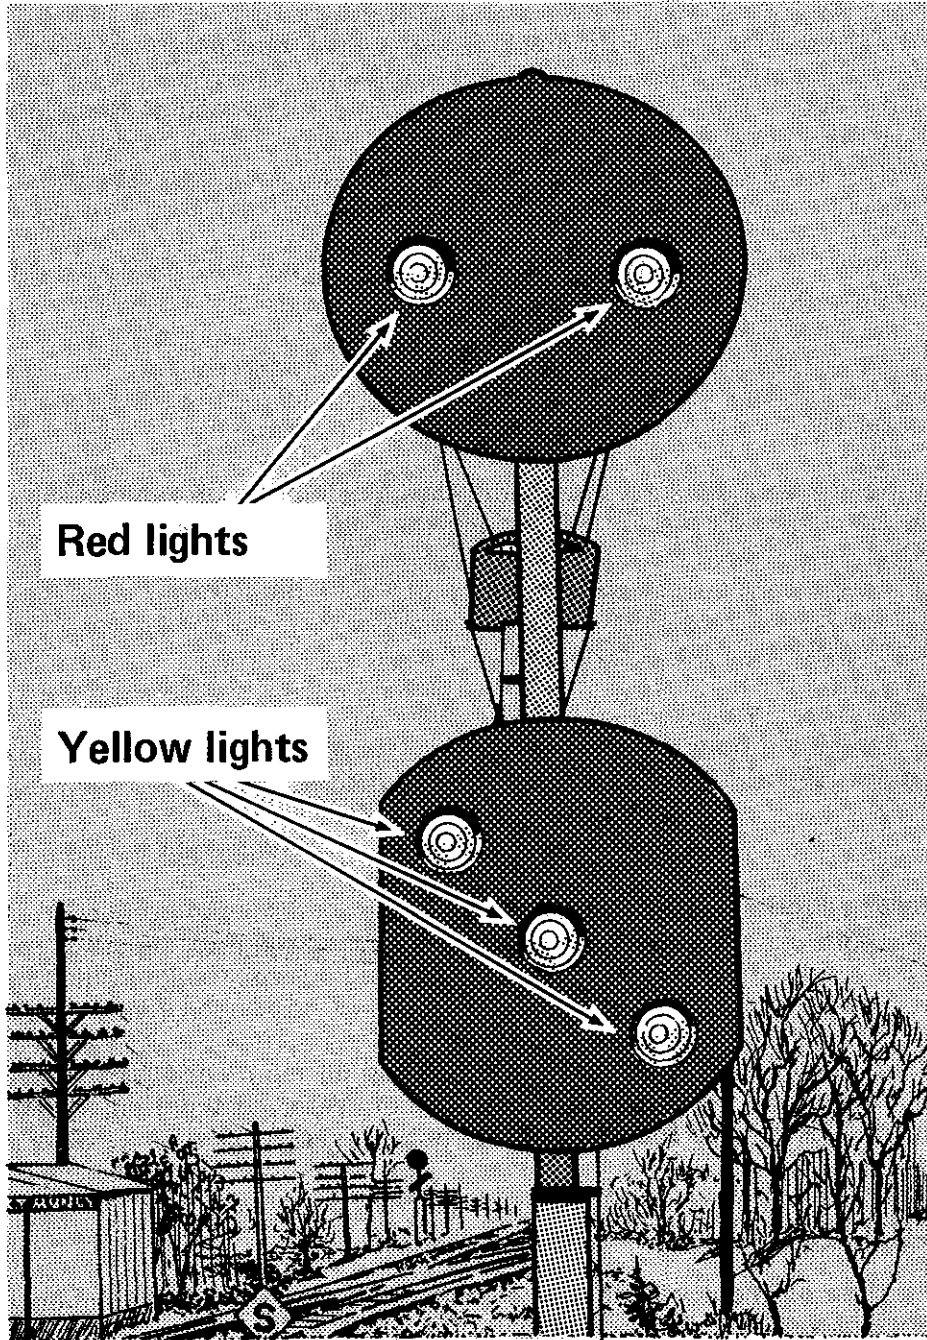
If the block beyond the signal is occupied, the signal will display the following aspect (see figure 3):

Figure 3. "Restricting" aspect shown on controlled signal at West End of Muncy siding viewed from the west.
