NATIONAL TRANSPORTATION SAFETY BOARD

RAILROAD ACCIDENT REPORT

REAR END COLLISION OF
CONSOLIDATED RAIL CORPORATION
FREIGHT TRAINS ALPG-2 AND APJ-2
NEAR ROYERSFORD, PENNSYLVANIA
OCTOBER 1, 1979

NTSB-RAR-80-2

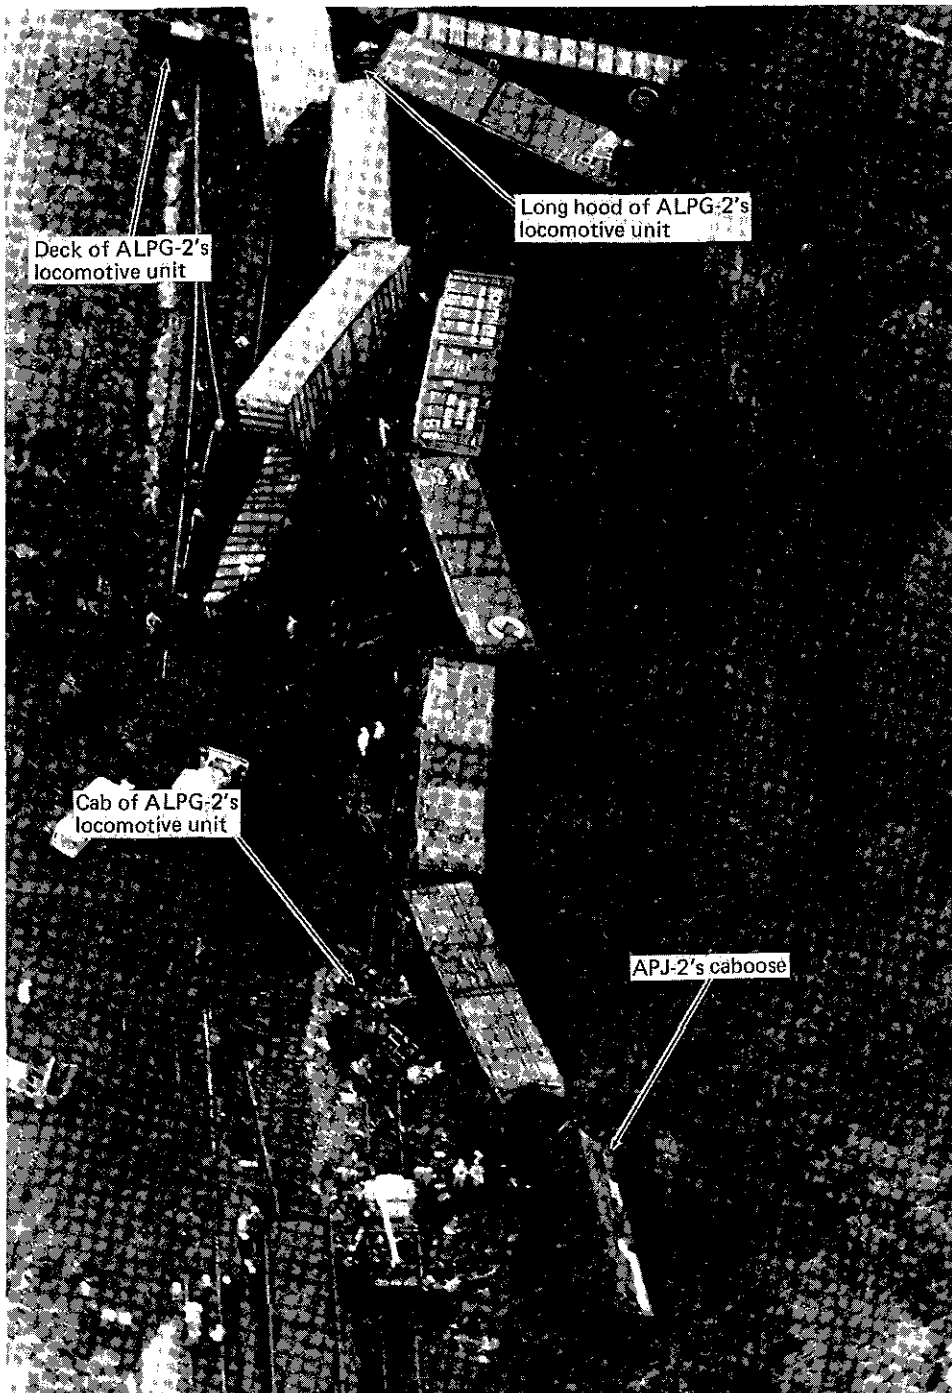
Figure 1. Aerial view of accident location from the west.

The caboose and four rear cars of APJ-2 derailed and derailed. Although the caboose overrode the locomotive unit of ALPG-2, it remained upright. The bodies of the four rear cars of APJ-2 remained intact and came to rest parallel to and south of Cromby siding. (See figure 1.) The fifth, sixth, and seventh rear cars derailed but stopped perpendicular to and blocked the main tracks and siding.

The short hood and cab of ALPG-2's locomotive unit were demolished and torn loose by the caboose of APJ-2. These parts of the superstructure were found straddling Cromby siding, about 100 feet east of the point of impact. The unit's remaining superstructure and diesel engine were also separated from the deck and were found on track No. 2 about 325 feet east of the point of impact. The deck of the unit was found crosswise on track No. 1, opposite the engine and long hood portion of the superstructure. The 12 head cars of ALPG-2 derailed and most of these were scattered in varying attitudes on the main tracks north of APJ-2's cars and west of the wreckage of the locomotive unit. About 1,160 feet of track was destroyed.

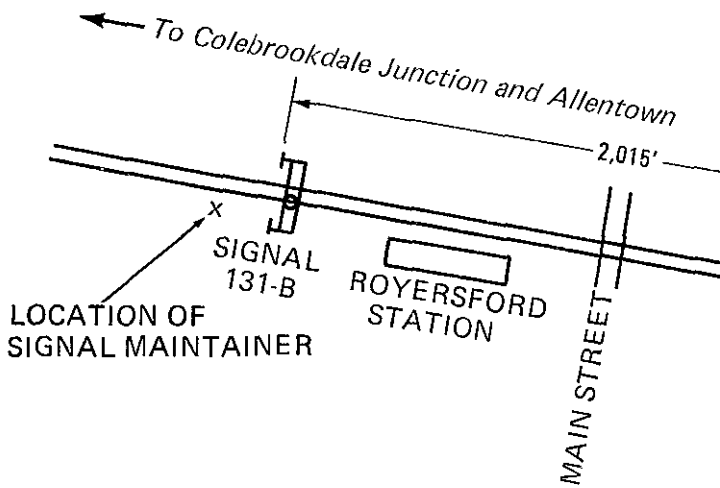
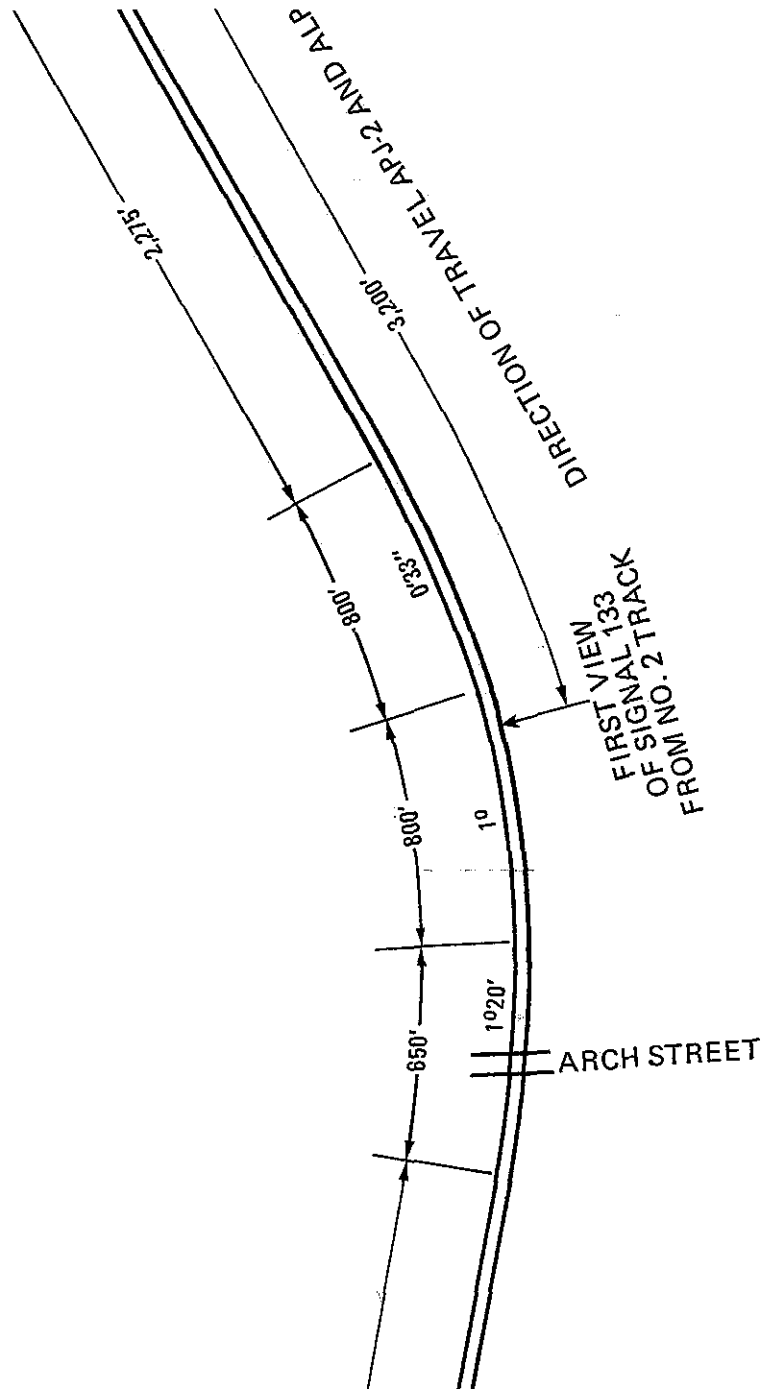
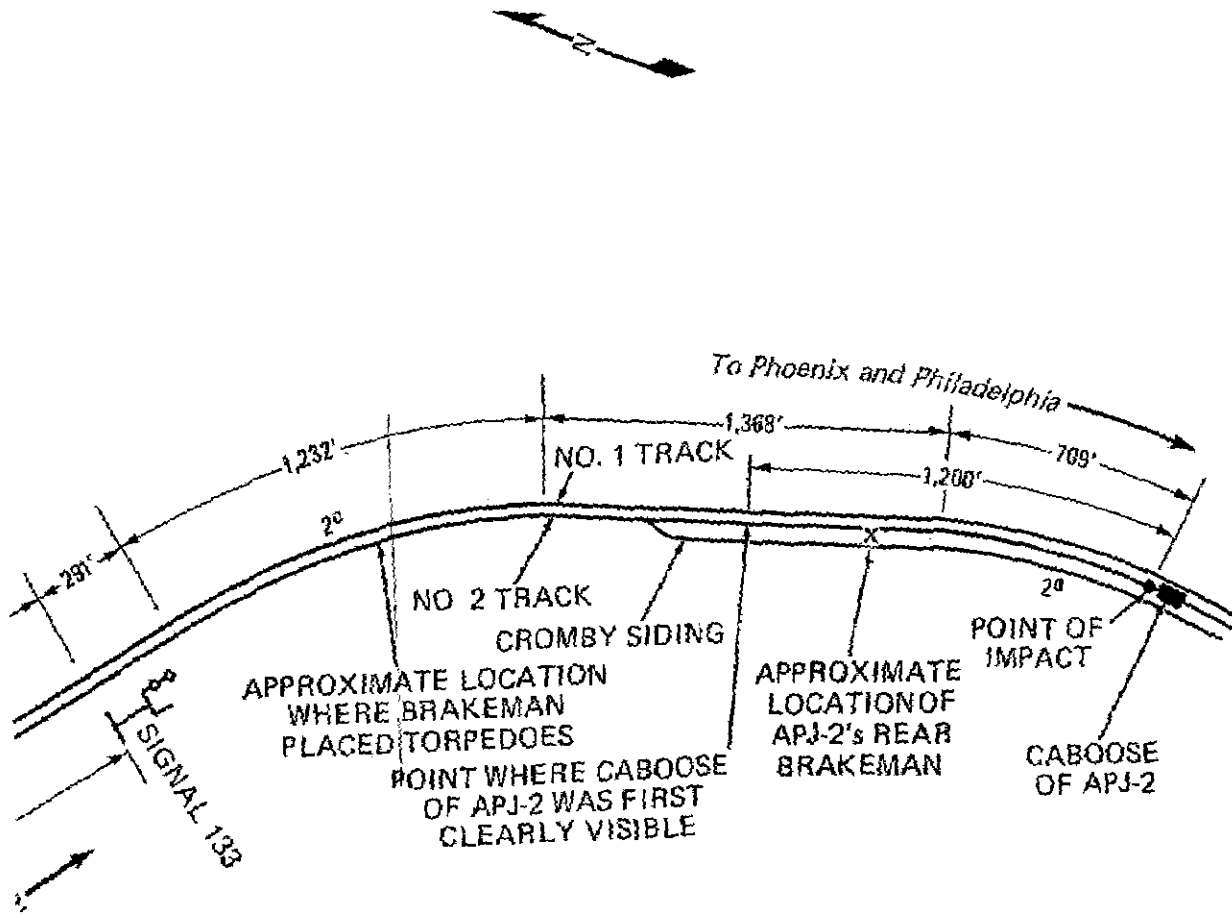
Figure 2.

Diagram of accident location and approach fr

in signal 131-B
