RAILROAD ACCIDENT REPORT

HEAD-END COLLISION
OF CONSOLIDATED RAIL CORPORATION
FREIGHT TRAINS UBT-506 AND TV-61
NEAR THOMPSONTOWN, PENNSYLVANIA
JANUARY 14, 1988

NTSB/RAR-89/02

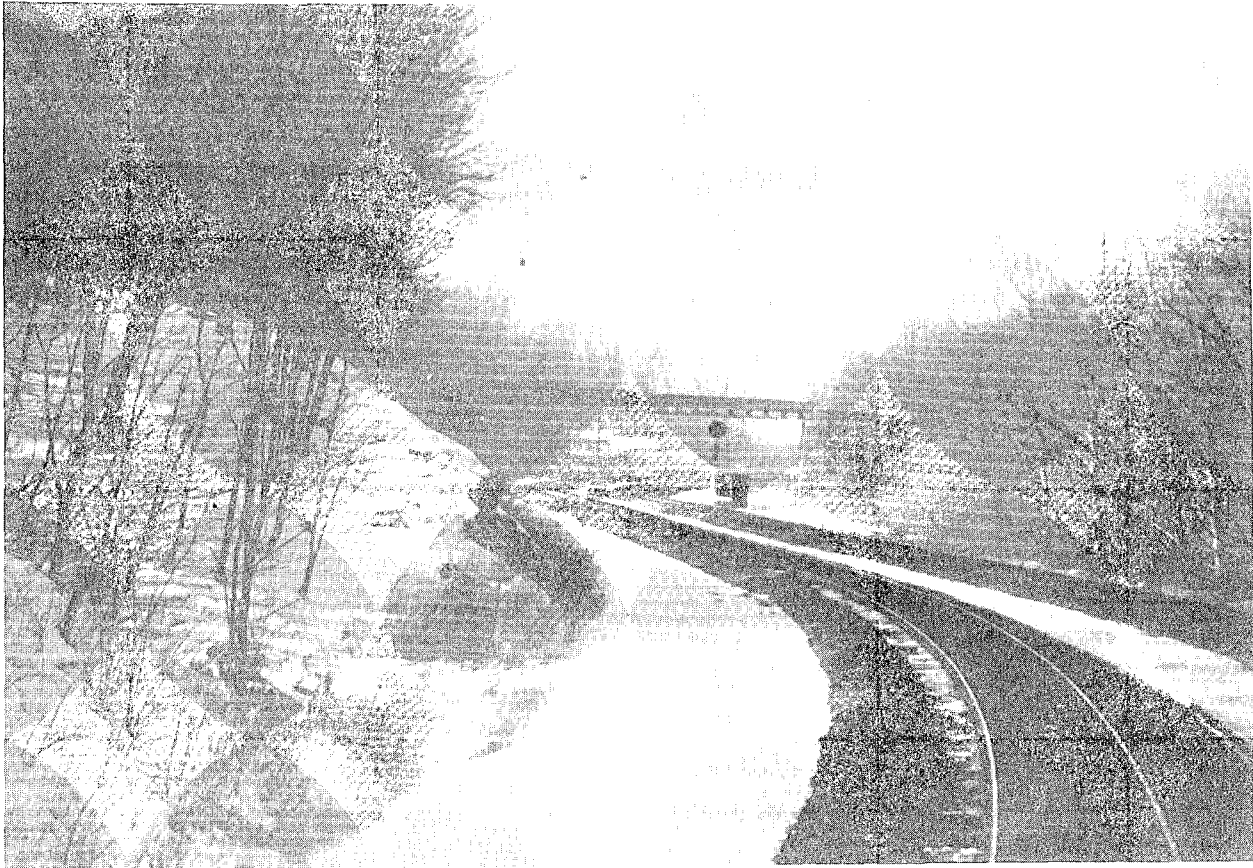
Distant signal 1421W, 11,573 feet east of switch 1E at CP Thompson, should have displayed "approach limited," and home signal 2W at CP Thompson should have displayed "limited clear." As at CP Port, TV-61 was restricted to a maximum of 40 mph through the interlocking. (See figure 4.)

Figure 4.--Westbound distant signal 1421W, located 11,573 feet east of switch 1E at CP Thompson, as viewed from a westbound train on track 1

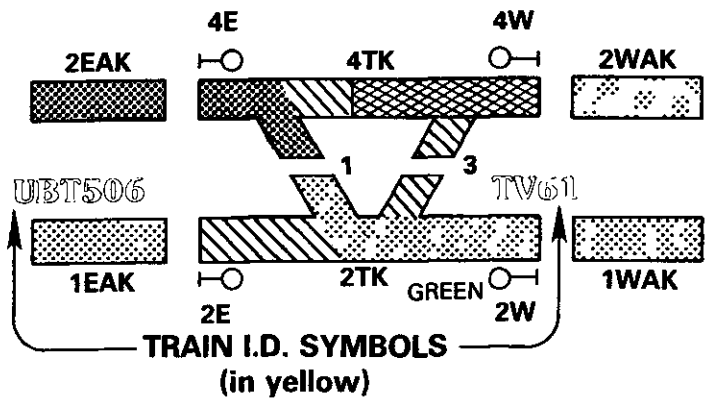
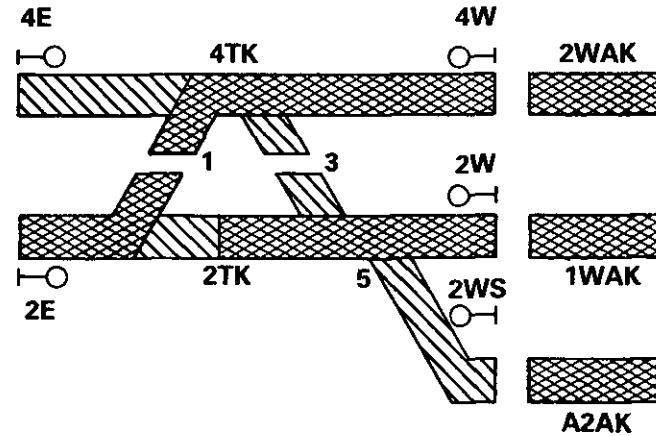
Figure 5.--The CRT display for CP Thompson and CP Port interlockings and the tracks connecting them at the Altoona dispatching center at 7:53:37 a.m., on , January 14, 1988. Track 1 is represented by the lower row of track circuits. Train UBT-506 had just passed home signal 2E and entered circuit 2TK causing the display for the crossover segment of the circuit to change from green to red, indicating that it was now occupied.

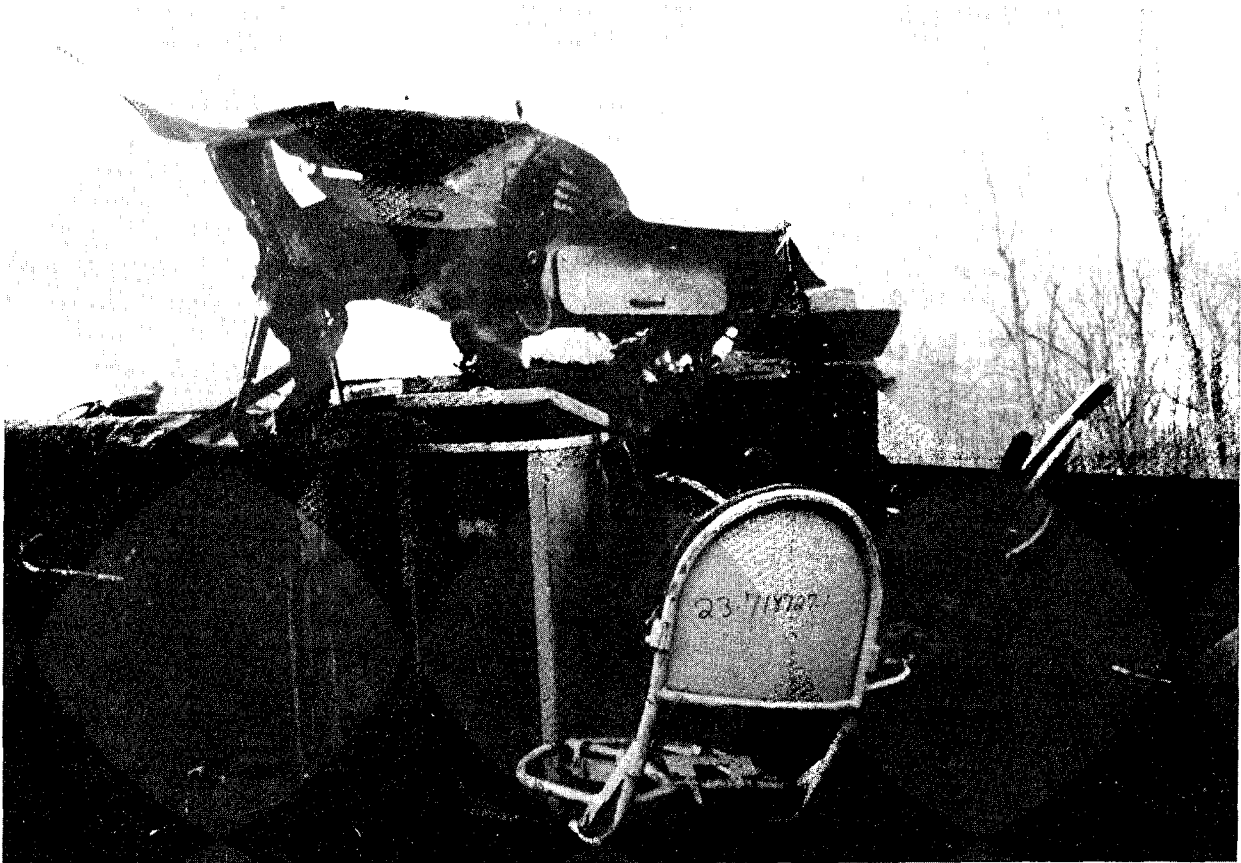
sheared off at the frame. The trailing unit of UBT-506, CR 6349, was overridden by the loaded hopper cars behind it. The hopper cars sheared off the superstructure and the upper part of the operating compartment, but left the short hood, control stand, and seats relatively undamaged. (See figure 8.) Unit CR 6349 came to rest on its left side.

Figure 8.--Operating compartment of CR 6349, trailing locomotive unit of train UBT-506, after the collision near Thompsontown

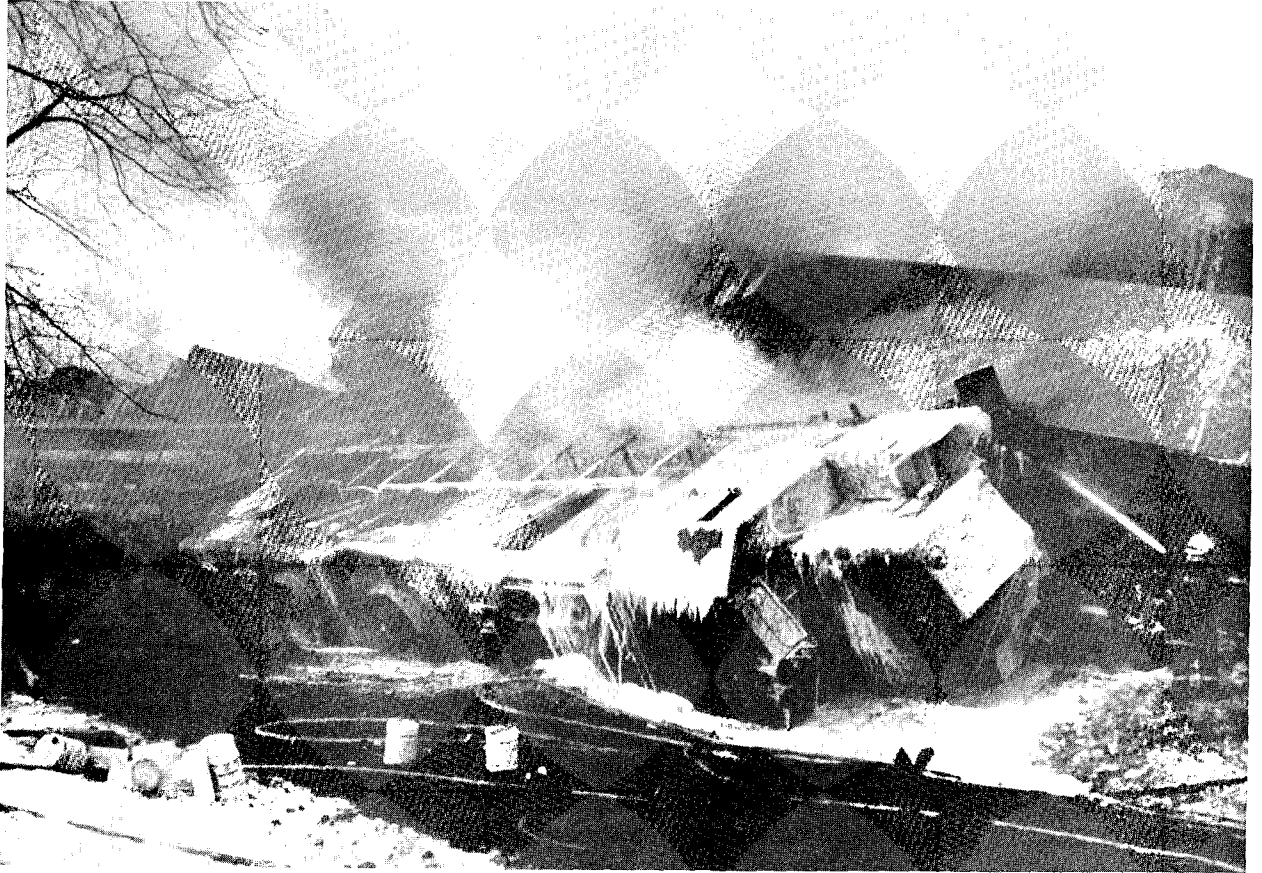
Unit CR 5017 came to rest on its right side atop the wreckage of UBT-506 and perpendicular to the track. The operating compartment remained intact, although there was heavy damage to the remainder of the carbody. The superstructure of the middle TV-61 unit was destroyed when it was overridden by the rearmost unit. The rearmost unit, CR 3054, came to rest on its left side in line with the track. The operating compartment of the unit was to the rear and did not sustain any distortion or intrusion, although the remaining superstructure was heavily damaged and deformed. (See figure 9.)

Figure 9.--CR 3054, the rearmost locomotive unit of train TV-61, after the collision near Thompsontown. The operator compartment of this unit escaped being heavily damaged and the conductor, who was inside, survived the accident.
