RAILROAD ACCIDENT REPORT

**REAR END COLLISION BETWEEN
BOSTON AND MAIN CORPORATION
COMMUTER TRAIN NO. 5324 AND
CONSOLIDATED RAIL CORPORATION
TRAIN TV-14
BRIGHTON, MASSACHUSETTS
MAY 7, 1986**

NTSB/RAR-87/02

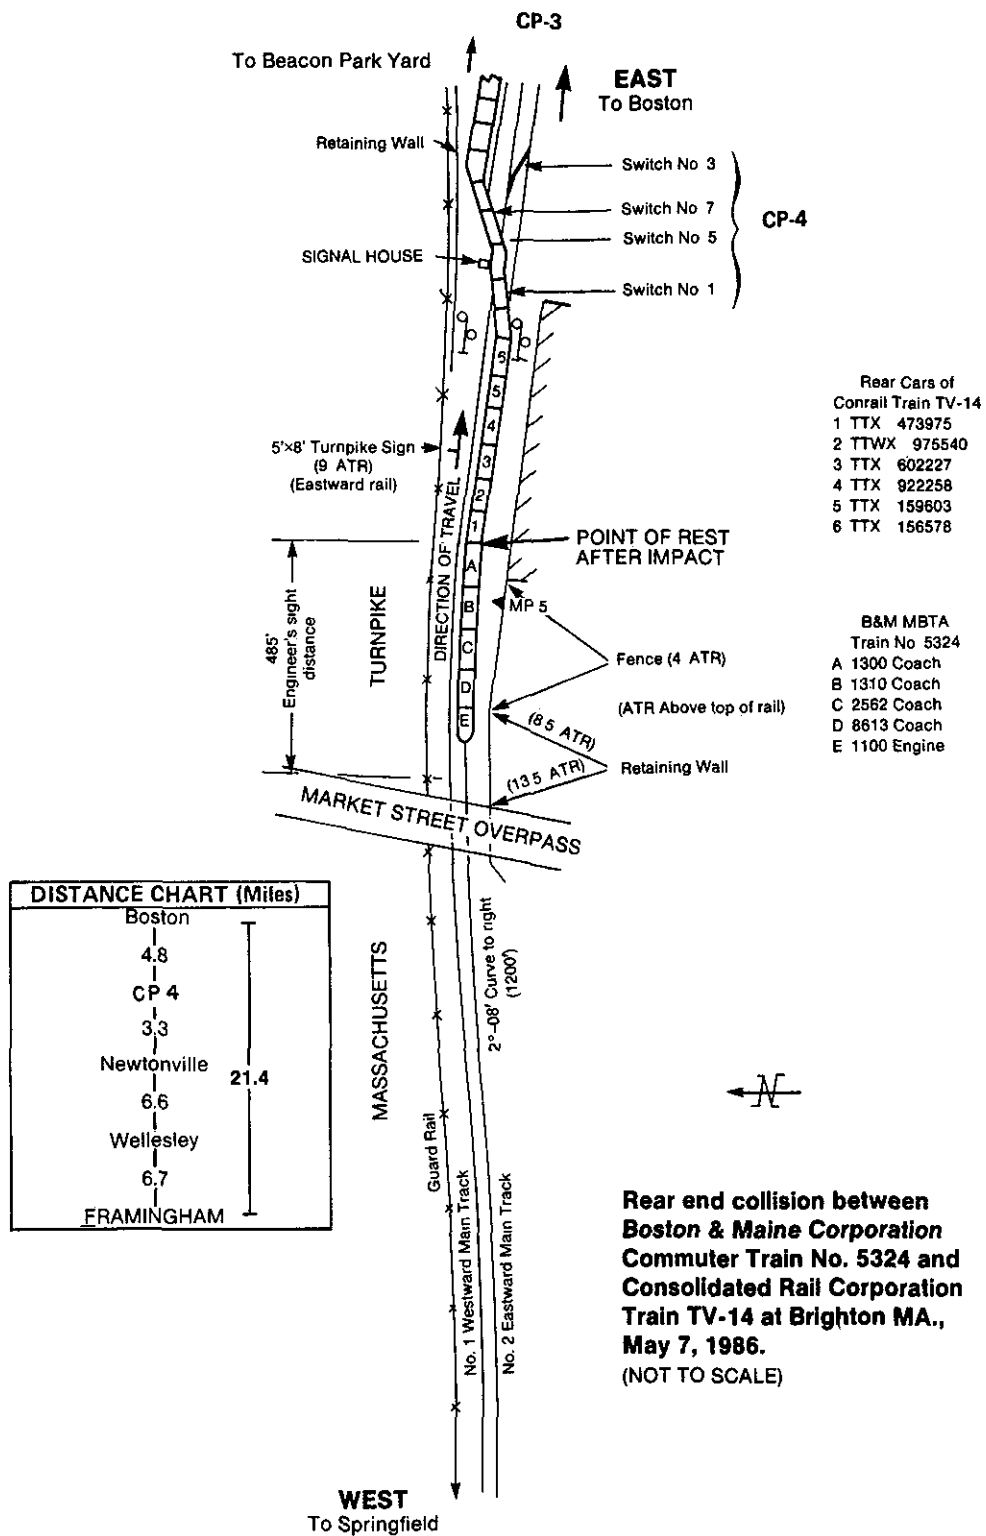
Figure 1.--Accident site.

Neither train was derailed. The accident occurred near MP 5 about 5,655 feet east of automatic block signal 6.2E. (See figure 1.) After the accident the automatic brake handle was found in the emergency position and the throttle was in the off position.

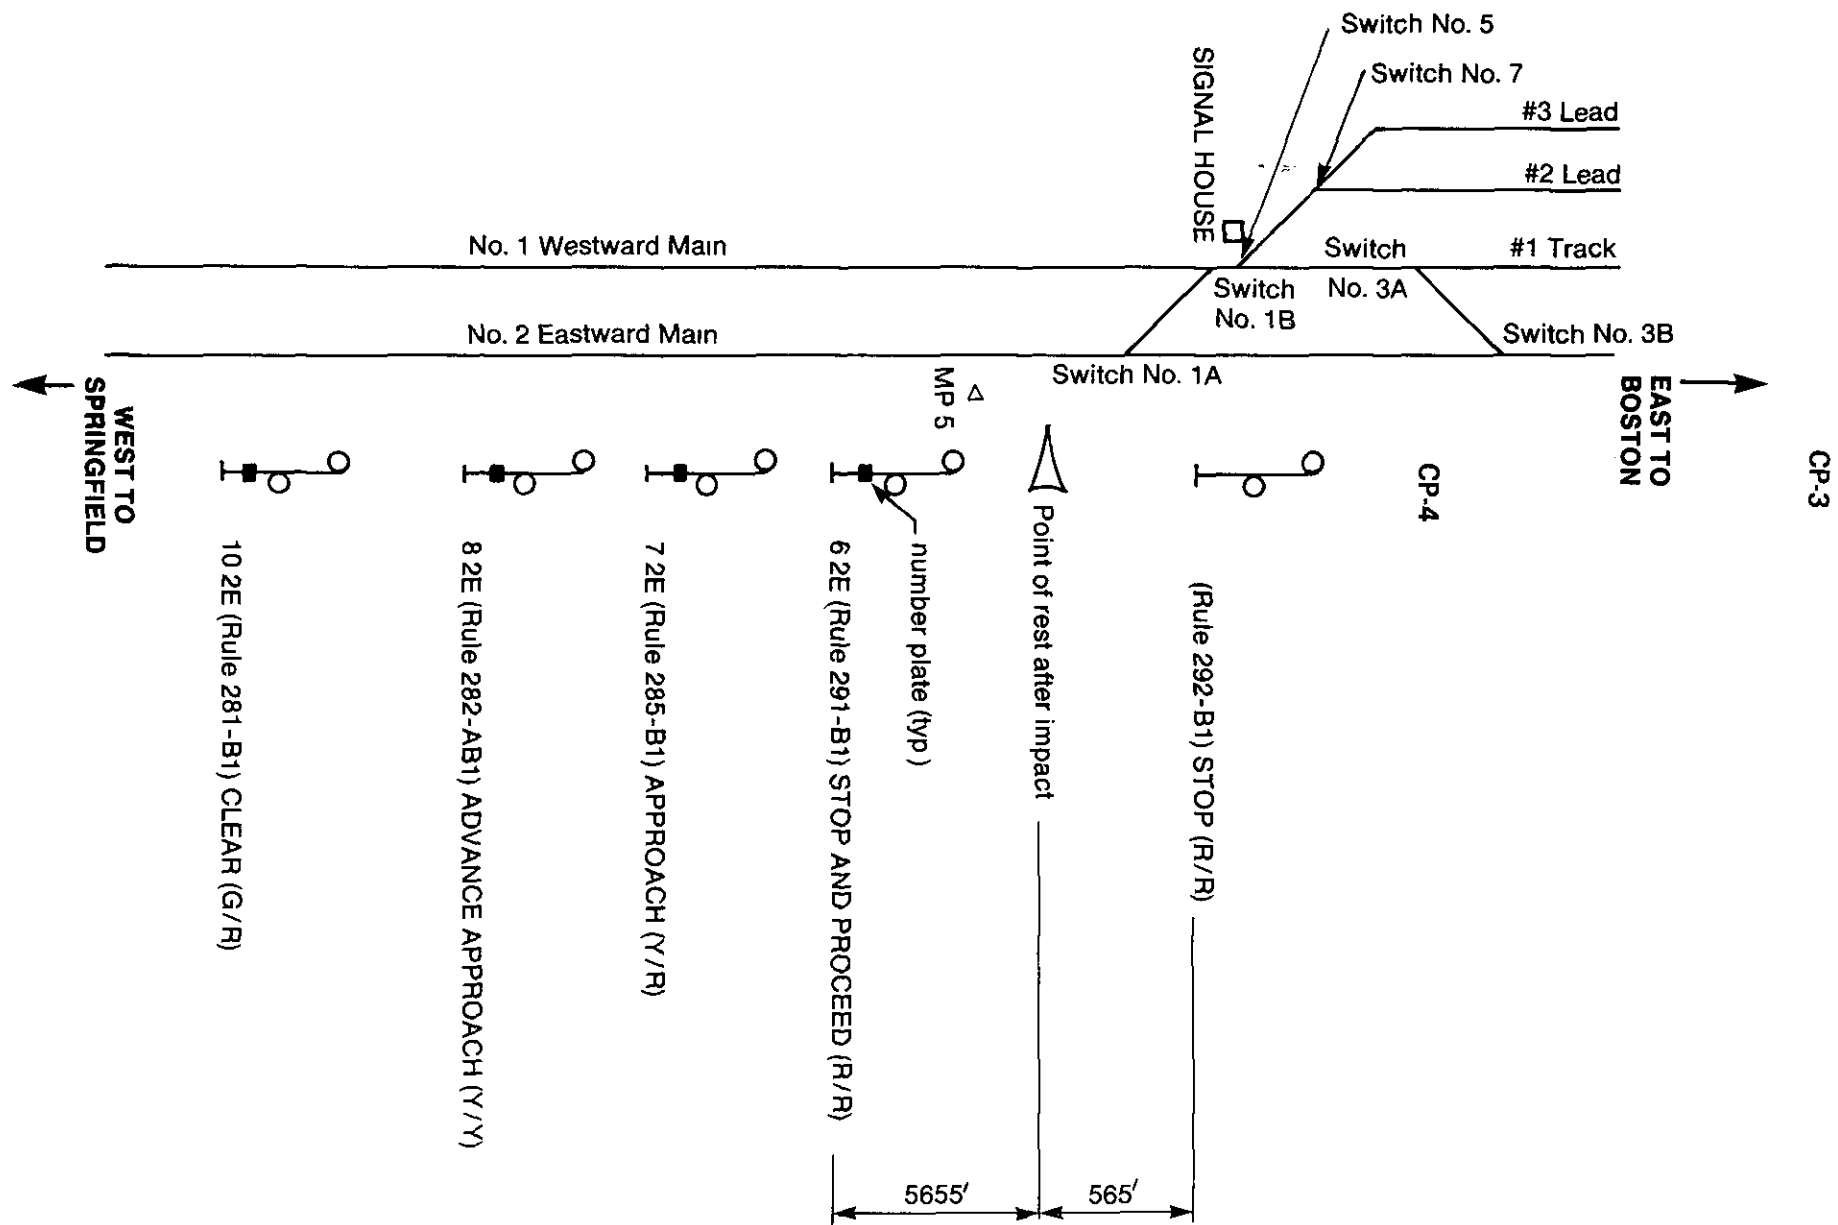
Figure 2.--Signal system indications observed following the accident.

The Signal System.—The signal system was checked in detail through the area where the accident occurred and no defects or faults were found. All testing and records required of Conrail by the FRA were up to date.

3. The signal aspects displayed to the rear of train TV-14 were correct; there were no deficiencies found within the signal system.
4. Although the engineer of train No. 5324 stated that he was not distracted by conversation with the railway and bus inspector, the manner in which the train was operated indicates inattentiveness on his part.

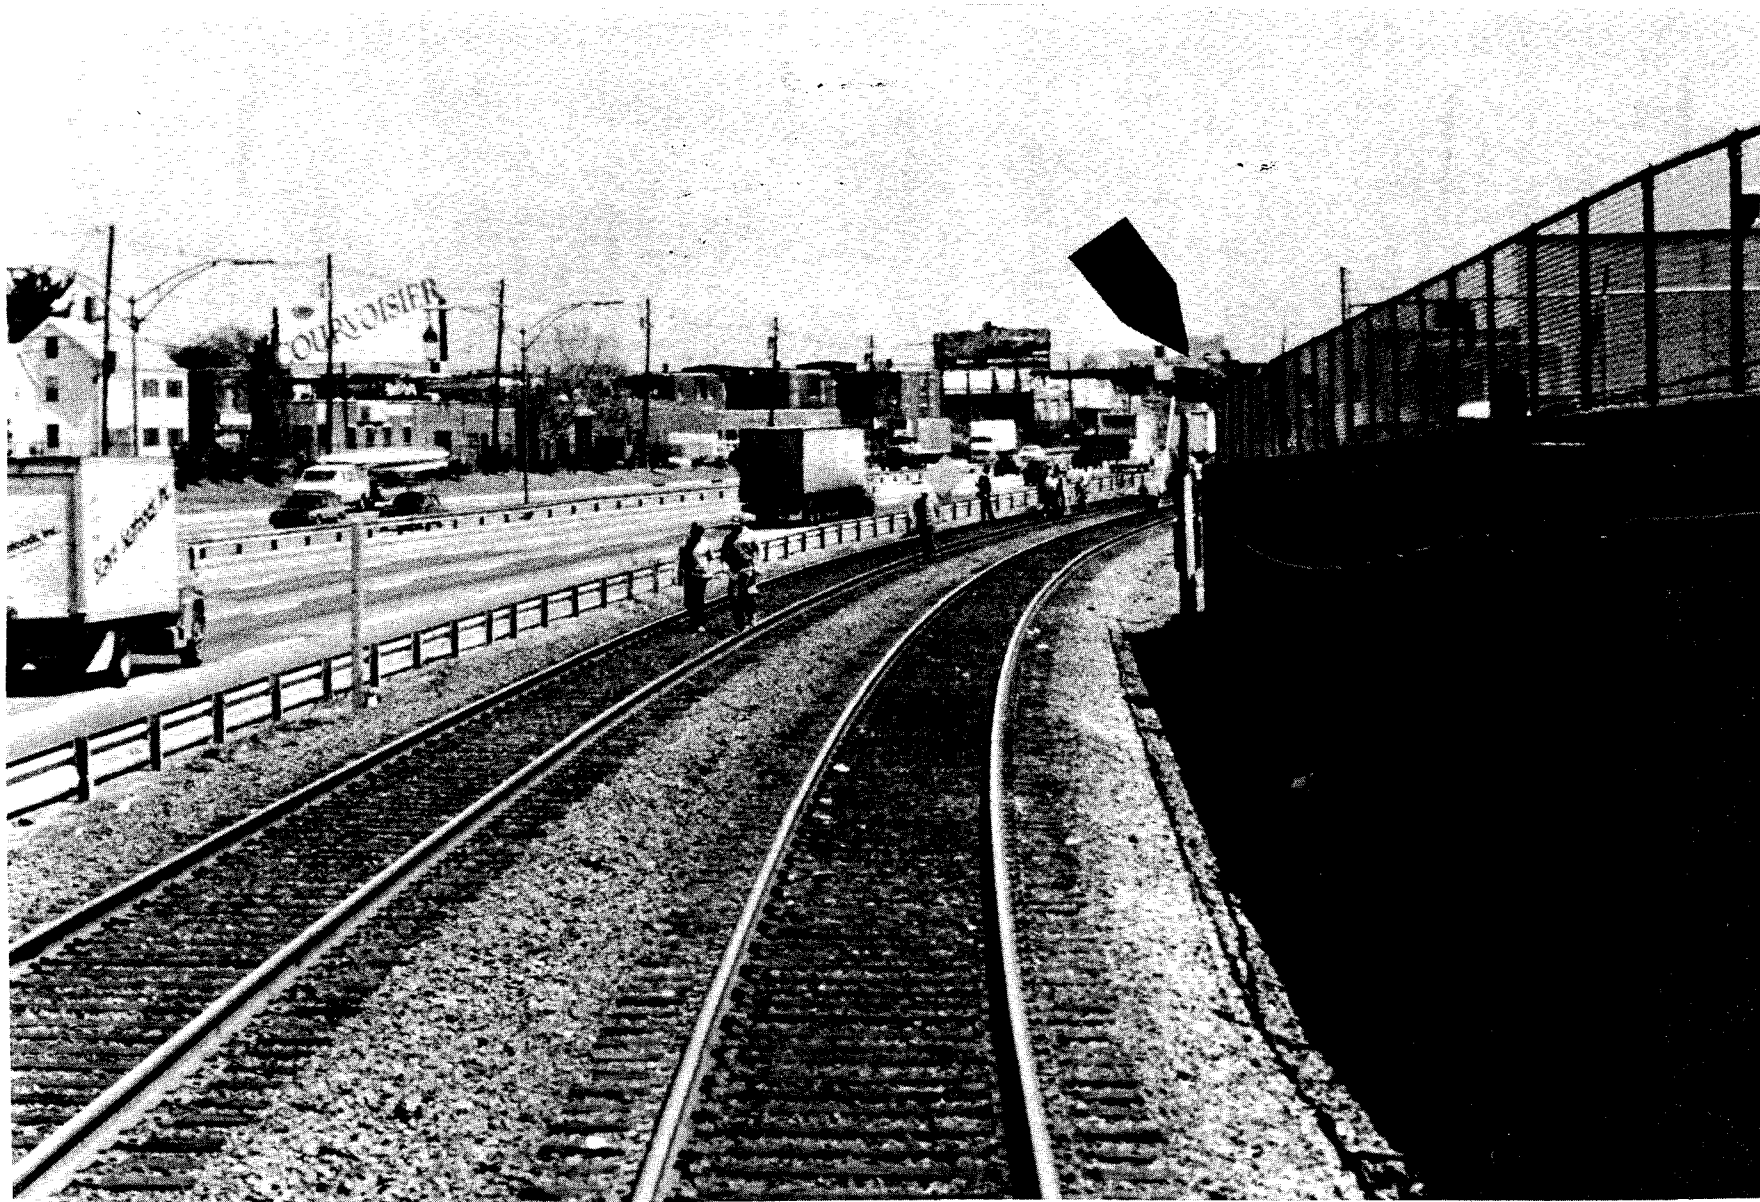
Figure 3.--Arrow indicates site of large plywood board placed at the location of the last car after impact with train TV-14.

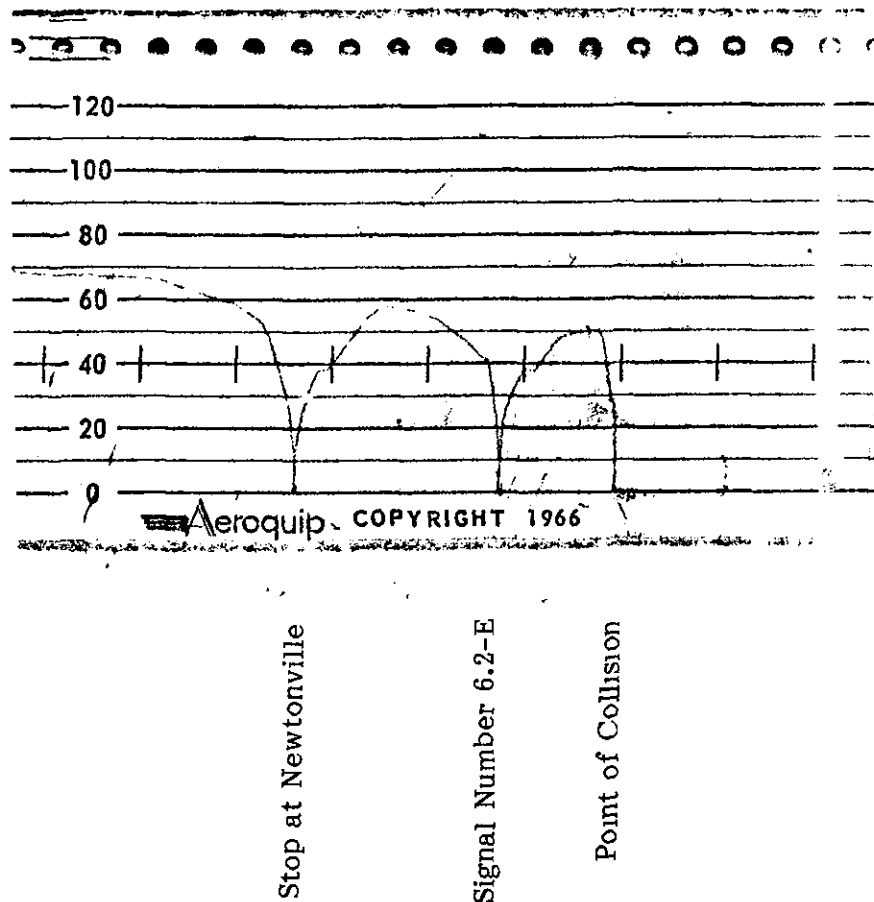
Figure 4.--Speed tape of train No. 5324.

The speed tape from control coach 1310 indicated that train No. 5324 had attained a maximum speed of 50 mph between signal 6.2E and the point of collision. Further, the speed tape indicated a speed of 25 mph just before impact occurred (see figure 4). The accuracy of the speed recorder from coach No. 1310 was tested by applying a prescribed frequency test signal, directly to the recorder unit which corresponded to a speed in miles

per hour and by-passing the sensor unit. The coach wheels were measured to determine the correction factor for wheel wear. The tests indicated that the speed recorder was accurate to plus or minus 2 mph over the speed range at which the commuter trains were operated.

In response to questions by Safety Board investigators in a deposition proceeding, the chief mechanical officer for the B&M said that the speed observed during bench calibration tests may differ as much as 10 mph when the unit is placed in service on a piece of equipment because the testing did not include the sensor unit and the wiring on the equipment. The speed recording unit from control coach No. 1310 was then placed back into service on other coach equipment. The recorder units of locomotive 1100 and control coach 1300 were not tested.
