PB89-917004
NTSB/RHR-89/01

RAILROAD/HIGHWAY ACCIDENT REPORT

CONSOLIDATED RAIL CORPORATION TRAIN COLLISION
WITH ISLAND TRANSPORTATION CORPORATION TRUCK
ROOSEVELT AVENUE GRADE CROSSING
NEAR LAFAYETTE STREET
CARTERET, NEW JERSEY
DECEMBER 6, 1988

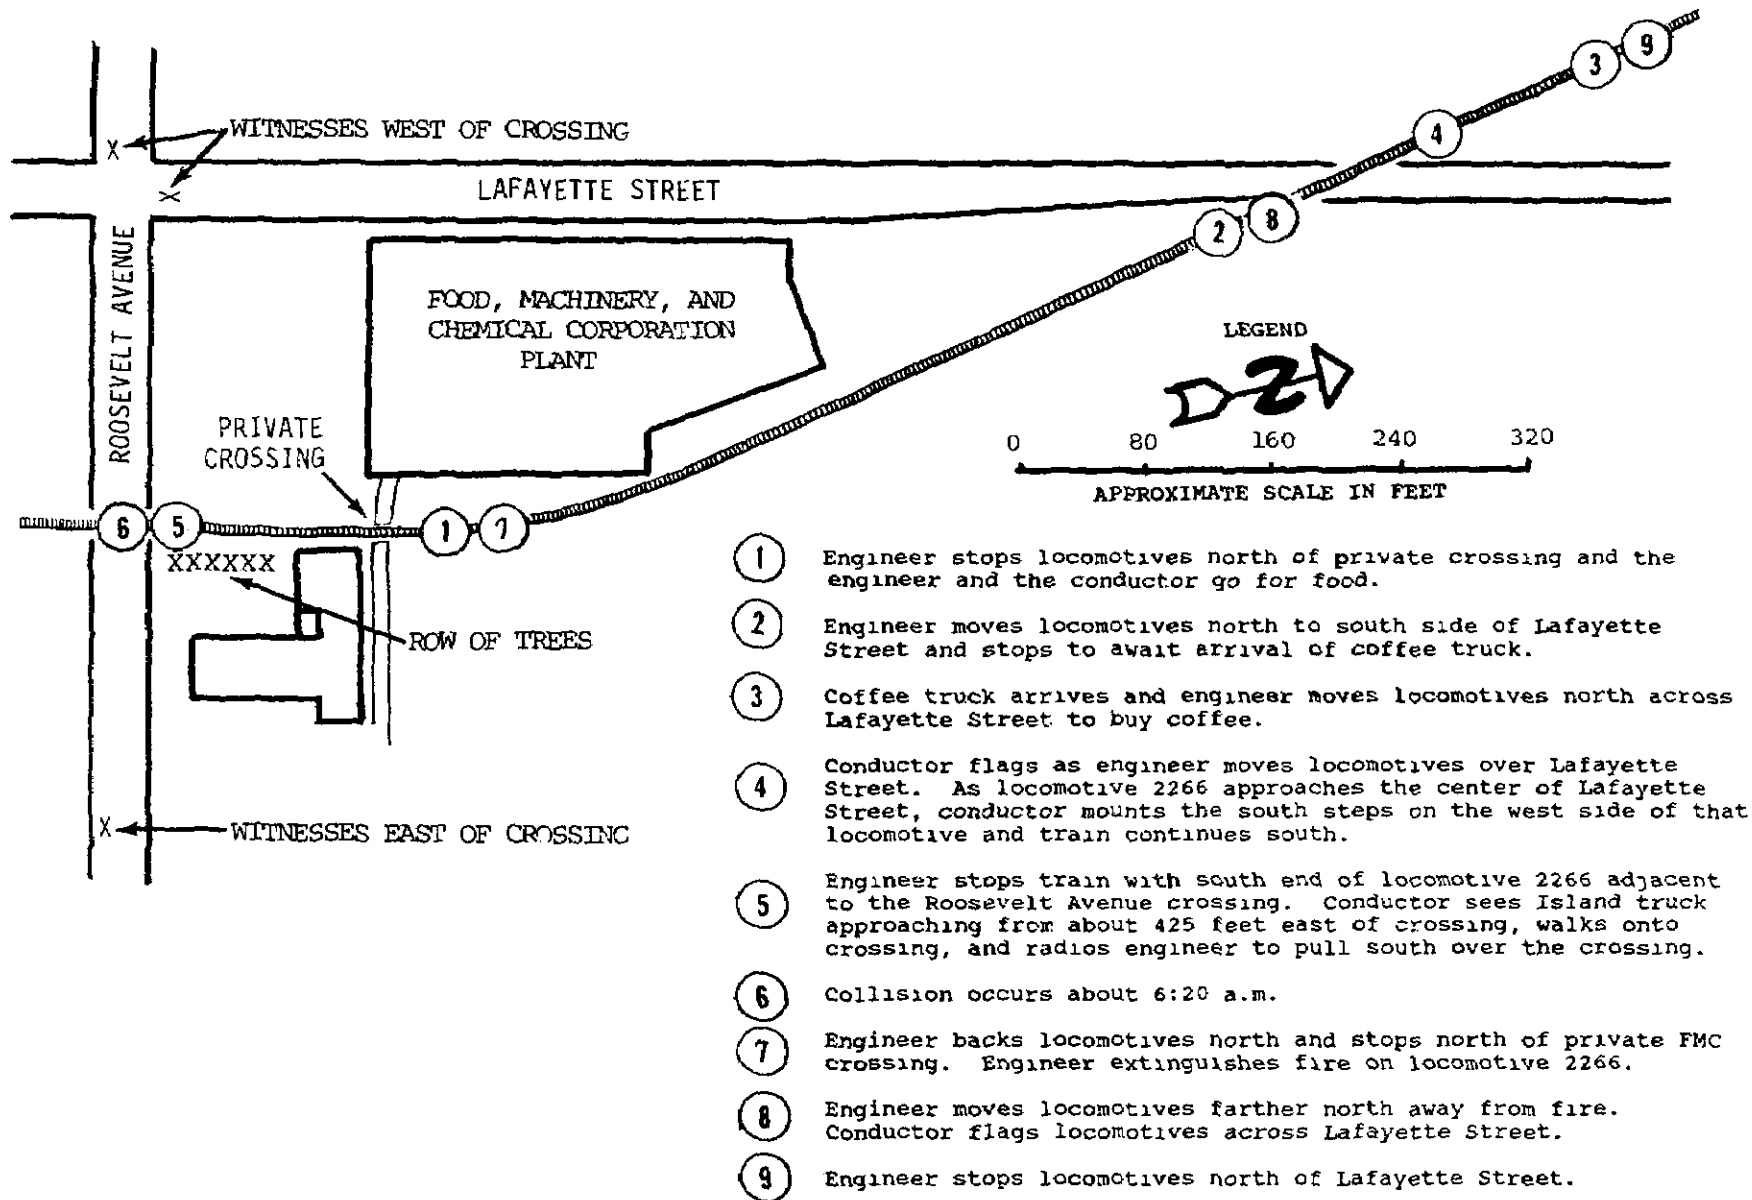
Figure 1.--Train movements reported by the traincrew.

The conductor stated that several seconds later he radioed the engineer to pull north fast. He stated he then panicked because he saw a collision was imminent, and ran north along the west side of the train away from the crossing. He reported that he heard but did not see the collision. (See figure 1.)

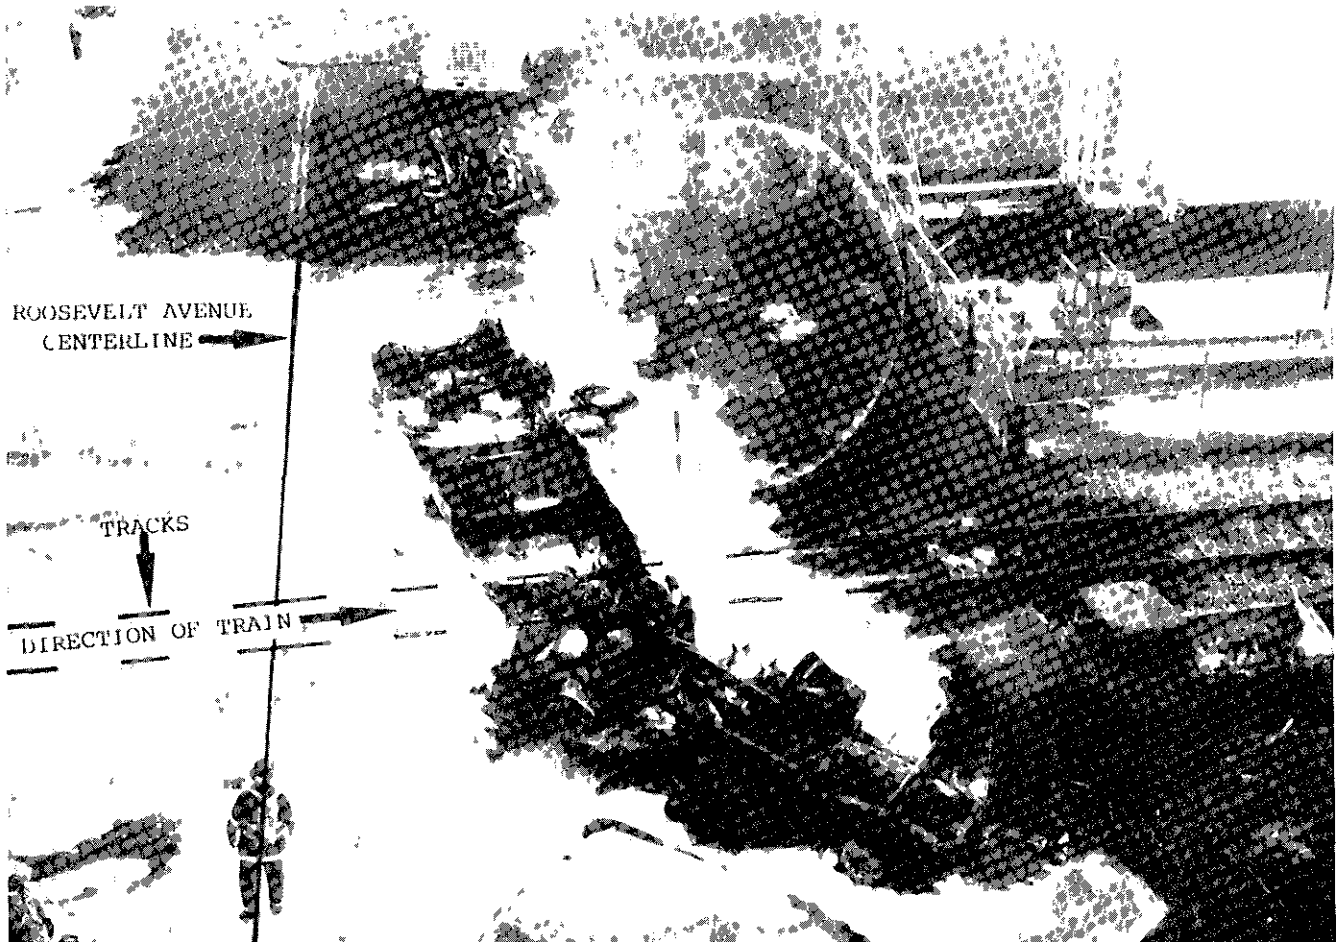
Figure 2.--Final rest position of the Island truck.
(Photo courtesy of the Carteret Police Department)

After the collision the Island truck came to rest overturned in the eastbound lane of Roosevelt Avenue lying generally in an east-west direction across the railroad tracks. The part of the semitrailer resting over the tracks was between 15 and 21 feet from the front of the semitrailer and about 27 feet south of the north curblane of Roosevelt Avenue. (See figure 2.)

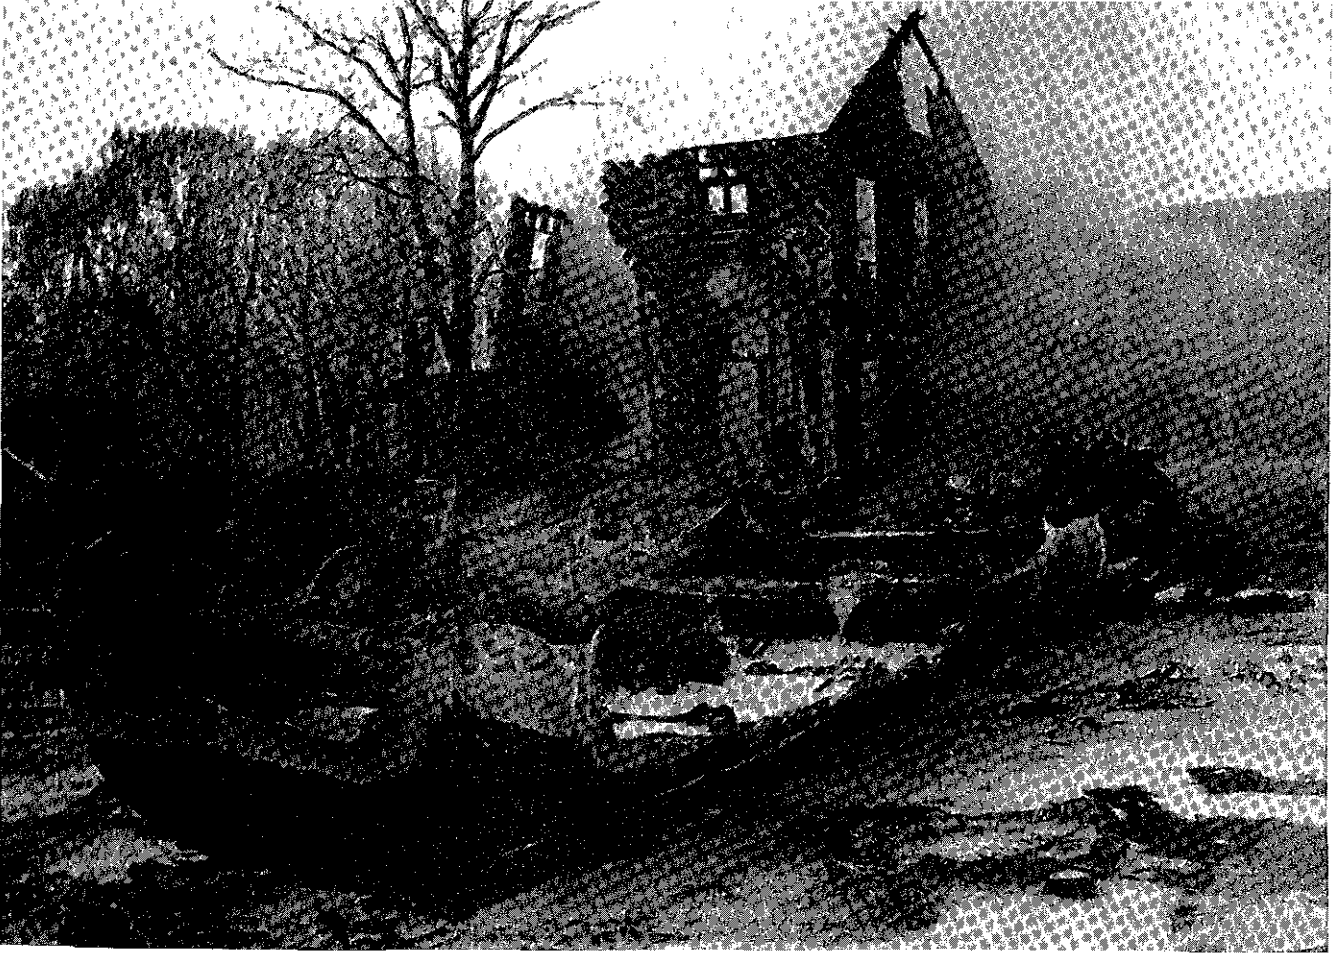
Figure 3.--Left side of Island semitrailer with house destroyed by fire in background.
(Photo courtesy of the News-Tribune.)

The truck was destroyed in the collision and fire and the front of locomotive 2266 was damaged. The two houses southwest of the crossing and a pickup truck parked between the tracks and the houses were destroyed in the fire. (See figure 3.) A third house west of the crossing was damaged. At least three other unoccupied vehicles, other buildings, electrical utility poles and light fixtures in the vicinity of the crossing were destroyed or damaged. The accident resulted in an estimated \$250,000 property damage.

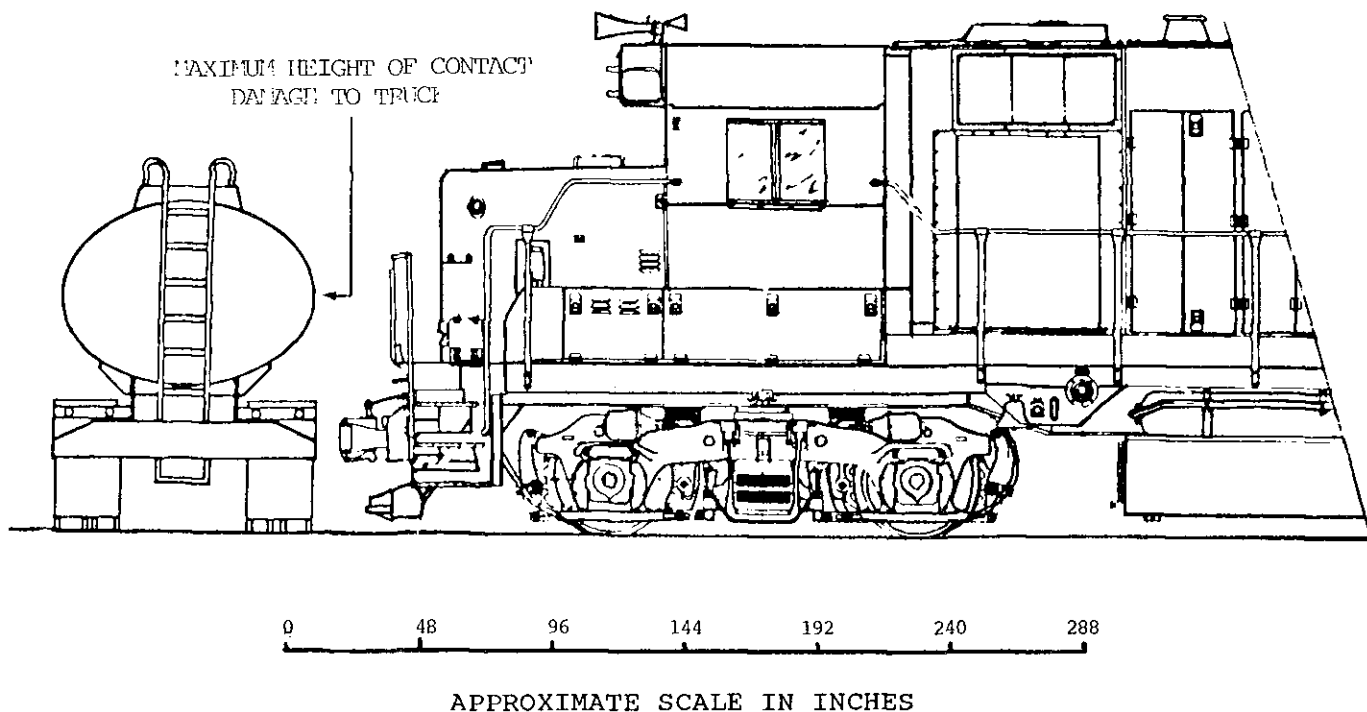
Figure 5.--Location of maximum height of contact damage to right side of Island semitrailer, and rear of semitrailer and left side of locomotive 2266 to same approximate scale.

Approximately the bottom two-thirds of the semitrailer's aluminum tank was melted. On the part of the semitrailer that remained, four-inch-wide contact damage was noted along the right

side of the tank beginning at a point seven feet from the front and at a point 36 inches below the top walkway. (See figure 5.)

Part of the tank forward of this damage was melted away above a height of 36 inches below the top walkway. The damage which could be seen, with three gaps where the tank material was melted away above the general location of the damage, extended on the right side of the remaining tank material to a point 19 feet from the front and 49 inches below the top walkway.

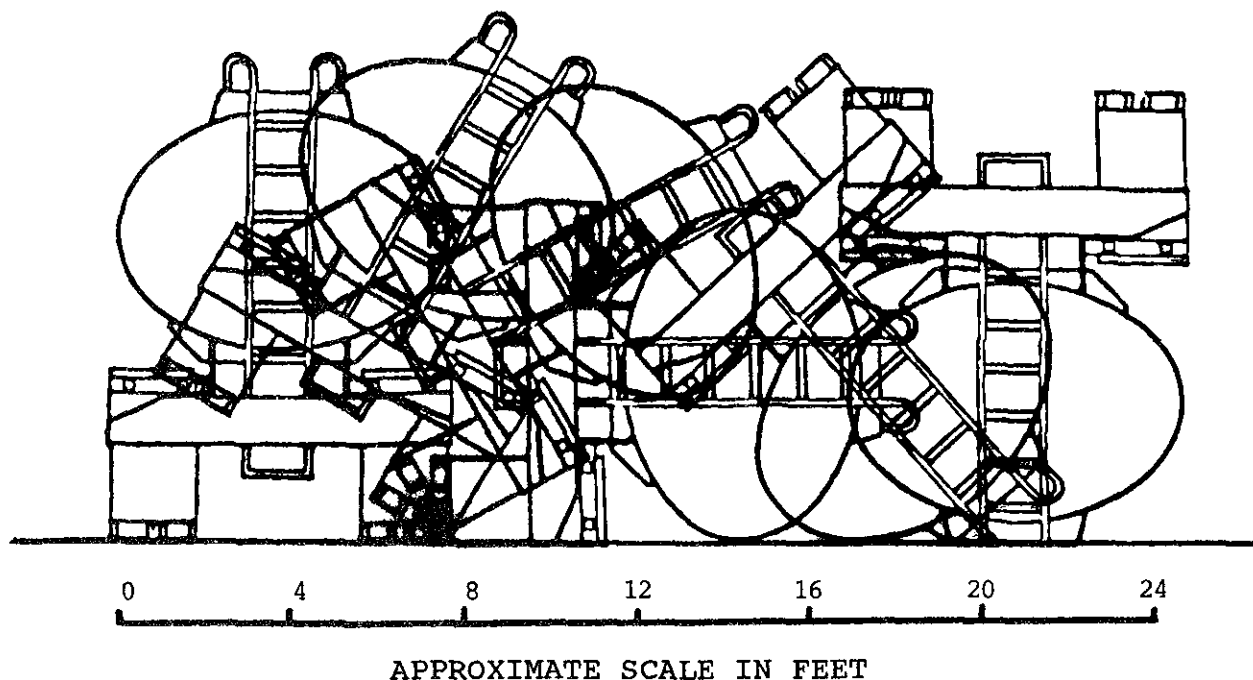
Figure 6.--Minimum lateral distance for semitrailer to roll over 180 degrees.

Using the exterior dimensions of the semitrailer, the Safety Board determined that the minimum distance the semitrailer had to travel laterally in a 180-degree rollover was 24 feet. (See figure 6.)

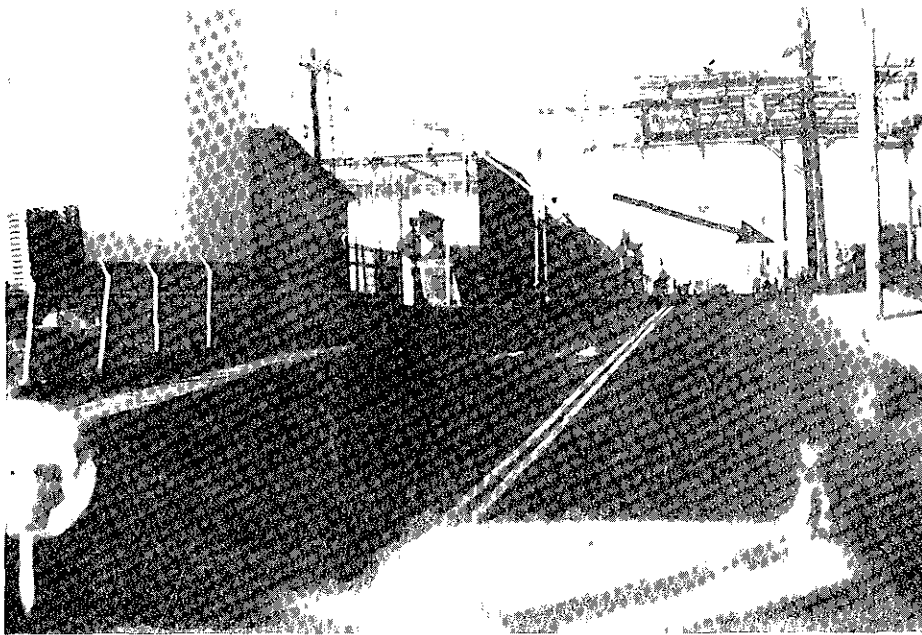
Visibility Tests.--Night visibility tests were not performed because the street lamp located 44 feet north of the crossing that was damaged in the fire was not replaced. With the head end of the test locomotive stopped even with the north curblines of Roosevelt Avenue, visibility tests performed in clear daylight indicated that when the test truck was about 425 feet east of the crossing utility poles on the north side of Roosevelt Avenue partially obstructed the test truckdriver's view of the head end of the test locomotive. (See figure 7.)

Figure 7.--View of the locomotive (arrow) from the test truck 400 feet east of the crossing.

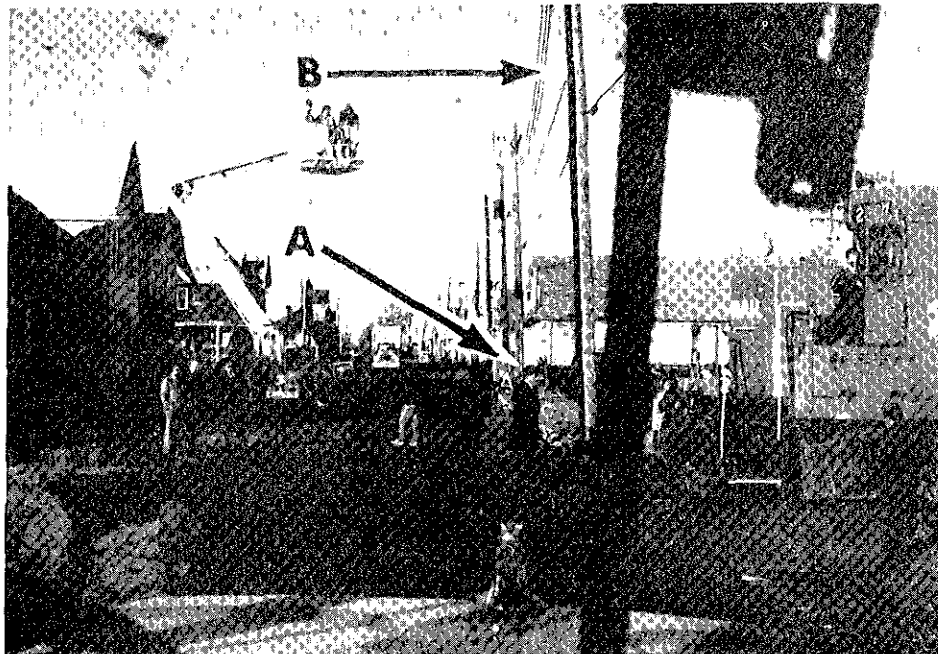
Figure 8.-- View of locomotive and position of conductor (arrow A) from truck 100 feet east of the crossing. Arrow B indicates the location of the 400 watt street lamp which was destroyed.
