PB91-916304
NTSB/RAR-91/04

RAILROAD ACCIDENT REPORT

DERAILMENT OF
CSX TRANSPORTATION INC. FREIGHT TRAIN
AND HAZARDOUS MATERIALS RELEASE
NEAR FREELAND, MICHIGAN
ON JULY 22, 1989

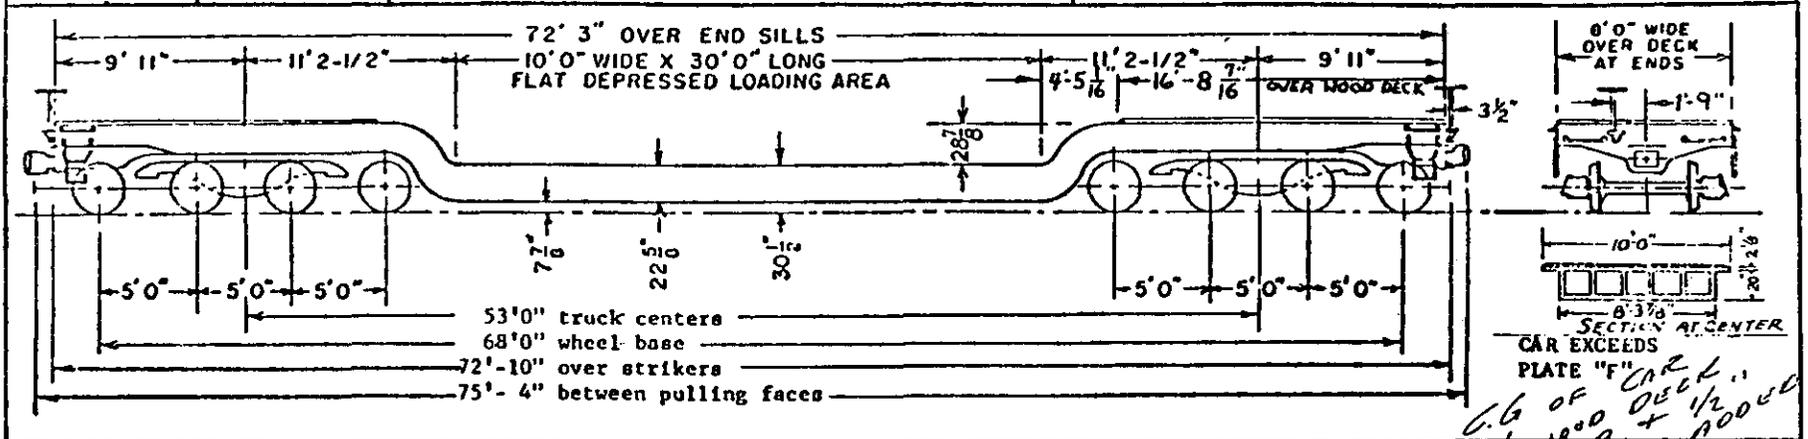
According to ATSF records, the shipment on ATSF 90005 (see figure 2) originated on the ATSF in Chanute, Kansas, and after being transported 830 miles to Chicago, Illinois, was interchanged there with the CSX at the Belt Railway Yard. ATSF reported that following the interchange, the CSX detained ATSF 90005 to repair the braking system. CSX replaced five brake shoes before moving the car about 230 miles to Flint, Michigan, where CSX freight train R-331-22 picked it up to take it to its final destination in Midland.

A postaccident inspection of ATSF 90005 revealed that the number 2 axle had been in contact with the B-end⁵ span bolster at least twice, once on the right and once on the left side of the span bolster directly above the number 2 axle. The metal transfers on the left side were unoxidized; the contact on that side centered on the span bolster about 13 inches in from the L2 (second wheel, left side) wheel flange. An 8-inch cone-shaped wear pattern was evident on the left side contact point of the span bolster, metal had extruded onto the leading⁶ edge. The right side of the span bolster evinced a similar 6-inch conical pattern, and metal transfers were present on the number 2 axle beneath the contact point. The span bolster abrasion surface on the right side and the metal transfers on the axle beneath that abrasion were oxidized.

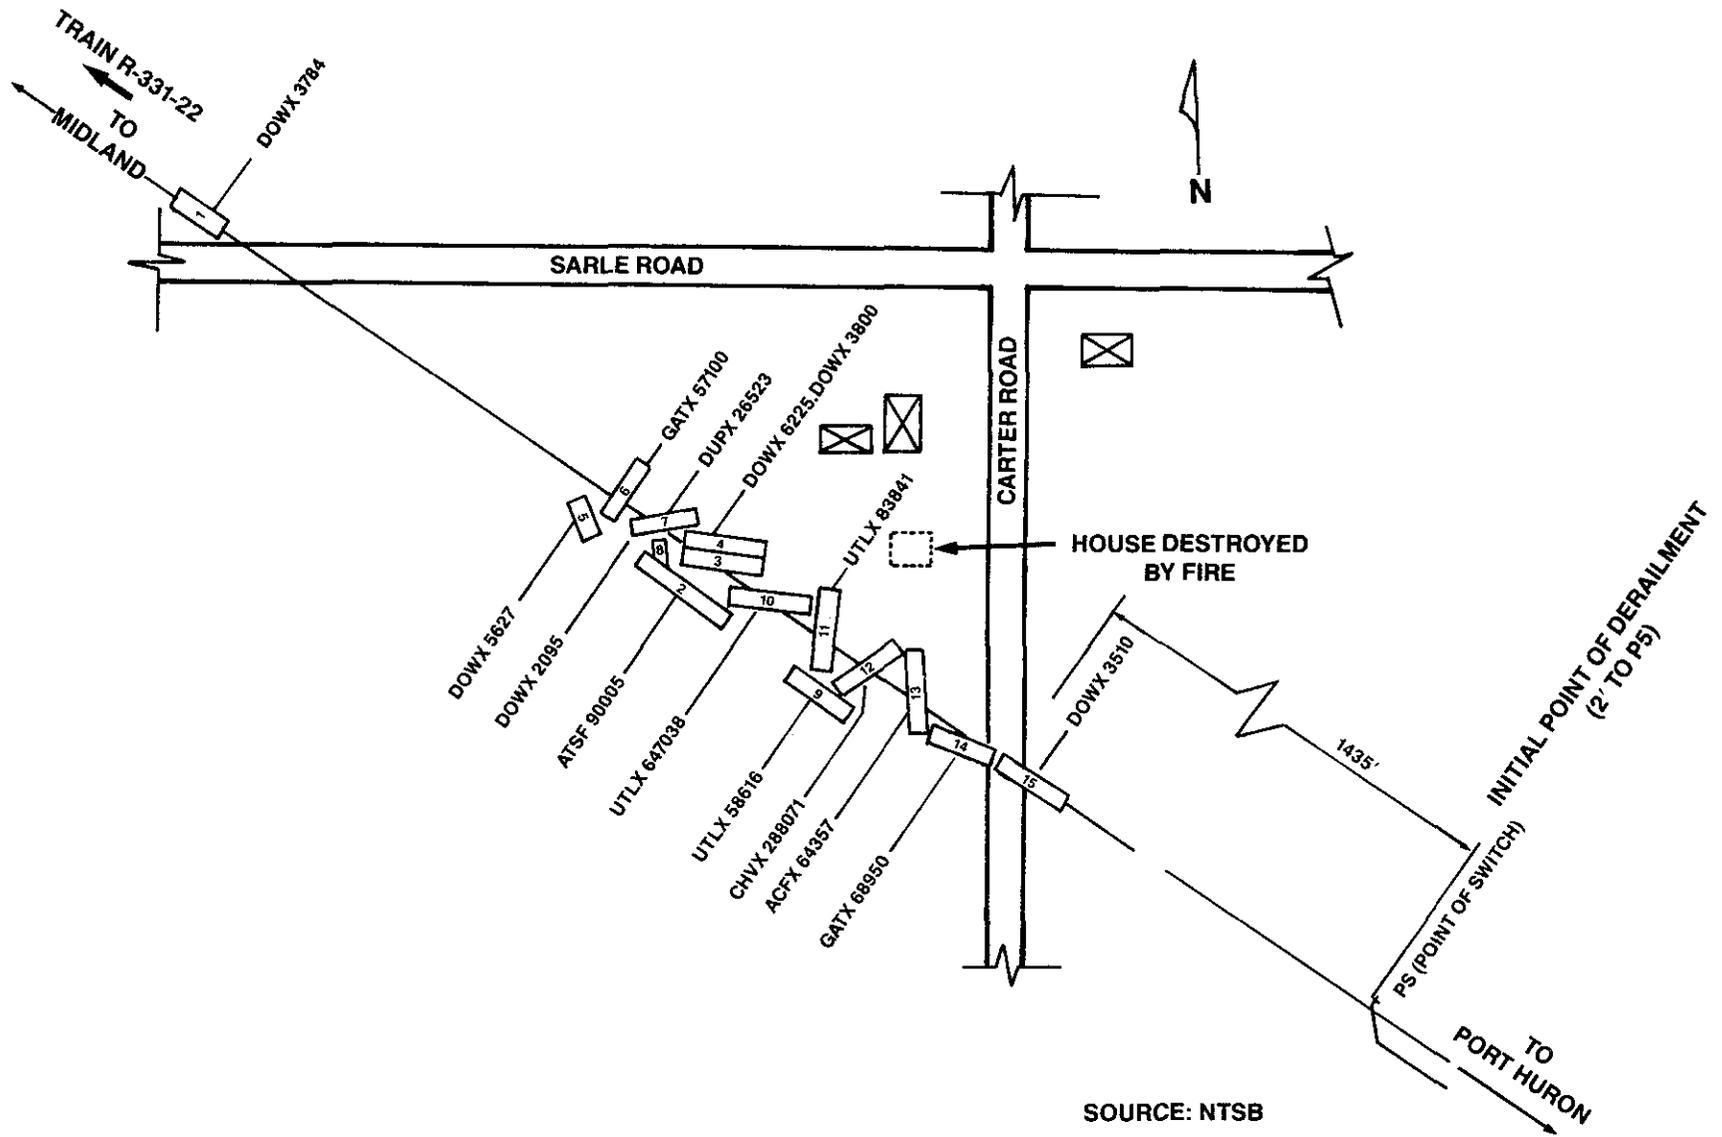
Figure 4 --Identification of derailed cars, freight train R-331-22.

Derailed Tank Cars --All hazardous materials tank cars that derailed, including the five that were loaded and the one that was not, were damaged, and all were equipped with top and bottom shelf-type couplers. The tank car types involved were Department of Transportation (DOT) 105, DOT 111, and DOT 112. Damage was as follows:

GATX 57100, DOT 111A100W (6th car), was not equipped with a head shield (a supplemental heavy steel plate on the end(s) of a car) or a jacket (a thin outer shell used to contain insulating material wrapped around the tank), the underframe and the left side at the B-end were severely dented and scraped, the outer leg for the bottom outlet was missing (the leg failed at the shear bolts that attached it to the tank), the A-end head was dented above the center line of the car and the B-end was dented below the centerline of the car, the A-end sill was broken, one coupler was disengaged, and one coupler was broken. The trucks were destroyed.

DUPX 26523, DOT 112A200W (7th car), was not equipped with head shields or a jacket, both ends and the tank shell were dented and scraped (the dent in the A-end head was 14 inches deep and 5 feet in diameter), the A-end sill was bent and buckled, the A-end coupler was disengaged, the B-end knuckle was broken, and the B-end body bolster was bent. Both trucks were derailed.

UTLX 647038, DOT 111A100W6 (10th car), was not equipped with head shields and had a jacket and thermal insulation, the right side of the tank had a 3-inch by 6-inch hole near the B-end (about 2 inches from the seam), the A-end stub sill was bent downward and spread open, the jacket had deep dents in both ends, the jacket was torn near the B-end saddle bracket and at the middle of the car, burn damage to the jacket was extensive,

the A-end saddle bracket was bent, one coupler was disengaged, the other coupler was damaged, and both tank heads were severely dented. The trucks were destroyed

UTLX 83841, DOT 105A300W (11th car), was not equipped with a head shield but did have a jacket. Both stub sills were damaged, the B-end sill was broken off and missing beyond the end of the car, and the A-end sill was bent downward at approximately a 20-degree angle. Almost all of the B-end head above the centerline of the car was punctured, and the head was severely dented below the centerline. Fire damage to the jacket was extensive. Both couplers were broken, and both trucks were destroyed.

CHVX 288071, DOT 111A100W1 (12th car), was not equipped with head shields but did have a jacket and thermal insulation, the B-end tank head had a 10-inch by 14-inch puncture below the centerline of the car and was dented above and below the centerline, the A-end tank head was dented above and below the centerline of the car, the jacket was dented and scraped near the sill on the B-end, and the jacket was extensively burned on the B-end and partially burned on the A-end. Both couplers were disengaged. The trucks were destroyed.

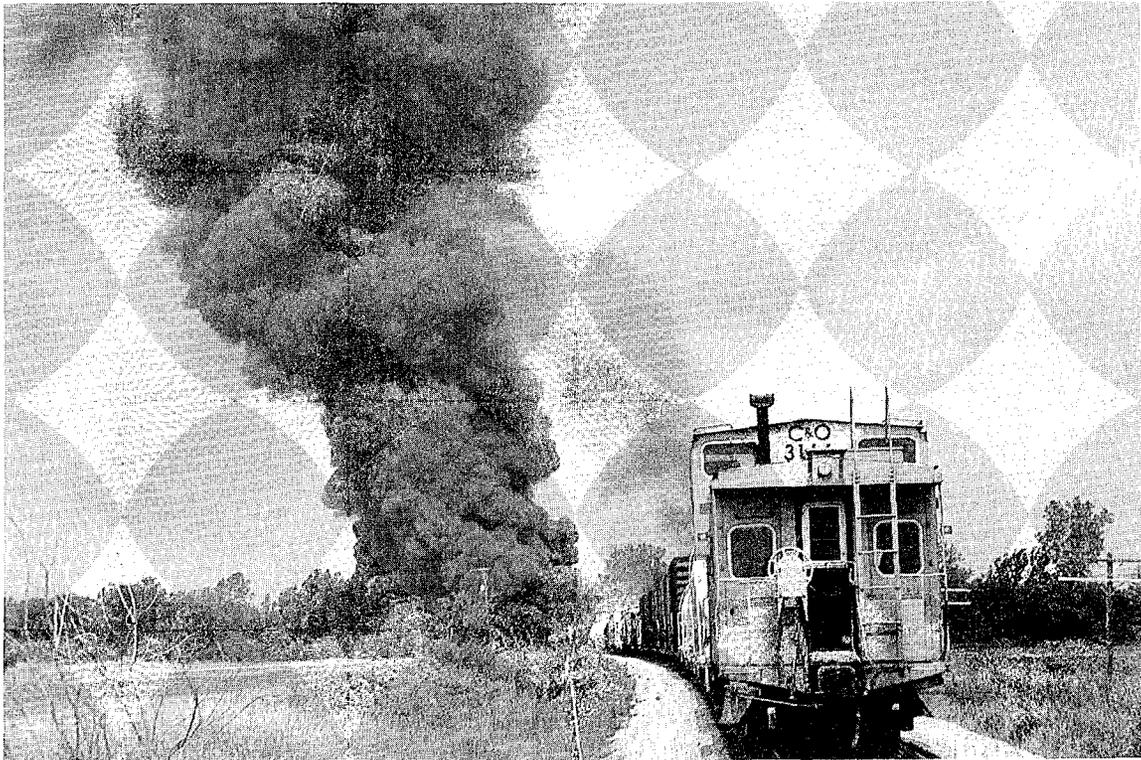
Figure 5.--Fireball and smoke cloud following derailment.

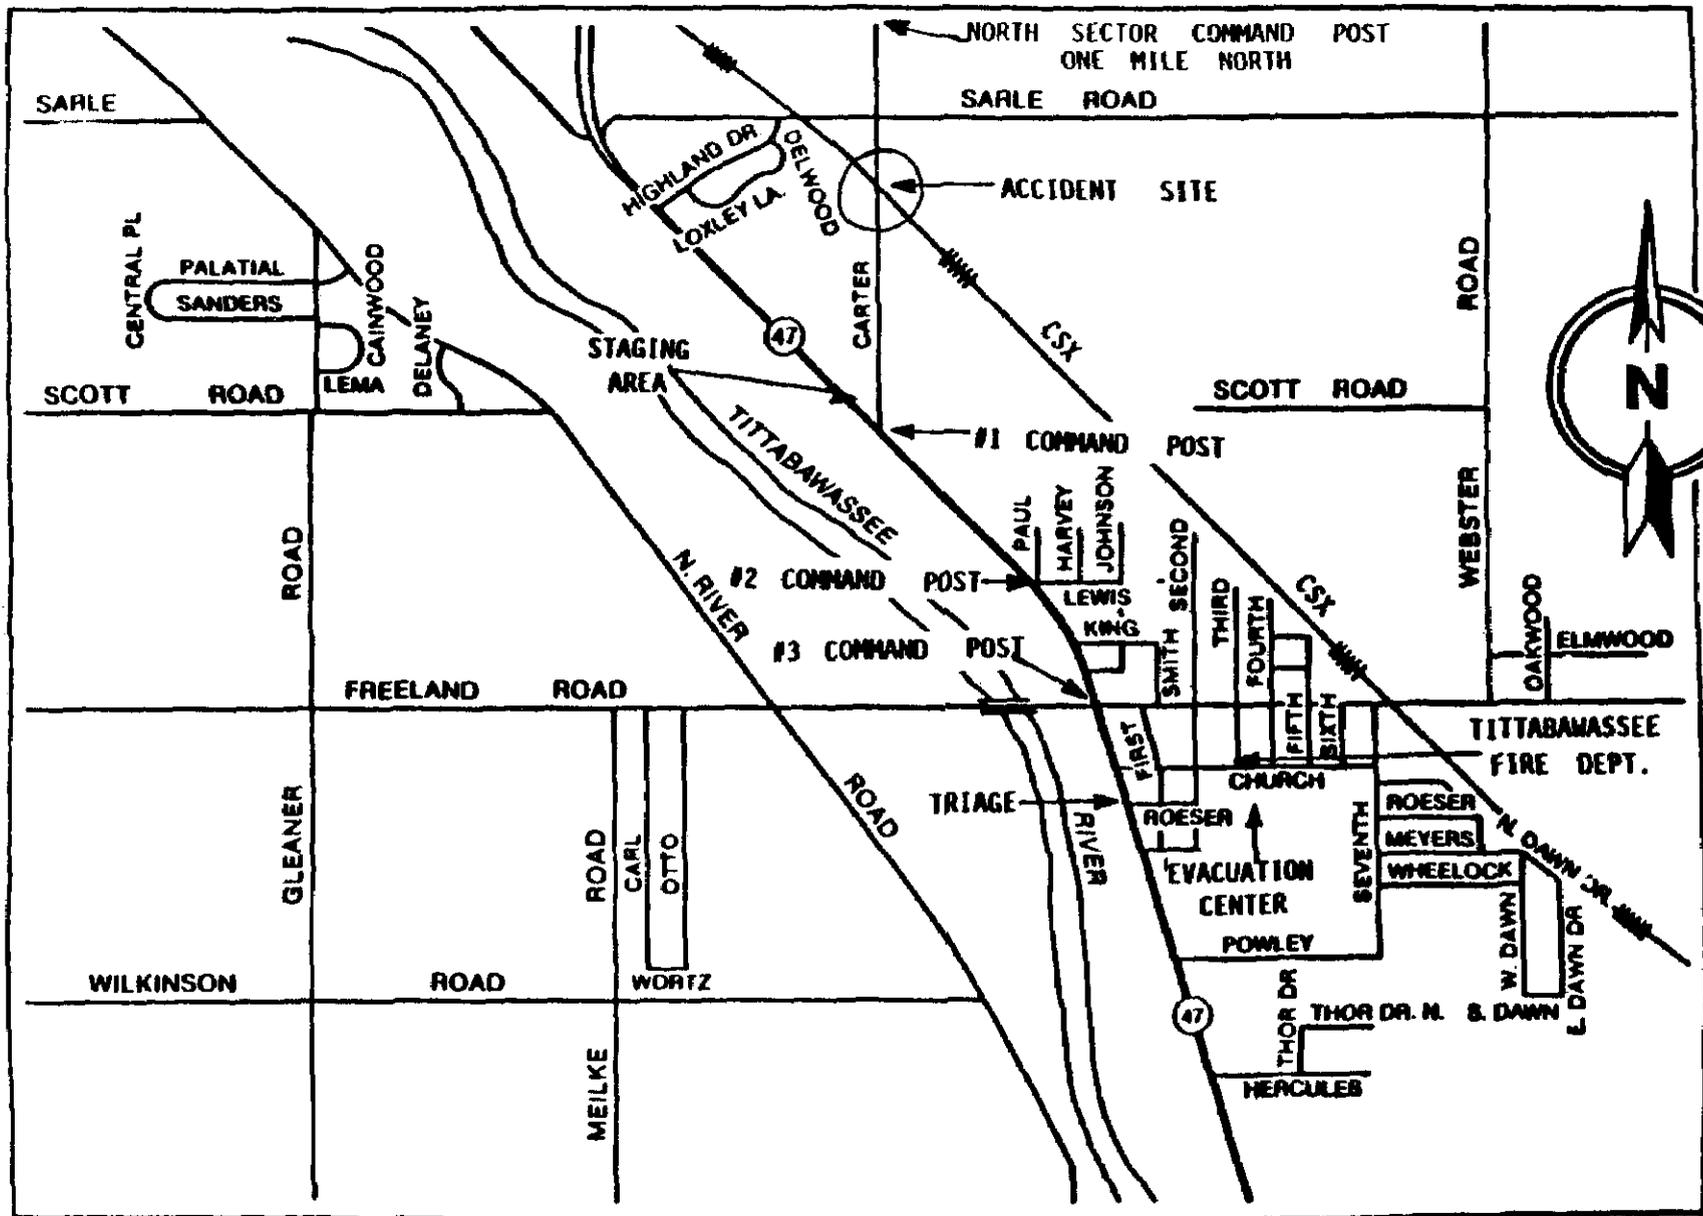
Of the 14 freight cars that derailed, 6 were tank cars that sustained damage resulting in either partial or total loss of load. A flatcar loaded with a heat recovery steam generator (HRSG) module overturned, and the module was destroyed. One nearby residence was destroyed by the fire that ignited following the release of hazardous materials.

Figure 6.--Accident site and surrounding area, Freeland, Michigan.

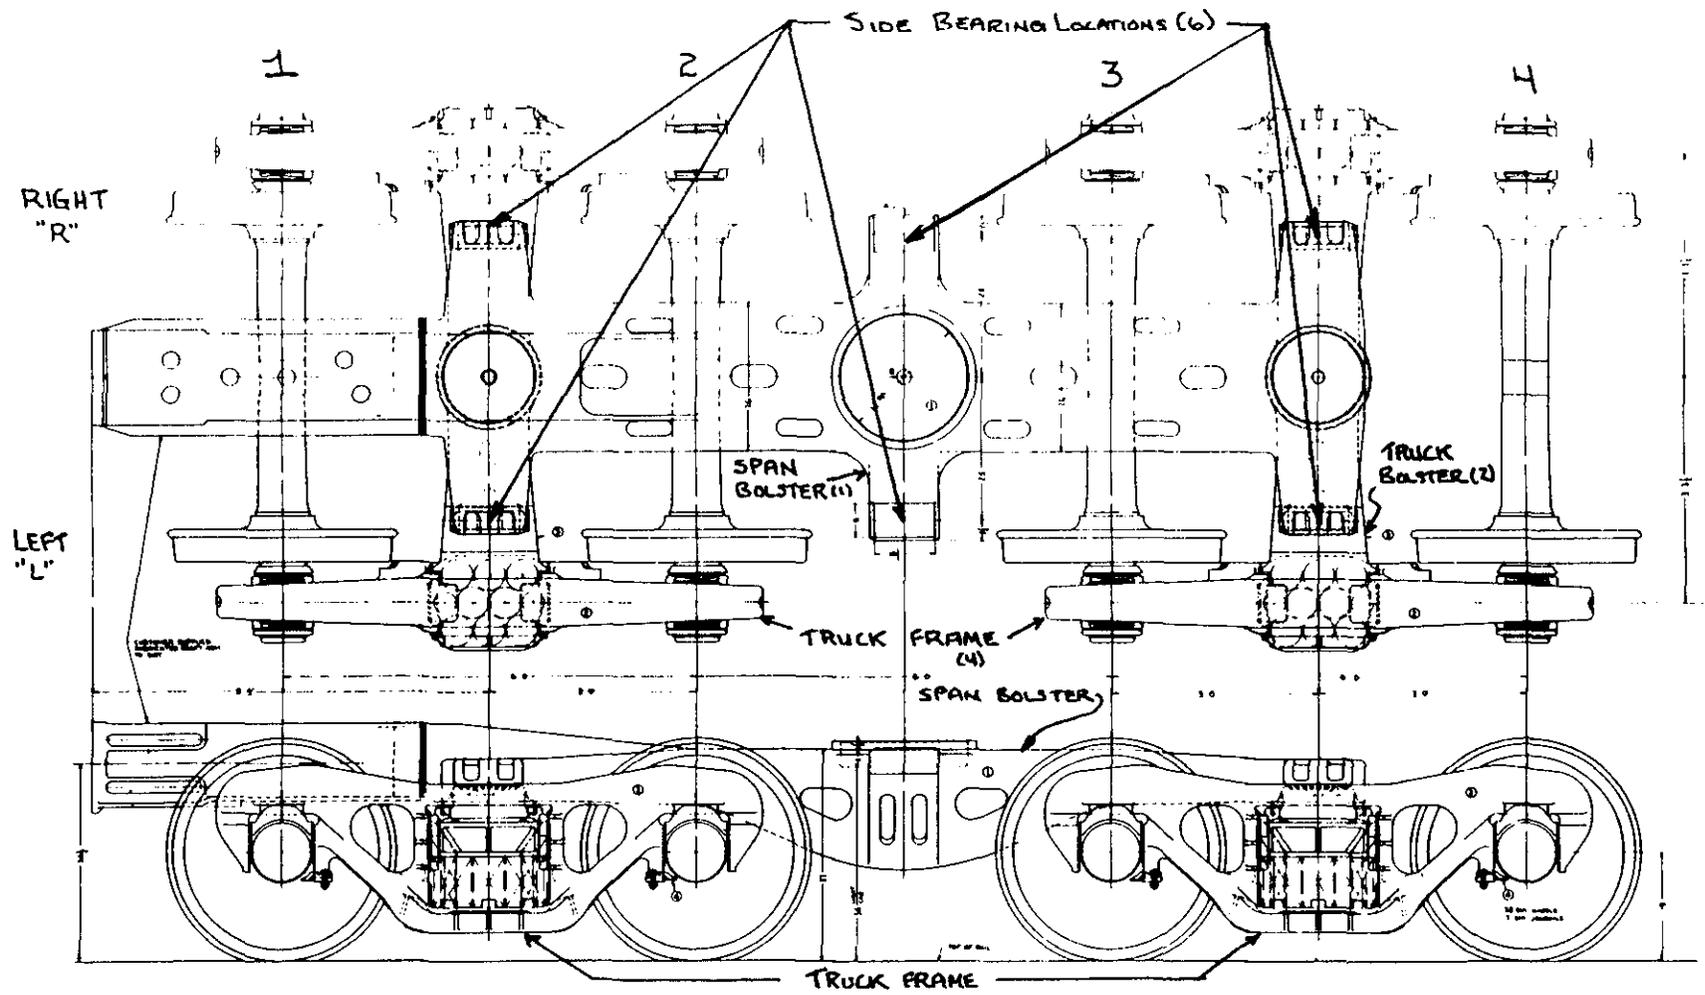
Figure 7 --Railcar truck assembly configuration

The car had hanger-type brake beams. The brake shoes on both B-end trucks had been overriding.⁷ The R1, L2, R3, and L4 had been overriding the wheel flanges, the L1, R2, L3, and R4 had been overriding the outside edge of the wheel rims. The overriding brake shoes were at diagonally opposite locations on each truck. The shoes contacting the wheel flanges had contoured to the flange profile, and some were worn about 50 percent cross-sectionally through the brake shoe.

Part of the R2 wheel flange had worn away continuously around the circumference at the point of wheel-rail interface. The wear angle formed at the juncture of the tread and flange was sharply defined, and no metal extruded onto the flange. Wear began near the apex of the wheel flange, extended inward toward the hub, and ended about 3/8 inch above the tread surface at the throat of the flange. The wear surface face was smooth, and the fracture surface of the interior wear surface edge was irregular. The interior edge was about 1/16 inch from a perpendicular at the base of the wheel flange.

When ATSF 90005 was rebuilt in February 1989, according to information provided by ATSF, "it was necessary to place three-sixteenths (3/16) inch to one-quarter (1/4) inch shims in the center bowl of the span bolster on the end of the car that had no side bearing clearance." ATSF stated that "this was done after the original record of repairs was completed and, through inadvertence, no supplemental or amended record was made." No shims were found during the investigation and reassembly of the trucks following the accident.

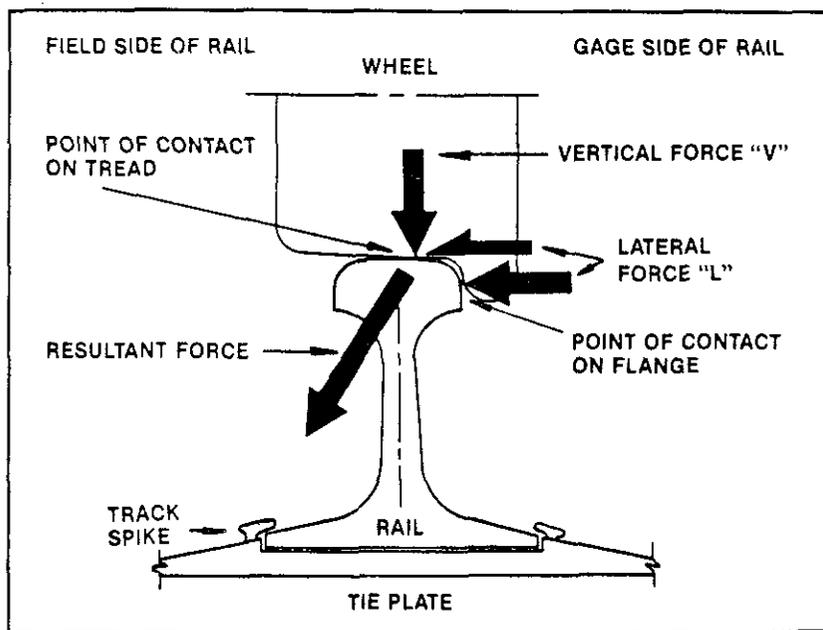
According to the AAR Steering Committee for the Track Train Dynamics Program,³⁰ wheel lift derailments, which are related to the forces present at the wheel-rail interface, may be associated with track-train dynamics (see figure 9).

The reaction of forces at the wheel-rail interface will determine the tendency for a wheel to derail. The term commonly used to identify this reaction is L/V (L over V) [lateral to vertical force] ratio as shown in [figure 9]. The greater this ratio becomes, the greater the likelihood of derailment.

Figure 9 --Lateral to vertical force relationship between rail and wheel

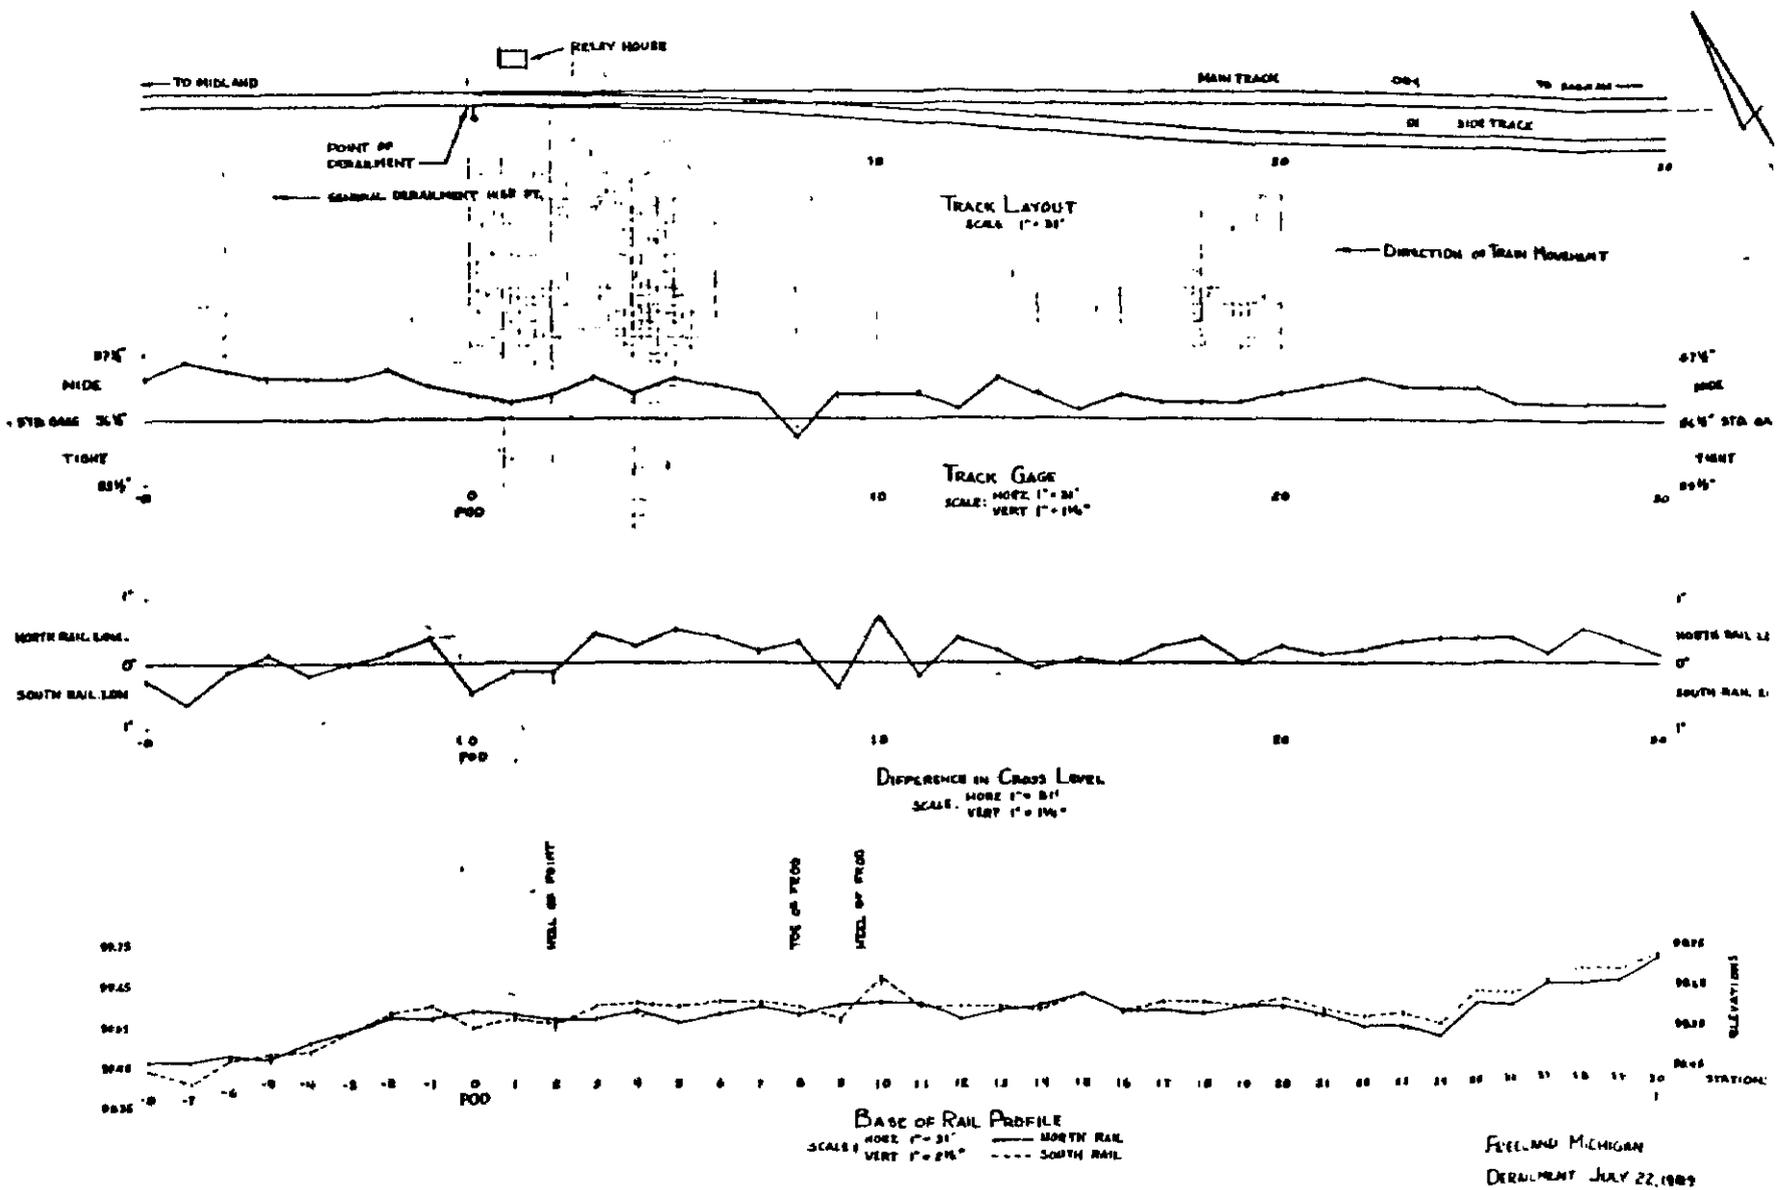
TRACK GEOMETRY MEASUREMENTS

Postaccident Survey --To determine surface conditions after the accident, track geometry was measured at 15 5-foot intervals 465 feet before and 124 feet after the POD, base-of-rail levels and track gauge were measured under load,¹³ and track alignment was measured under static conditions (See appendix D.)

CSX had last operated a track geometry car over this subdivision on June 22, 1989. During that evaluation, a 1 5/8-inch cross level deviation on the north rail was detected at MP 11.9, which was the POD. CSX records indicate that this irregularity in track surface was repaired on June 26; they do not show that any previous accidents had occurred at this location. (Title 49 CFR 213.63 allows a 1 3/4-inch tolerance for class 3 track.)
