PB93-916303
NTSB/RAR-93/02

RAILROAD ACCIDENT REPORT

DERAILMENT AND SUBSEQUENT COLLISION
OF AMTRAK TRAIN 82 WITH RAIL CARS
ON DUPONT SIDING OF CSX TRANSPORTATION INC.
AT LUGOFF, SOUTH CAROLINA, ON JULY 31, 1991

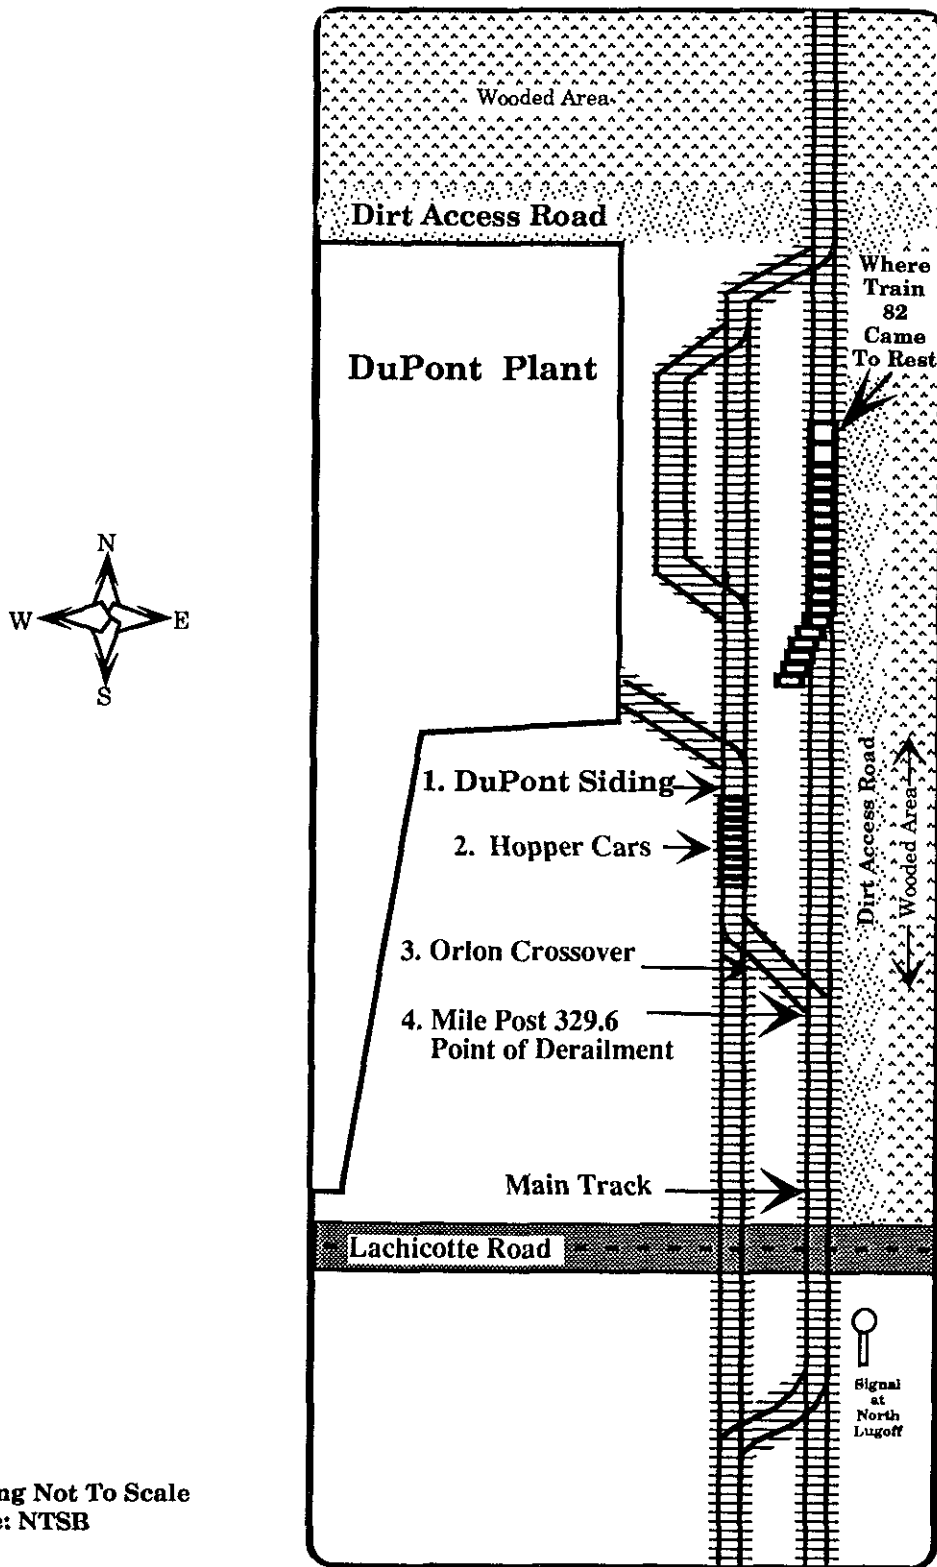
Figure 1 --Detail of accident site

The accident occurred near the E.I. DuPont May plant on a single main track that has a parallel auxiliary track. The derailment occurred at the Orlon crossover switch that connects the main track and the auxiliary track, which is known as the DuPont siding. (See figure 1.) The last six passenger cars (13 through 18) derailed, moving left (westward) toward the siding. The cars collided with the first of nine hopper cars that were parked north of the Orlon crossover at the south end of the siding. The collision caused a hopper car to turn over and a wheel set (an axle and a pair of wheels) from the first hopper car to penetrate the west side of the last passenger car. The derailed passenger cars came to rest 1/4 mile north of the Orlon crossover. They remained upright and parallel to the track.

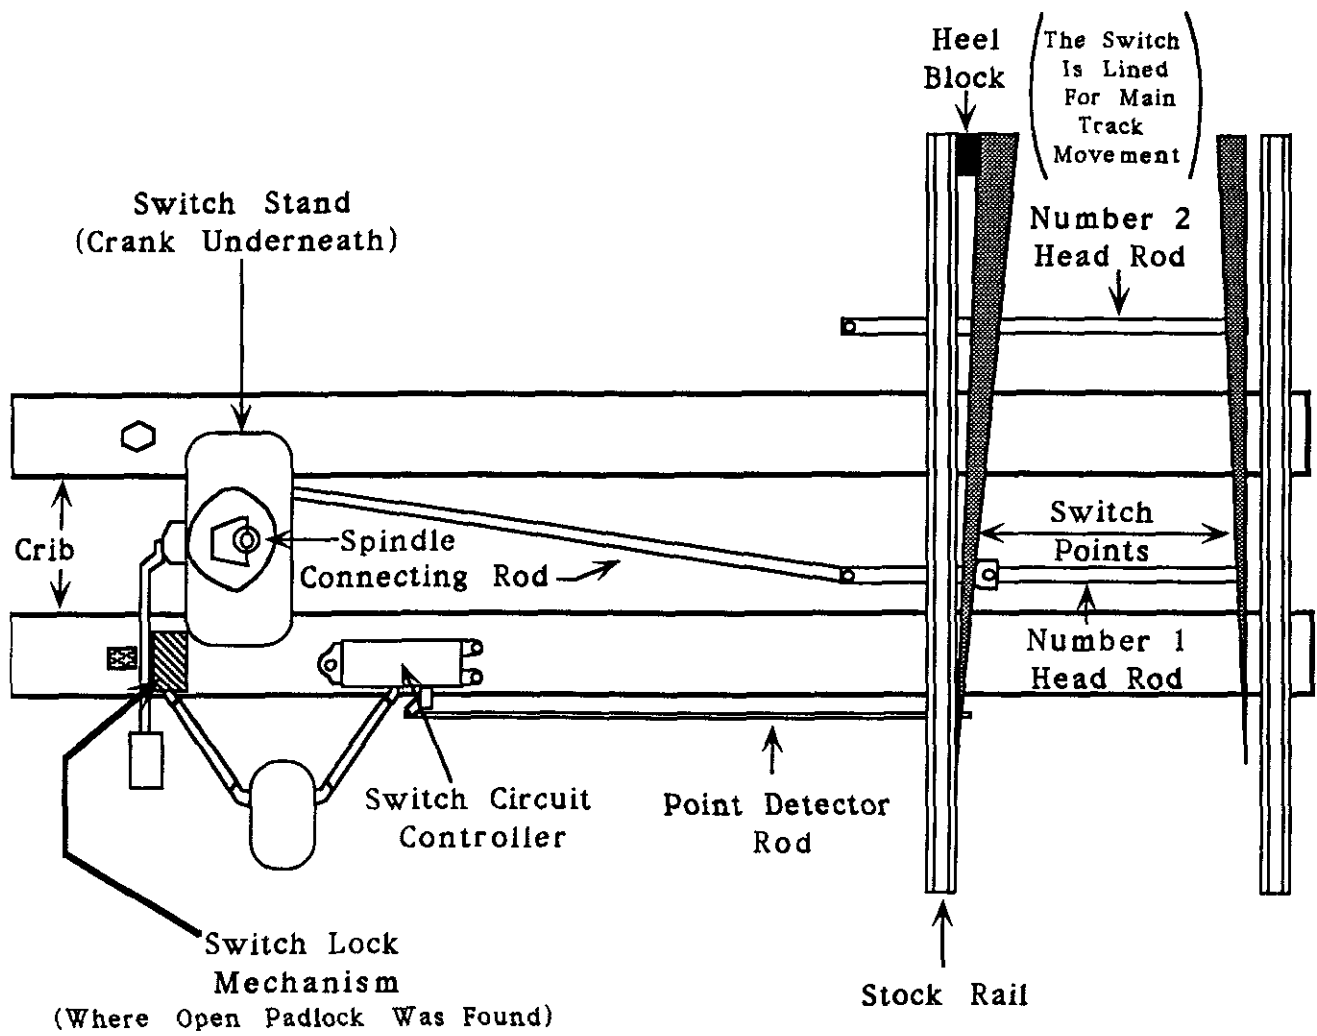
Figure 2 --Diagram of switch stand

After the accident, the main track crossover was found to have the connecting rod disconnected from the switch stand crank. The switch point was not secured to the stock rail, the cross pin that attached the switch stand crank to its spindle was not in place, and the crank had dropped onto the safety plate. The cross pin was found near the switch stand. (See figure 2)

The crank was lower than it should have been because the missing cross pin allowed the crank to drop down on the spindle to the safety plate. The safety plate performed its intended function of keeping the spindle and crank engaged, although the cross pin was missing. If a normal amount of ballast had been in the crib, the switch connecting rod would have been positioned farther down the crank lug. However, the ballast was high enough that the connecting rod had been pushed up and was rubbing the underside of the switch stand.

Because the connecting rod was higher than it should have been and the crank was lower than it should have been, the lug end of the crank and the connecting rod were minimally engaged. The motion, induced by the train, was intensified by the cross level deficiency of the track, which caused the connecting rod and crank to overcome the minimal connection and separate as train 82 passed over the switch.

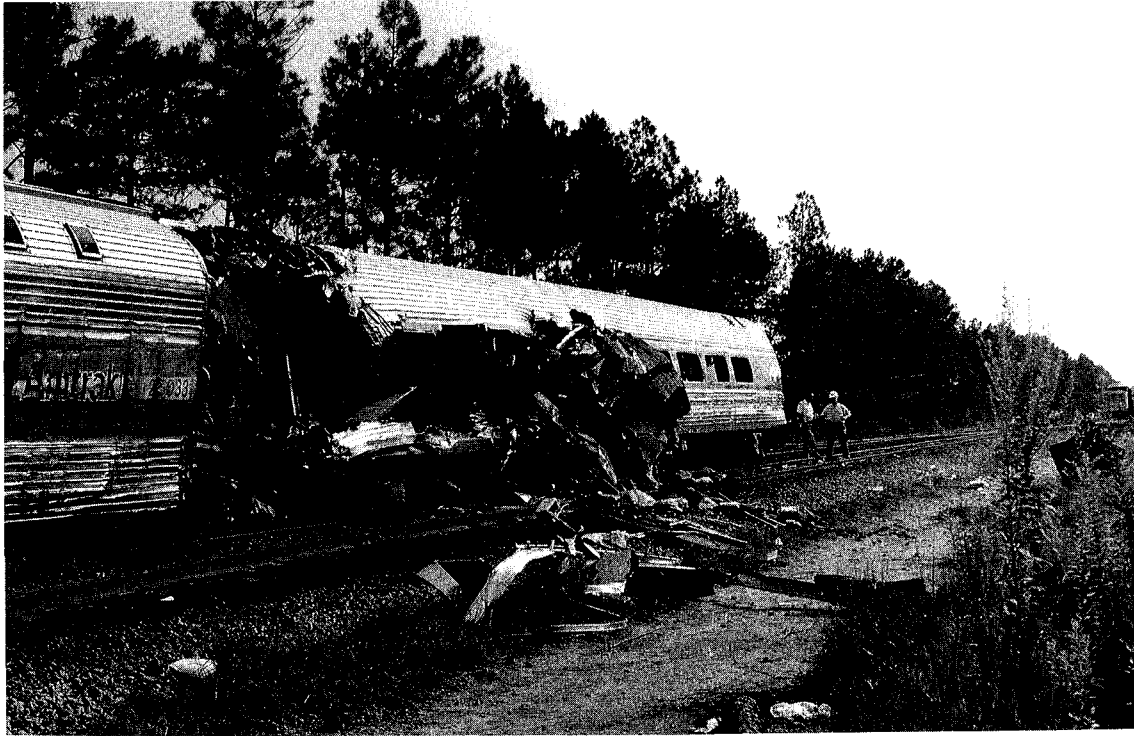
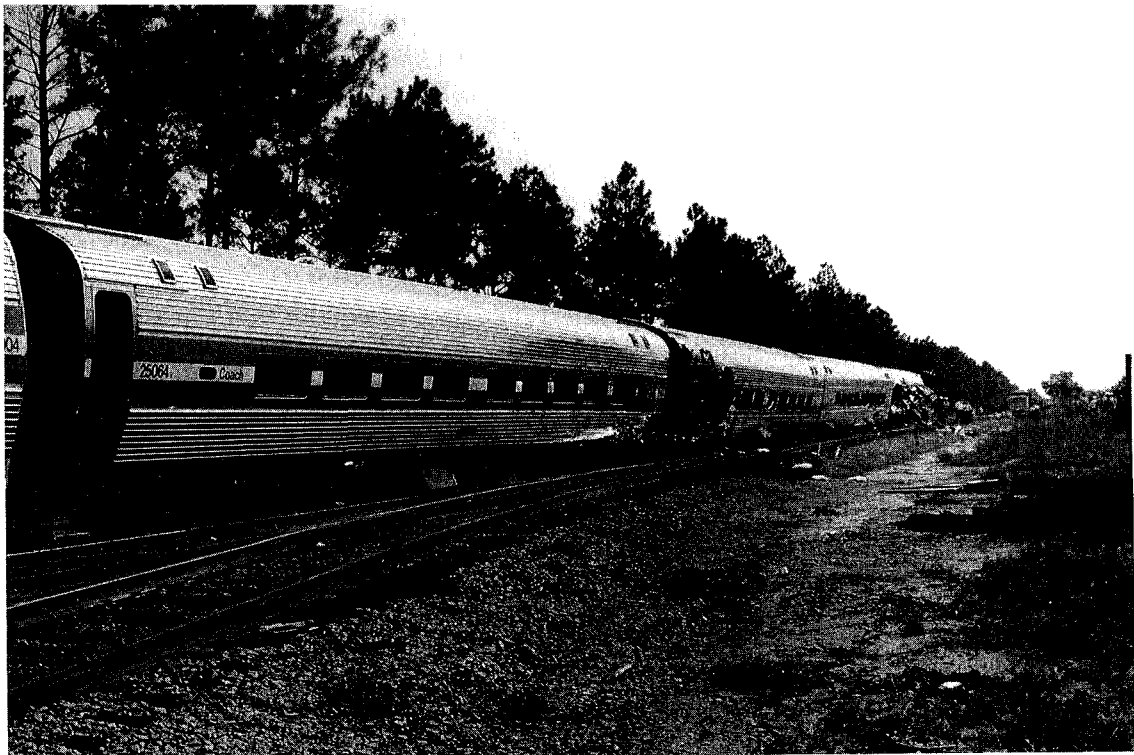
Figure 4.--Photographs of derailed cars.

The last six passenger cars derailed. The 13th car showed minor damage, and the 14th, 15th, and 17th cars showed substantial damage. The left (west) sides of coaches 25060 and 26002, the 16th and 18th cars, respectively, were severely damaged. Coach 26002 had a wheel set in its left midsection (See figure 4.) The first two hopper cars were damaged on their east sides and undercarriages.

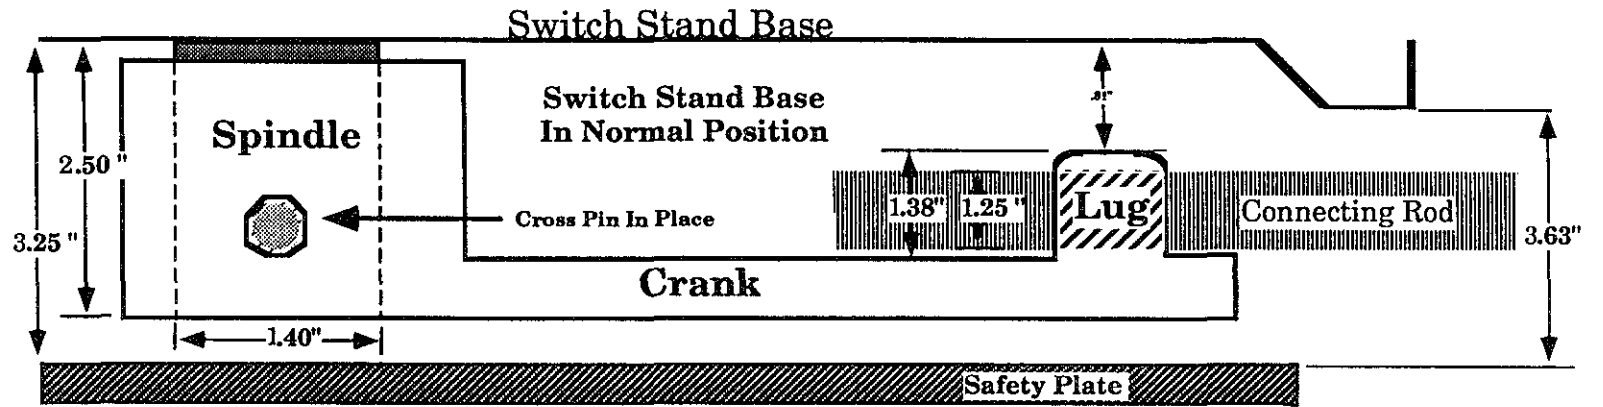
**Area Underneath Switch Stand
As Found In Post Accident
Investigation**

The tie crib at the switch stand was full of ballast. Ballast and debris under the switch stand between the ties was excessive and rubbed against the bottom of the connecting rod, the number 1 head rod, the number 2 head rod, and the switch lock rod. Some ballast and debris was found on the safety plate. (See figure 6.)

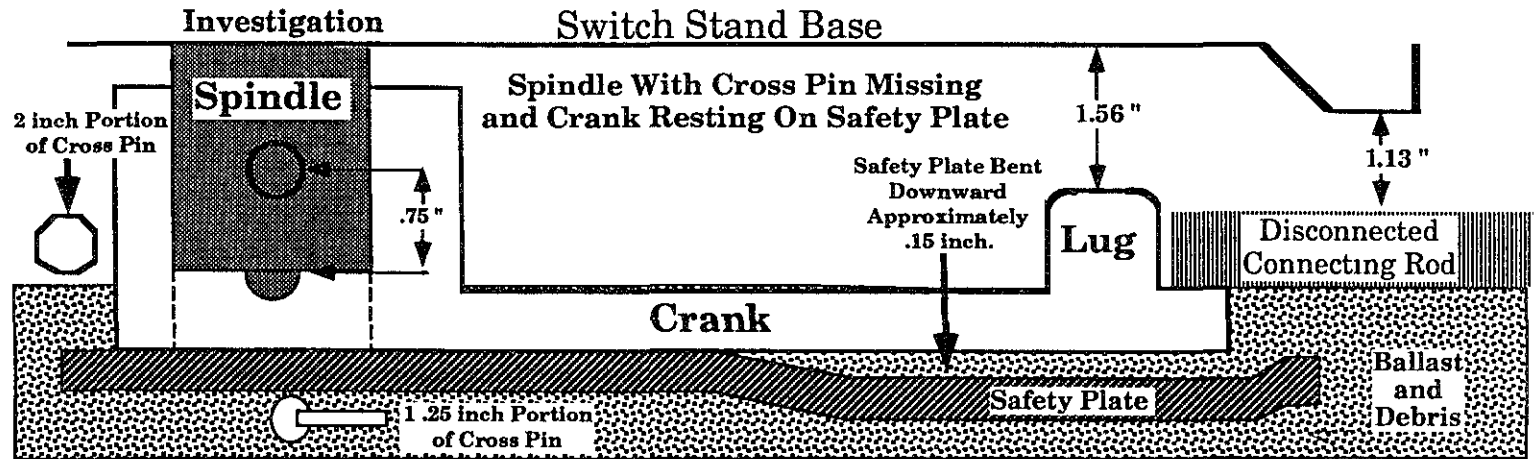
Figure 5 --Diagram of crank showing spindle and connecting rod.

When initially examined at the accident scene, the connecting rod was not connected to the lug on the end of the crank, but was found on the ballast next to the crank. Rub marks were evident on the underside of the switch stand housing and on top of the connecting rod.

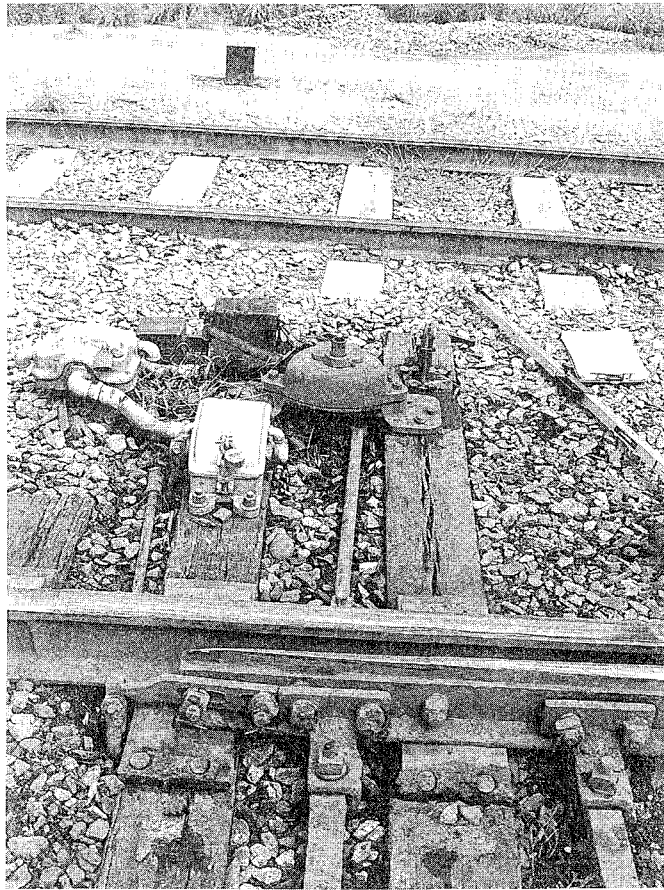
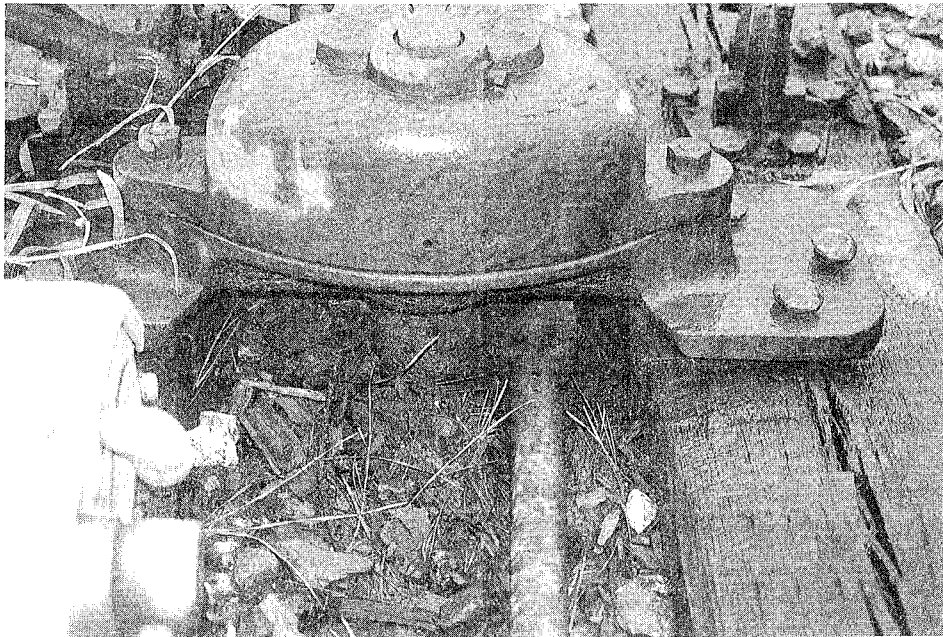
Figure 6.--Photographs of switch stand and connecting rod.

A 2-inch piece of the cross pin was found lying on top of the ballast below the switch stand. A 1.25-inch piece was buried in the ballast about 3 inches deep, which violates FRA regulations.

The Safety Board concludes that the cross pin had been missing for some time before the accident because one piece of the cross pin was found under 3 inches of ballast and debris, another piece of the cross pin remained on top of the ballast, and both pieces were heavily corroded.

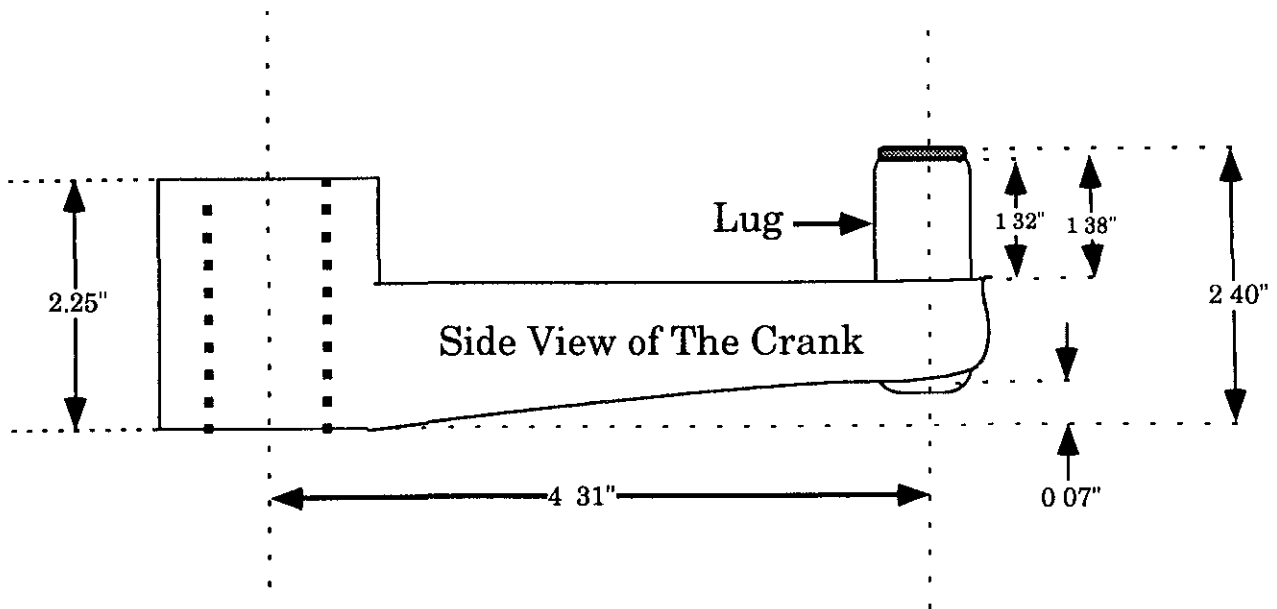
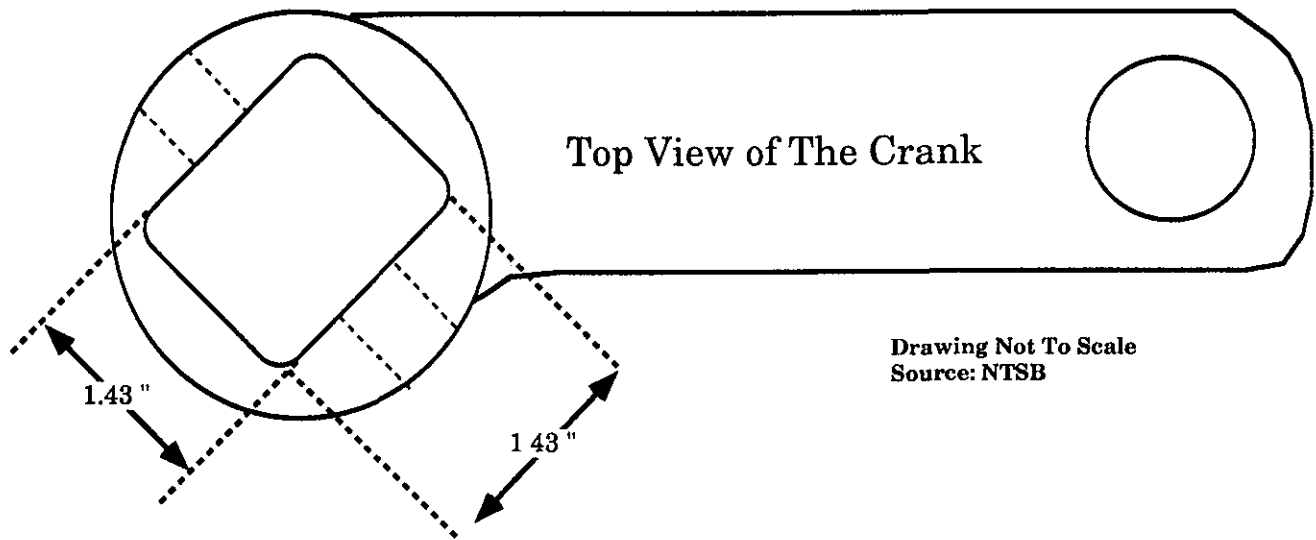
Figure 7 --Crank and connecting rod

Investigators reattached the connecting rod to the crank (see figure 7) and duplicated the switch connection that existed at MP S329.6. They found that after the connecting rod was attached as it had been before the accident, it could be manually separated from the crank.

After reconstructing the switch and stand to duplicate the conditions of the accident, the Safety Board found that the connecting rod could be manually separated from the crank. The bolt that connected the connecting rod to the number 1 head rod should have been secured by a cotter pin. Instead, it was secured by a nail. A cotter pin was also missing from the bolt that fastened the head rod to the left-hand switch clip, which also lacked a cotter pin. The section of the safety plate that was directly below the spindle was at the proper depth, however, the section that was below the lug end of the crank was bent downward slightly. About 1.5 inches of the spindle was still inserted into the crank, which rested on the safety plate.
