# NATIONAL TRANSPORTATION SAFETY BOARD

## RAILROAD ACCIDENT/INCIDENT SUMMARY REPORT

DERAILMENT OF AMTRAK TRAIN 87,  
SILVER METEOR, IN PALATKA, FLORIDA,  
ON DECEMBER 17, 1991

Accident Number:	DCA-92-MR-001
Location:	Palatka, Florida
Date and Time:	December 17, 1991, at 11:25 a.m.
Railroad:	National Railroad Passenger Corporation (Amtrak) on CSX Transportation Inc. track
Train:	Amtrak train 87 (Silver Meteor)
People on Board:	5 operating crewmembers, 5 on-board service personnel, and 172 passengers
Injuries:	61 (crew and passengers)
Damage:	\$1.4 million
Type of Occurrence:	Derailment
Phase of Operation:	En route to Tampa, Florida, from New York, New York

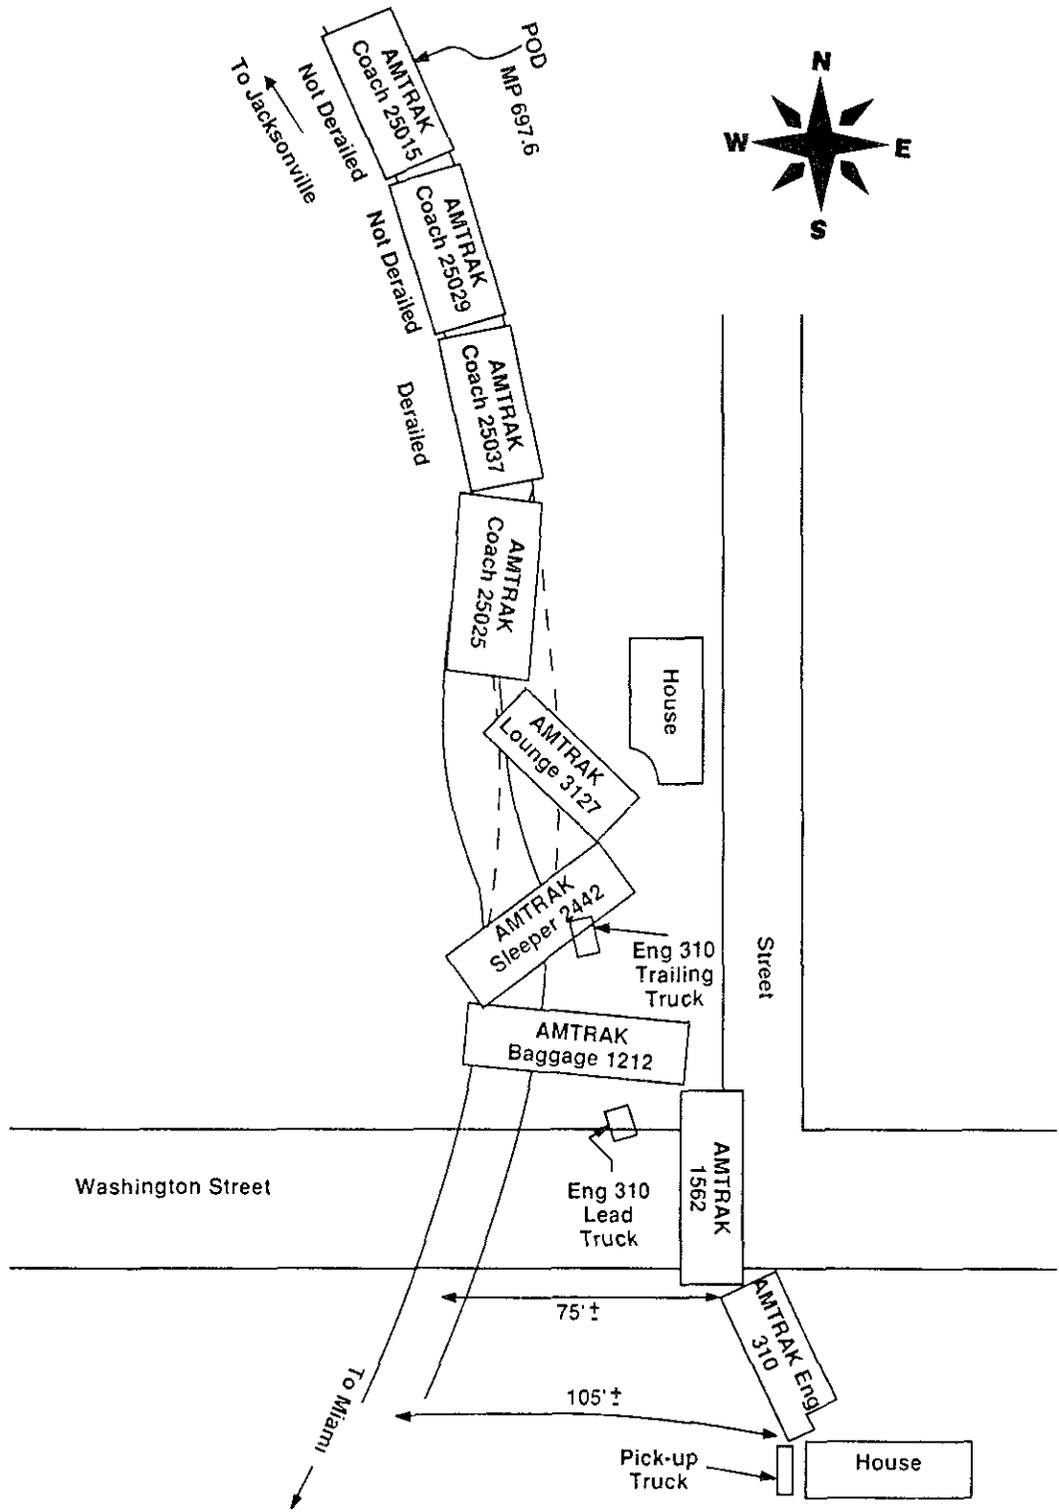
Figure 1.--Car positions after train derailment.

At 11:25 a.m. on December 17, 1991, National Railroad Passenger Corporation (Amtrak) train 87, operating on CSX Transportation Inc. (CSXT) track, derailed at milepost (MP) A697.6 in Palatka, Florida. Train 87 consisted of a locomotive and eight cars; the locomotive and first six cars derailed. The derailment occurred while train 87 was negotiating a 6° 6' curve to the right (west). The derailed equipment struck two homes and blocked the street north of the Palatka station. (See figure 1.) Eleven passengers sustained serious injuries and 41 received minor injuries. Five operating crewmembers and four on-board service personnel had minor injuries.

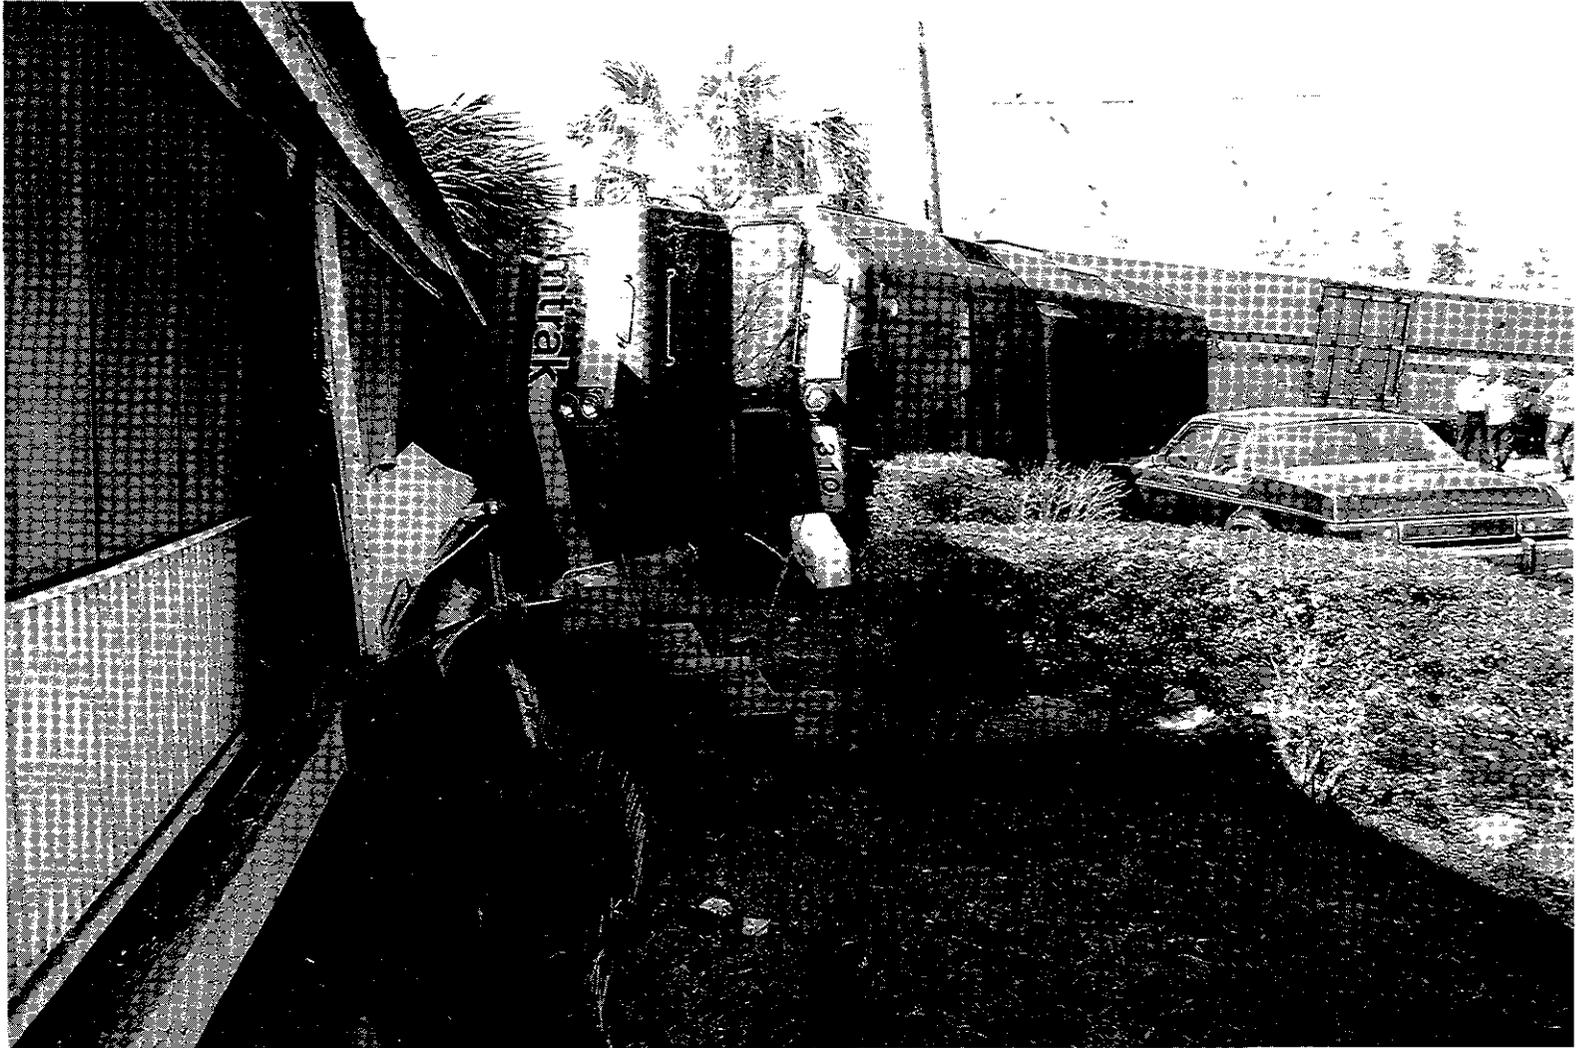
Figure 2. --Locomotive after derailment.

About 300 feet into the 30-mph curve, train 87 derailed at MP A697.6 about 0.5 mile north of the Palatka station. The locomotive crossed a street, rolled over onto its left side, and came to rest about 100 feet from the track. (See figure 2.) The first six cars derailed but remained upright; the last two cars did not derail. The train struck two houses, and the derailed equipment blocked the street. (See figure 3.)
