RAILROAD ACCIDENT INVESTIGATION

REPORT NO. 4125

THE DELAWARE AND HUDSON RAILROAD CORPORATION

AUGUST 12, 1967

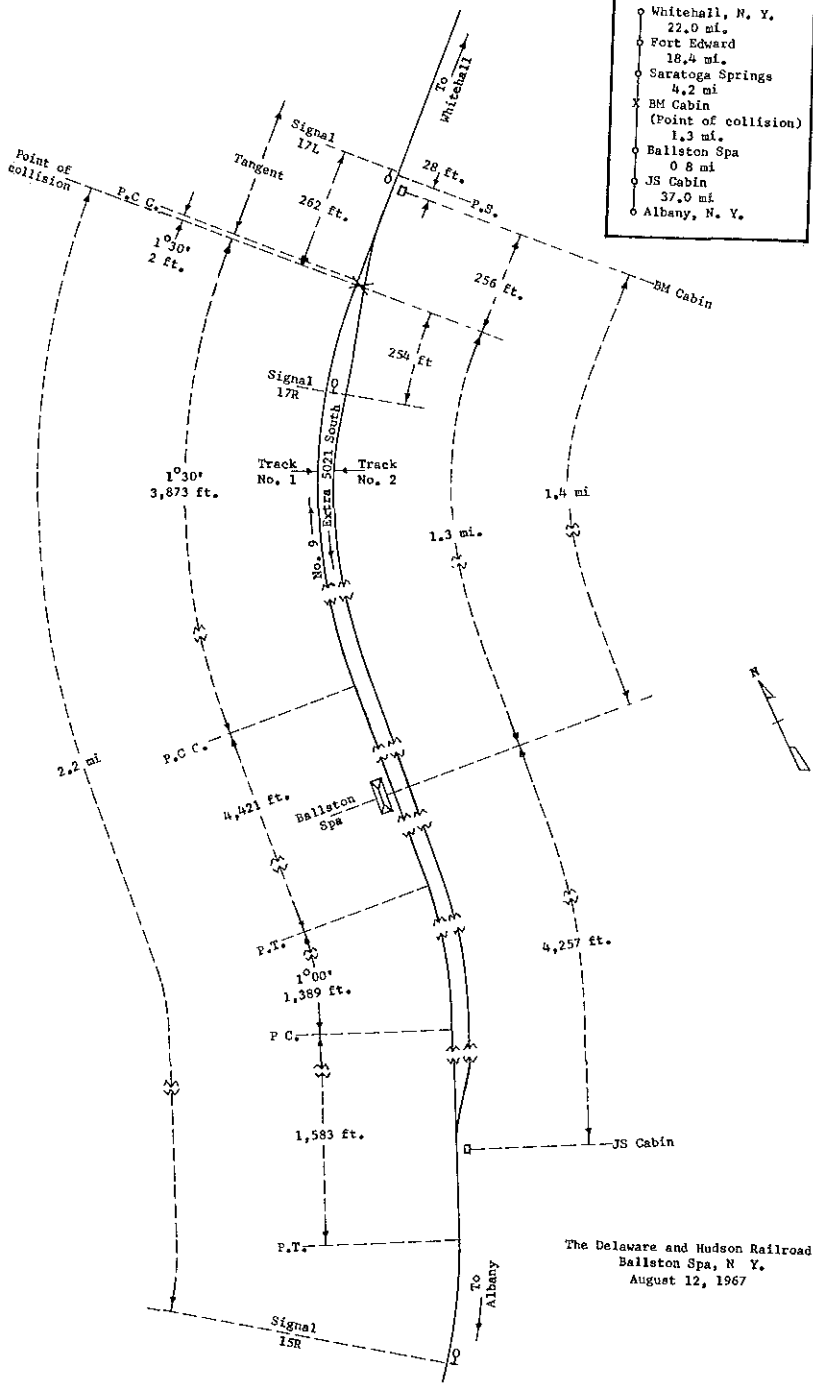
The Delaware and Hudson Railroad
 Ballston Spa, N. Y.
 August 12, 1967

No. 9 stopped with the front end 269 feet north of the collision point. Both trucks of the two diesel-electric units and the first two cars, and the front truck of the third car, were derailed. The derailed equipment stopped in various positions as shown in the photograph appended to this report.

The locomotive units and the 1st car were destroyed. The second car was heavily damaged and the third car was slightly damaged.
