RAILROAD ACCIDENT REPORT

DERAILMENT AND SUBSEQUENT BURNING
OF DELAWARE AND HUDSON
RAILWAY FREIGHT TRAIN AT
ONEONTA, NEW YORK
FEBRUARY 12, 1974

**NATIONAL TRANSPORTATION SAFETY BOARD
Washington, D.C. 20591
REPORT NUMBER: NTSB-RAR-74-4**

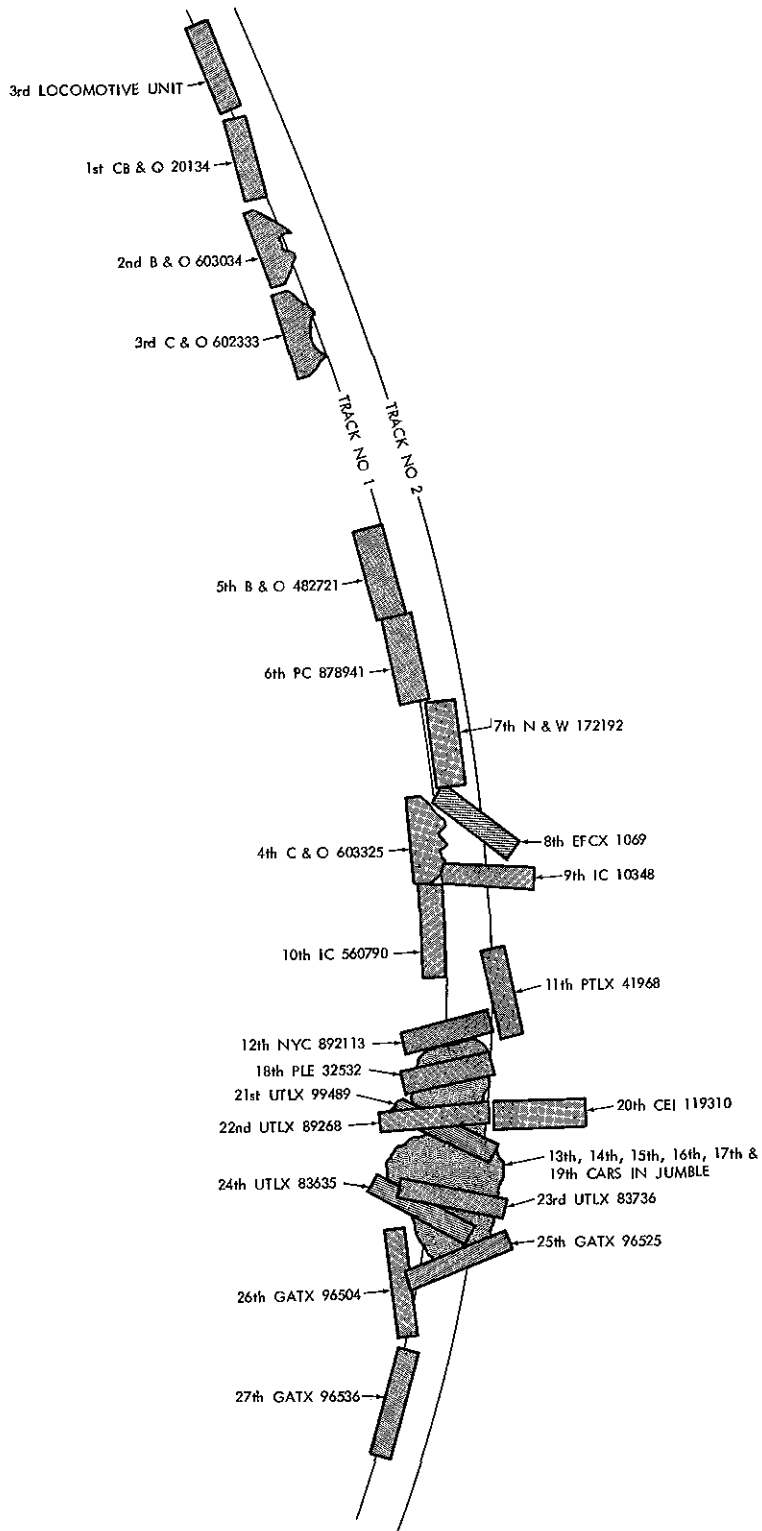
Cars 5, 6, and 7 passed Car 4 and stopped in various positions just north of Car 4. (See Figure 1.) Cars 1, 2, and 3 remained coupled to the locomotive, but overturned when they stopped.

Figure 1. Relative positions of derailed cars before explosions.

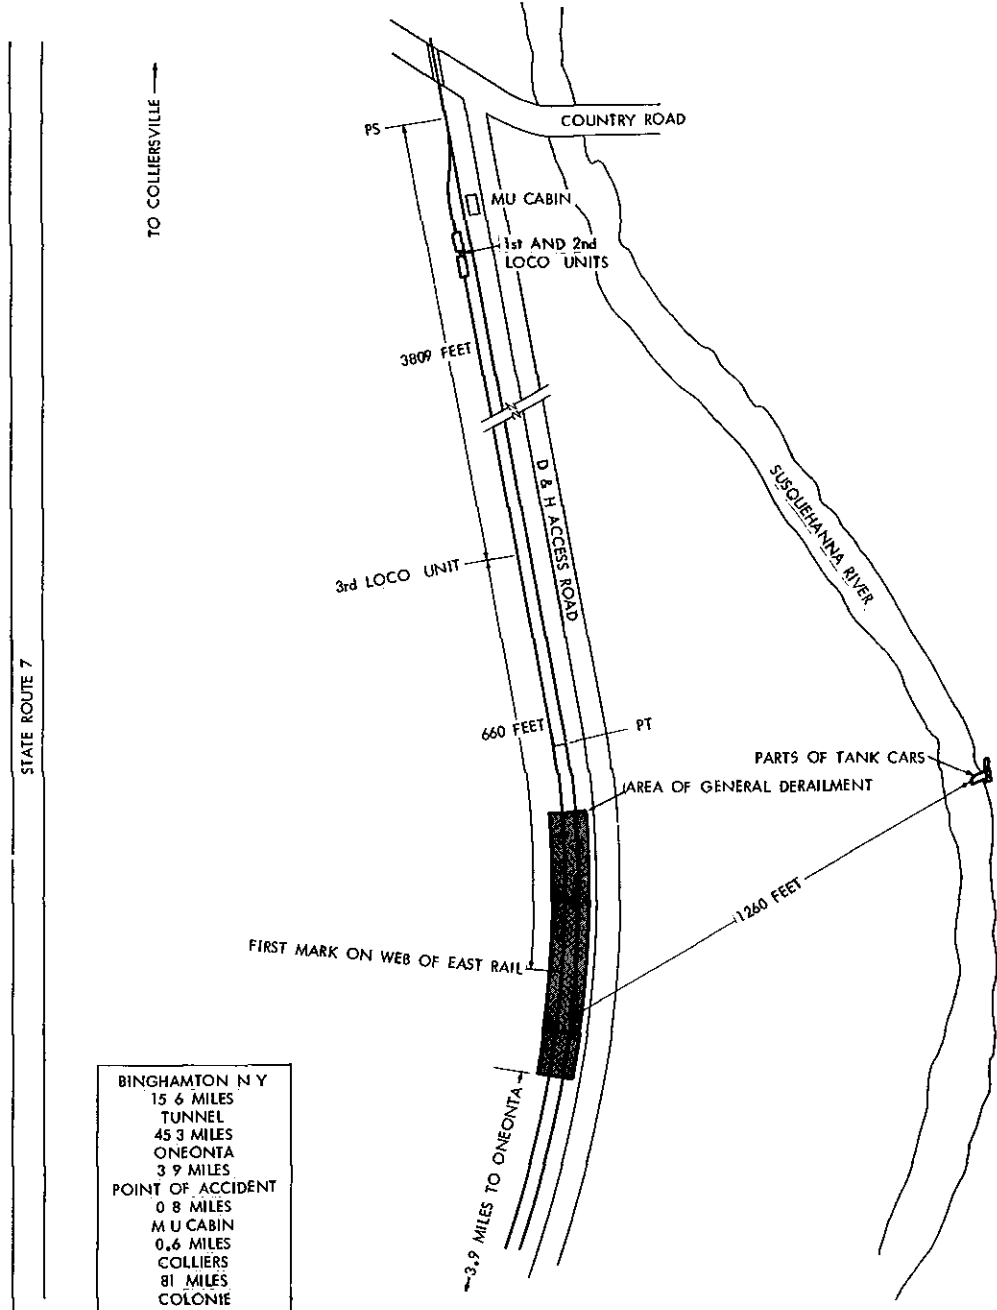
Damage. About 960 feet of the No. 1 track was destroyed during the accident. The east, or high rail, was canted outward and intermittent wheel marks were found on the web of the rail from a point about 560 feet north of the south end of the curve to where the third locomotive unit stopped. The west rail was displaced westward by the wheels of the locomotive unit and cars which dropped inside of the rail when the east rail moved outward.

Figure 2. Area of the derailment.

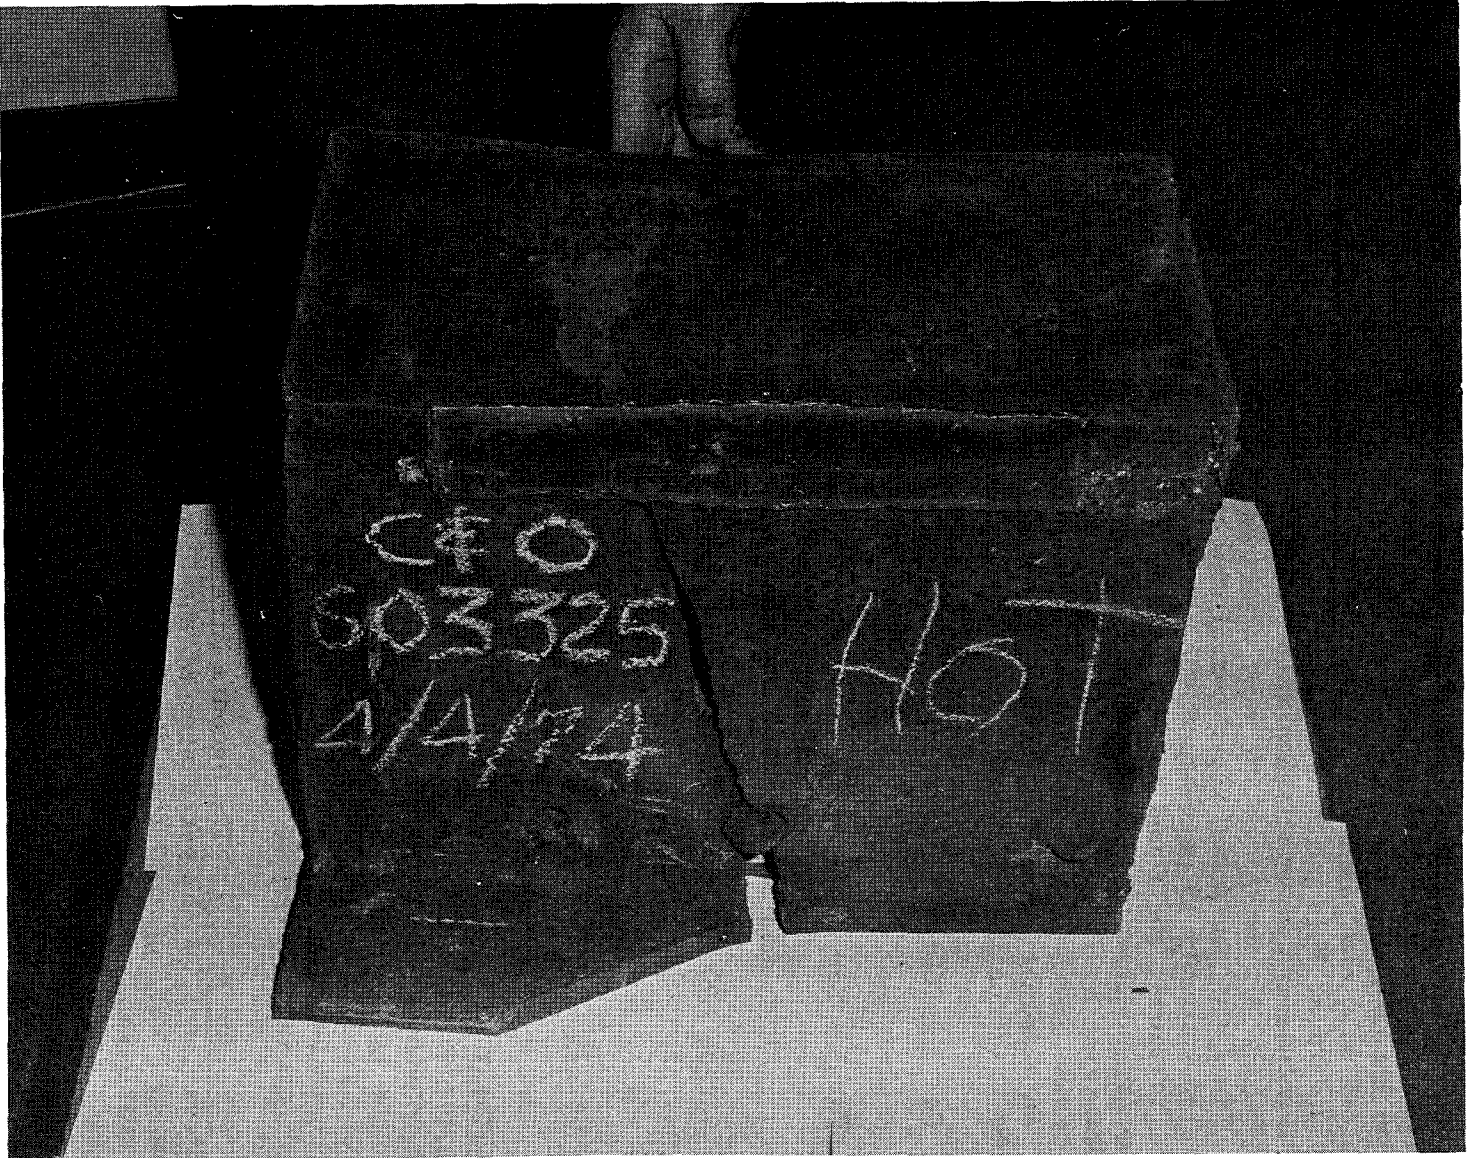
between the hoppers of the car. The sill was cracked where the bottom flange of the center sill had been removed to permit application of the hopper. Rivets attached a reinforcing angle to the inside of the sill in this area. The progressive crack had started in the rivet hole and extended through the remaining portion of the bottom flange, through the vertical web, and partially across the top flange. The sill was slightly bent upward at this point. The portion of the center sill which contained the fracture was removed and examined further. (See Figure 3.)

Figure 3. Portion of center sill removed from car -- showing fracture.

The fractured center sill of Car 4 weakened the car's structure to the extent that the heavy lading caused the center sill to be deflected downward as the train proceeded toward the accident site. The center sill probably deflected after the train was dispatched from Binghamton. Such a deflection would not be detected during a running inspection, and crewmembers would not be able to detect the deflection during en route inspections.

4. The fracture in the center sill started at a rivet hole and progressed across the vertical web of the sill.
5. The center sill was deflected downward by weight and vibration in the vicinity of the crack which raised the coupler on the north end allowed it to pull over the coupler of Car 3. Consequently, the train separated.

1. The Federal Railroad Administration (FRA) insure that inspection efforts of railroads to find defects on other cars having a center sill design similar to that which failed in this accident, are continued in periodic inspection until all such cars have been inspected. (Recommendation R-74-31)

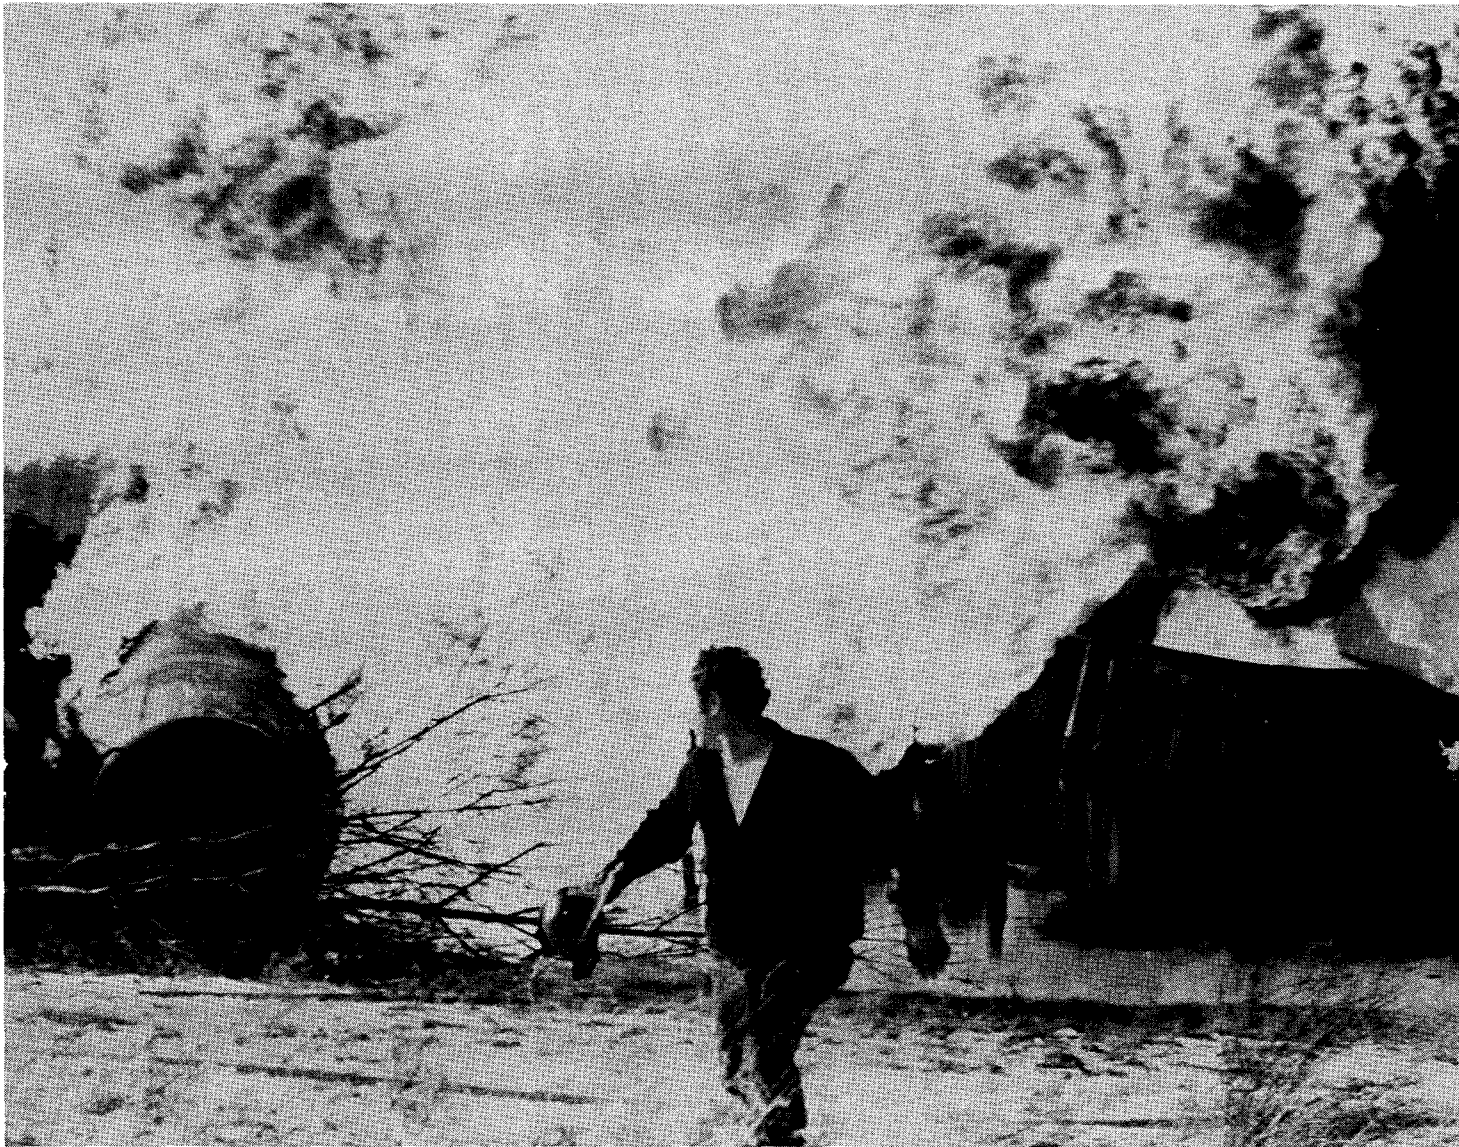
Figure 4. Location of some firemen at the time of violent reaction of fire.
