RAILROAD ACCIDENT INVESTIGATION

Report No 3836

THE DELAWARE AND HUDSON RAILROAD CORPORATION

COLLIERS, N Y

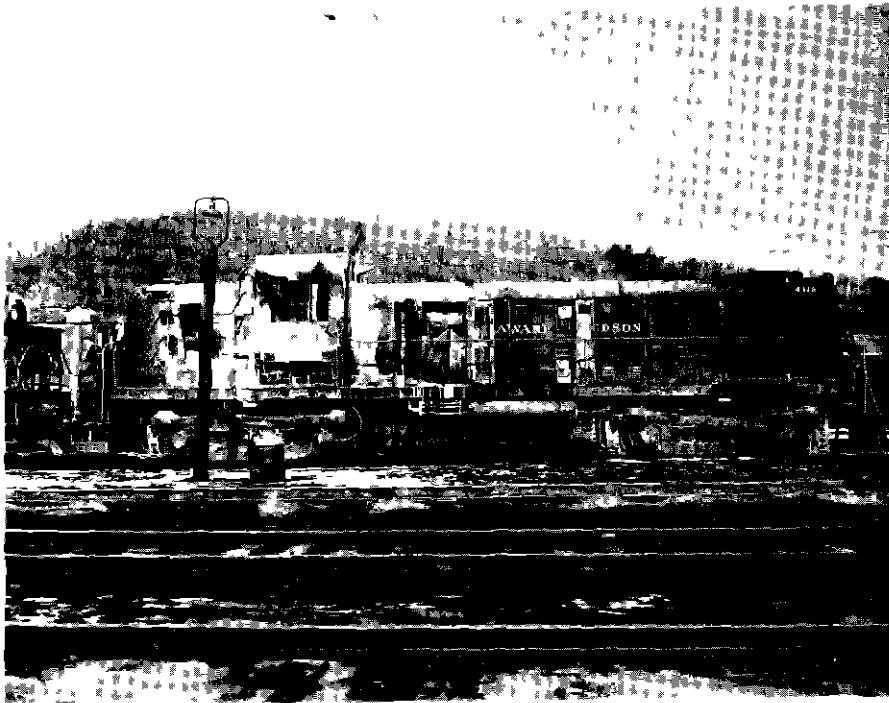
Diesel-electric unit 4116, leading unit of Extra 4118 North Control compartment was at south end of this unit at time of accident

The tractor stopped upright about 81 feet north of the point of accident and about 10 feet east of the centerline of the northward main track The semi-trailer was separated from the tractor and stopped on the southward main track structure about 76 feet north of the point of accident The tank of the semi-trailer was ruptured Gasoline became ignited and flames enveloped the control compartment of the leading diesel-electric unit The train stopped with the front end 775 feet north of the point of accident and immediately thereafter an explosion occurred in the leading diesel-electric unit No equipment of the train was derailed The leading diesel-electric unit was heavily damaged by the collision and fire The tractor and the semi-trailer were heavily damaged

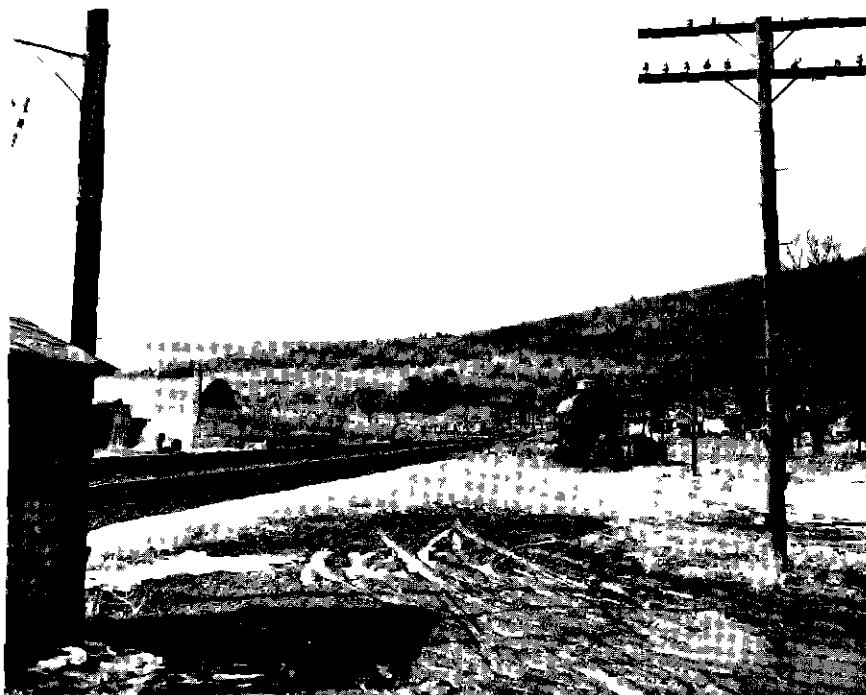
View of tracks south of rail-highway crossing. Photo taken from a point on the highway 50 feet west of the centerline of the northward main track

Throughout a distance of 88 feet in approach to the crossing the driver of an eastbound vehicle on the private road can see a northbound train on the northward main track throughout a distance of approximately 1,000 feet south of the crossing.
