ACCIDENT ON THE  
DENVER AND RIO GRANDE WESTERN RAILROAD  
AND THE  
ATCHISON, TOPEKA & SANTA FE RAILWAY-COLORADO  
AND SOUTHERN RAILWAY

SOUTH DENVER, COLO.

AUGUST 12, 1939

INVESTIGATION NO. 2374

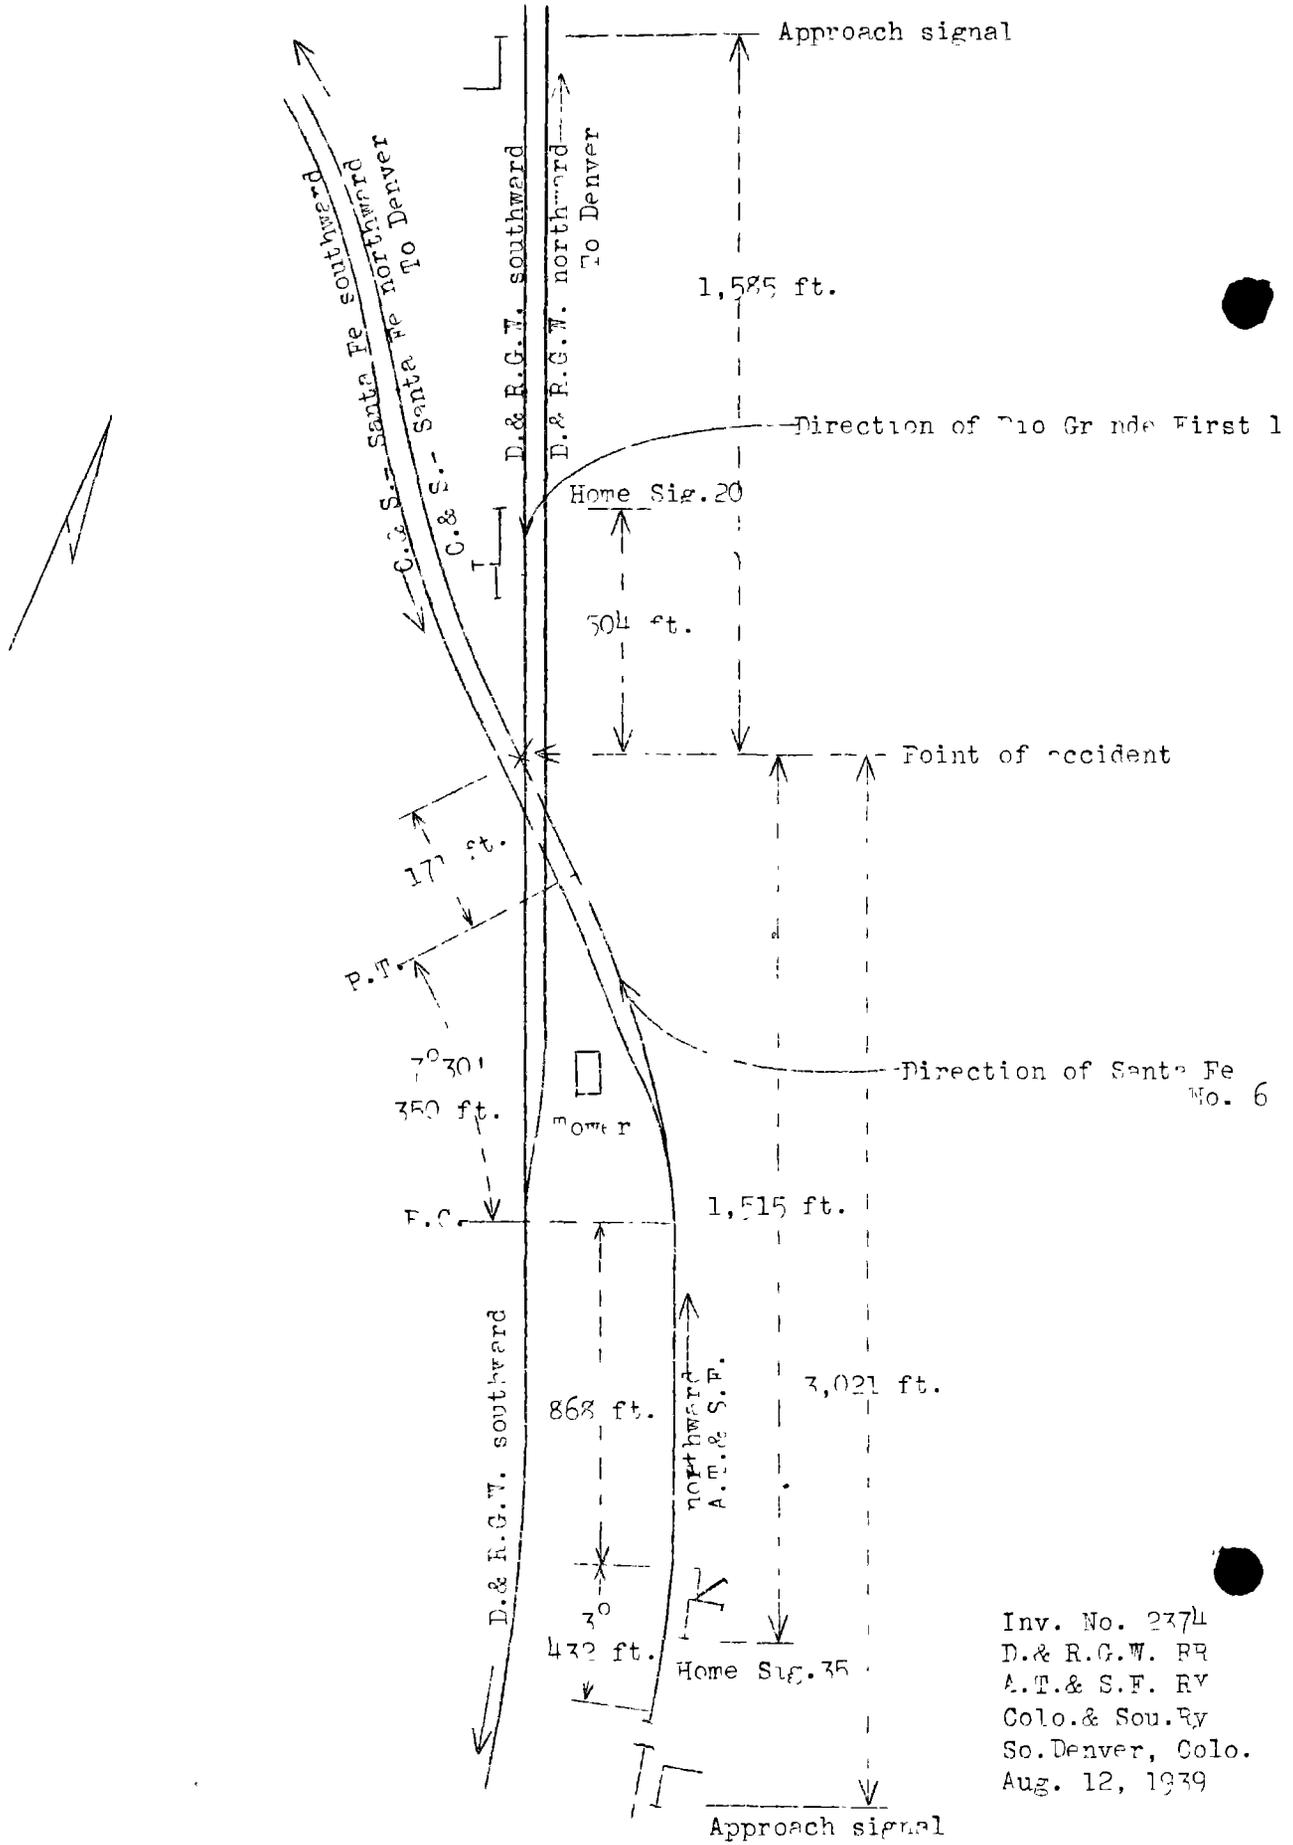
Inv. No. 2374  
 D. & R.G.W. RR  
 A.T. & S.F. RR  
 Colo. & Sou. Ry  
 So. Denver, Colo.  
 Aug. 12, 1939

The double-track line of the Santa Fe - C. & S. crosses the double track line of the Rio Grande at an angle of  $25^{\circ}45'$ . Approaching the crossing on the Rio Grande southward track there is a compound curve to the right 1,345 feet in length, which consists of a  $0^{\circ}11'$  curve 1,145 feet long and a  $2^{\circ}$  curve 200 feet long, followed by a tangent 3,462 feet to the crossing and 1,010 feet beyond. The grade for southward trains is generally ascending, varying from 0.55 to 0.58 percent to within 1,200 feet of the crossing; it is then level. Approaching the crossing from the south on the Santa Fe - C. & S. track there are, successively, a  $3^{\circ}$  curve to the left 432 feet in

length, a tangent 868 feet in length, a 7°30' curve to the left 350 feet in length, and a tangent 171 feet to the crossing. The grade for north-bound trains is 0.31 percent descending a distance of 1,300 feet then level 1,950 feet, 0.9 percent descending a distance of 250 feet, and then level a distance of 100 feet to the crossing.

At the time of this accident the interlocking machine, located in a tower in the southeast angle of the crossing, was a Saxby-Farmer mechanical machine with 26 working levers. There were no track circuits in this interlocking. In addition to mechanical locking on the machine, normal-indication electric locks were attached to the signal levers. The signals involved were of the 1-arm, upper-quadrant, semaphore type. The approach signal on each line was fixed in horizontal position; it was oil lighted and displayed a yellow aspect; its indication was "proceed at restricted speed." The home signal was electrically operated from the tower and its normal position was stop. The approach signal and home signal No. 35, governing northward movements on the Santa Fe - C. & S., were located 3,021 and 1,515 feet, respectively, south of the crossing. The indications and aspects of home signal No. 35 were as follows:
