# NATIONAL TRANSPORTATION SAFETY BOARD

✓  
DENVER AND RIO GRANDE  
WESTERN RAILROAD COMPANY  
TRAIN YARD ACCIDENT INVOLVING  
PUNCTURED TANK CAR,  
NITRIC ACID AND VAPOR CLOUD,  
AND EVACUATION  
DENVER, COLORADO  
APRIL 3, 1983

✓  
NTSB/RAR-85/10.

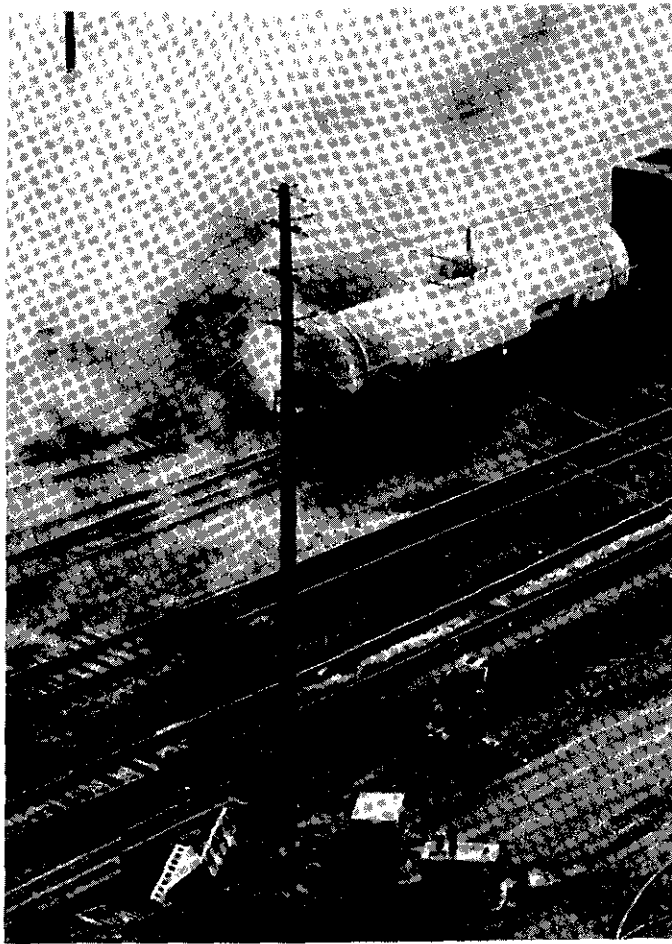
Figure 2.--Punctured Tank Car and Nitric Acid Vapor Cloud

The various guidelines given to the public safety officials were contradictory and contributed to a possibly unnecessary extension of the evacuation area. The decision by the Denver Hazardous Materials Coordinating Chief to withdraw the Fire Department, to cease the water attack, and to attempt to neutralize the spill was based on past experience. Chemtrec's instructions were consistent with this procedure. The application of water increased the size of the vapor clouds of the fires involving the

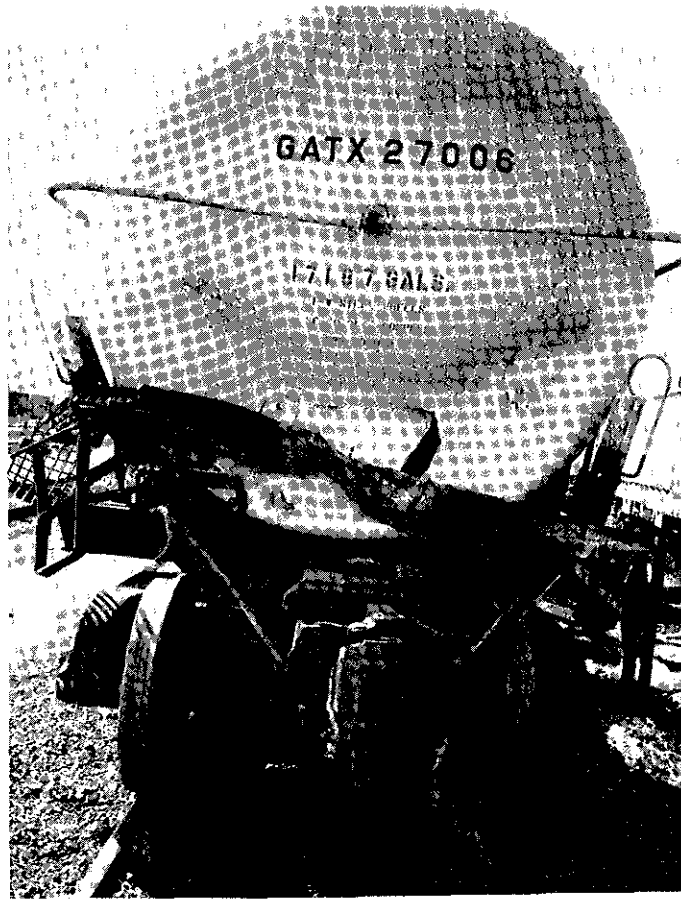
Figure 3.--Damage to A end of tank car GATX 27006.

The tank car (GATX 27006) had the top shelf broken off of the A end (north end) coupler as a result of the overriding by the box car. The bottom half of the tank head on the A end was crushed inward and punctured. The head had separated beginning about 6 inches from the bottom of the tank; the separation was 24 inches long with an opening 4 1/2 inches wide. There were two small punctures in the tank. The end running board and coupler attachments were bent and broken (see figure 3).

Since the engine foreman and engineer were not aware of the separation, the next switching movement following the separation was made as though all the cars still were attached to the locomotive. Therefore, instead of all the cars moving when the engineer accelerated quickly, a rapid closing of the space that separated the cars led to a collision at a speed of about 12 mph. As a result of the impact, the empty box car, now without a coupler, overrode the tank car and struck the tank head, puncturing the tank shell with its end sill.

Had the tank car been equipped with head shields, the end of the tank car probably would not have been punctured and the release of the material probably would not have occurred. Because the capability of the aluminum tank car to resist end puncture on impact has not been fully tested, the Research and Special Programs Administration (RSPA) in consultation with the FRA and AAR should subject the DOT 111 specification aluminum tank car to full testing and evaluation to determine what type of head shields are needed to protect the ends of aluminum tank cars. Thereafter RSPA should mandate their installation at an early date.

In consultation with the Federal Railroad Administration and the Association of American Railroads conduct a full testing and evaluation program to develop a head shield to protect DOT specification aluminum tank car ends from puncture and mandate installation of the head shield at an early date. (Class II, Priority Action) (R-85-61)
