RAILROAD ACCIDENT INVESTIGATION

REPORT NO. 4128

THE DENVER AND RIO GRANDE WESTERN RAILROAD COMPANY

SEPTEMBER 16, 1967

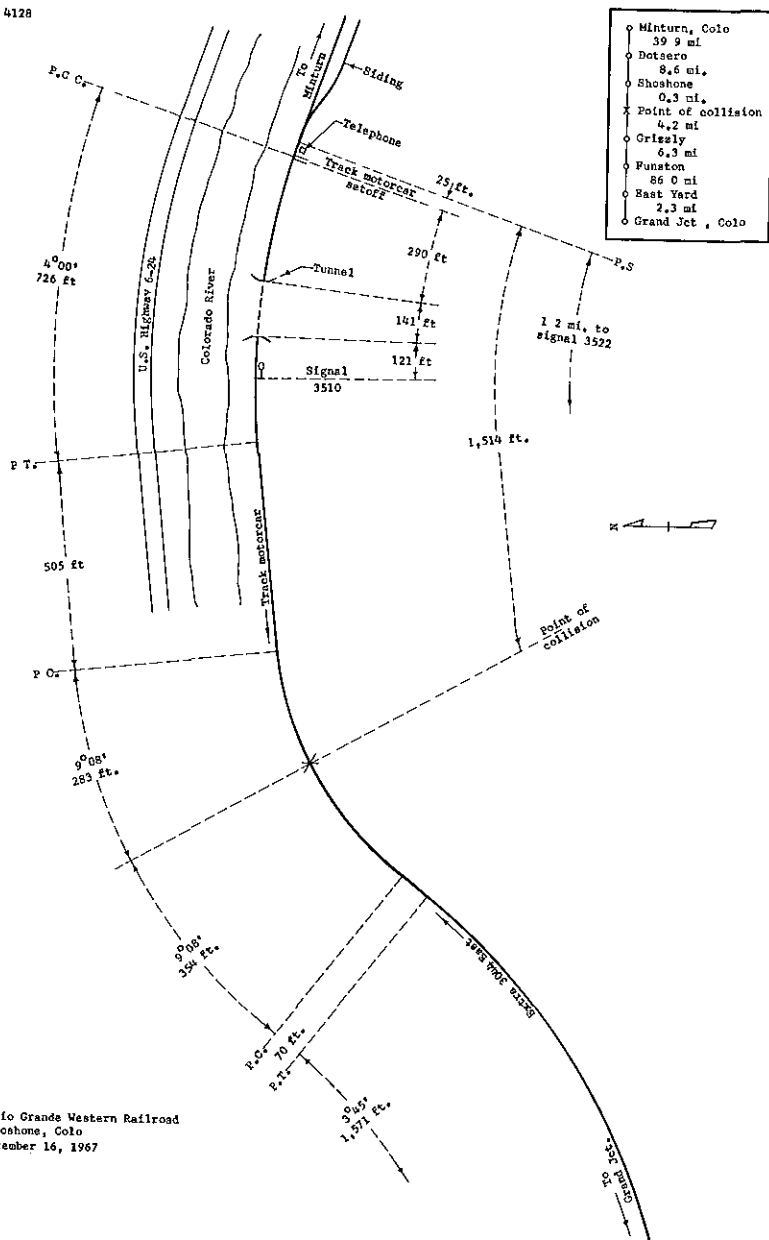
4128

The collision occurred on the main track, 1,514 feet west of the west switch of the Shoshone siding.

A track motorcar setoff is 25 feet west of the west siding-switch at Shoshone and a wayside telephone is nearby. The east end of a 141-foot tunnel is 290 feet west of the track car setoff.

In the Shoshone area, the main track is laid along the base of a mountainside on the south and along the Colorado River on the north. U. S. Highway 6-24 is across the river, about 250 feet from the track. Because of track curvature, the tunnel and the mountainside, the view between opposing movements approaching the collision point is materially restricted.

Automatic signal 3522 and controlled signal 3510, governing eastbound movements on the main track, are 1.2 miles and 577 feet west of the west siding-switch at Shoshone, respectively.

Westward on the main track from the track motorcar setoff at Shoshone there are, in succession, a compound curve to the left, having a maximum curvature of 4°00', 726 feet, a tangent 505 feet, and a 9°08' curve to the left 283 feet to the collision point and 354 feet beyond. From the east there are, successively, a 3°45' curve to the left 1,571 feet, a tangent 70 feet, and the curve on which the collision occurred. The grade is 0.57 percent ascending eastward at the collision point.
