INTERSTATE COMMERCE COMMISSION

REPORT OF THE DIRECTOR OF THE BUREAU OF SAFETY CONCERNING AN  
ACCIDENT ON THE DENVER AND RIO GRANDE WESTERN RAILROAD  
AT NIGER, COLO., ON DECEMBER 12, 1934

January 19, 1935

Inv. No. 1953  
Denver & Rio Grande Western  
Niger, Colo.  
December 12, 1934.

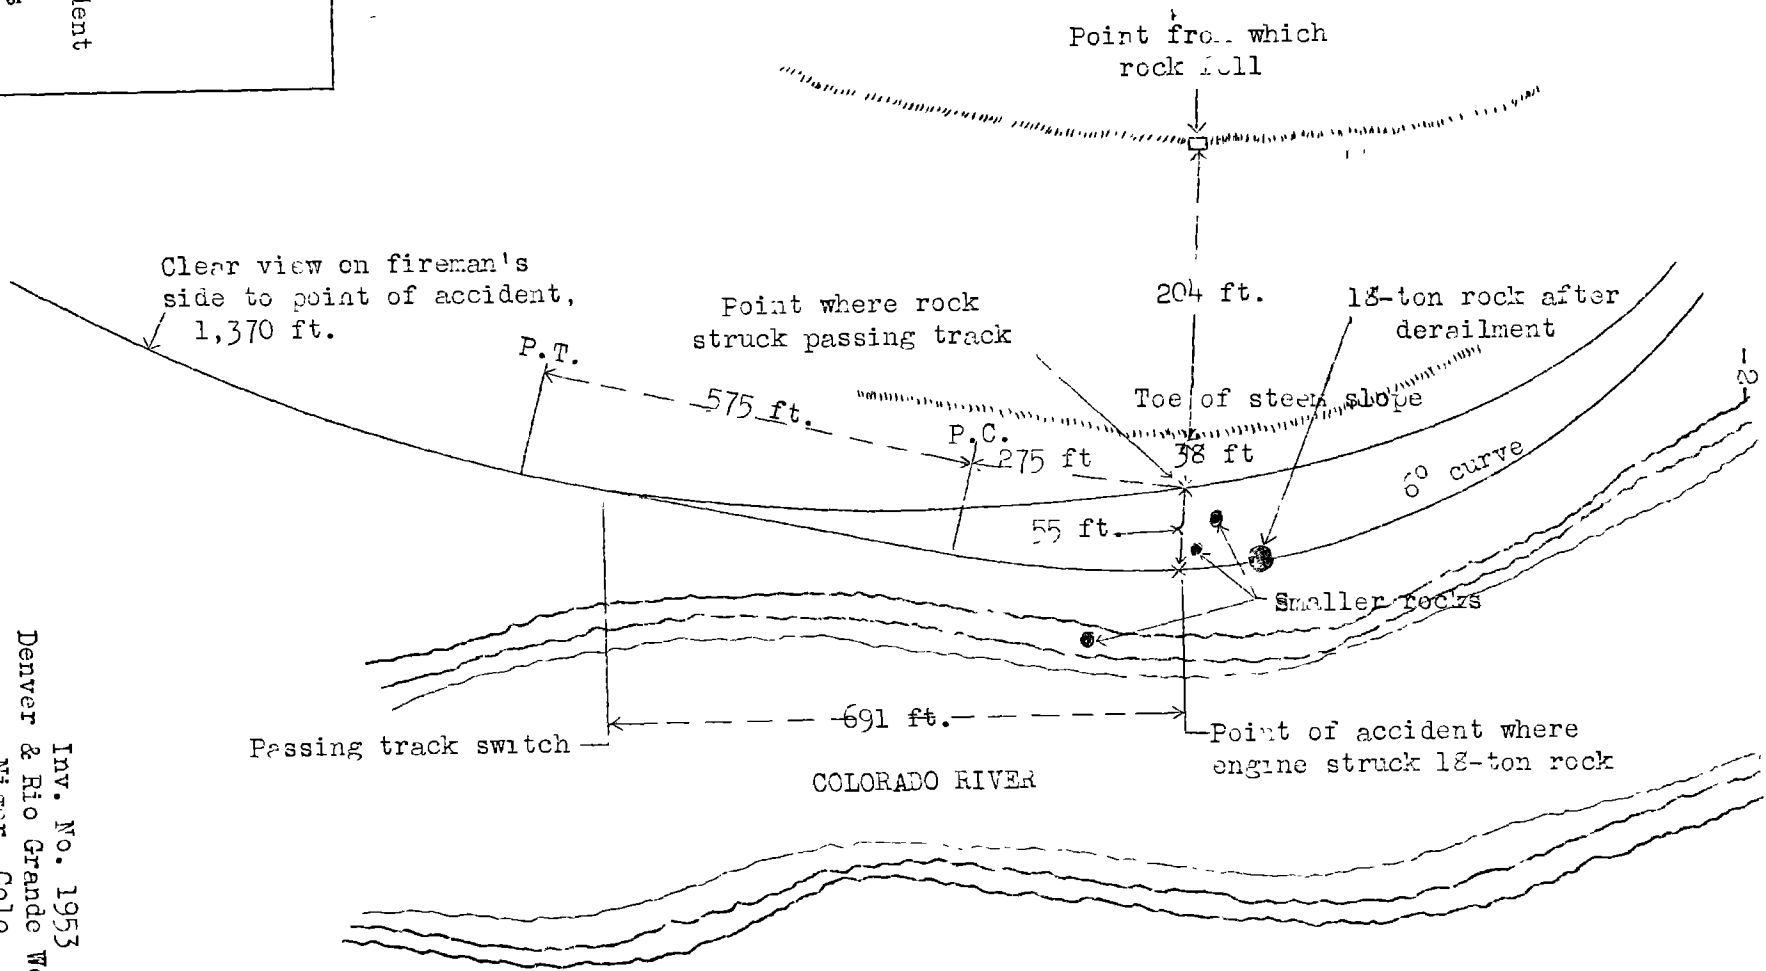
This accident was caused by a rock slide.

The slide consisted of about 100 tons of rock which broke loose from the edge of the cliff at a point about 200 feet above the track. In its descent a portion of this slide struck the north rail of the passing track, located 57 feet north of the main track, where apparently the rock broke into several pieces, which scattered in different directions, the largest piece, weighing approximately 18 tons, landing on the main track, and the evidence indicated that the engine shoved a piece for a distance of approximately 134 feet before going down the embankment and into the river.
