INTERSTATE COMMERCE COMMISSION

REPORT OF THE DIRECTOR OF THE BUREAU OF SAFETY CONCERNING AN
ACCIDENT ON THE DENVER AND RIO GRANDE WESTERN RAILROAD
NEAR RUBY, COLO., ON AUGUST 4, 1935.

October 8, 1935.

Inv. No. 2000
 Denver & Rio Grande Western R.R.
 Ruby, Colorado
 August 4, 1935

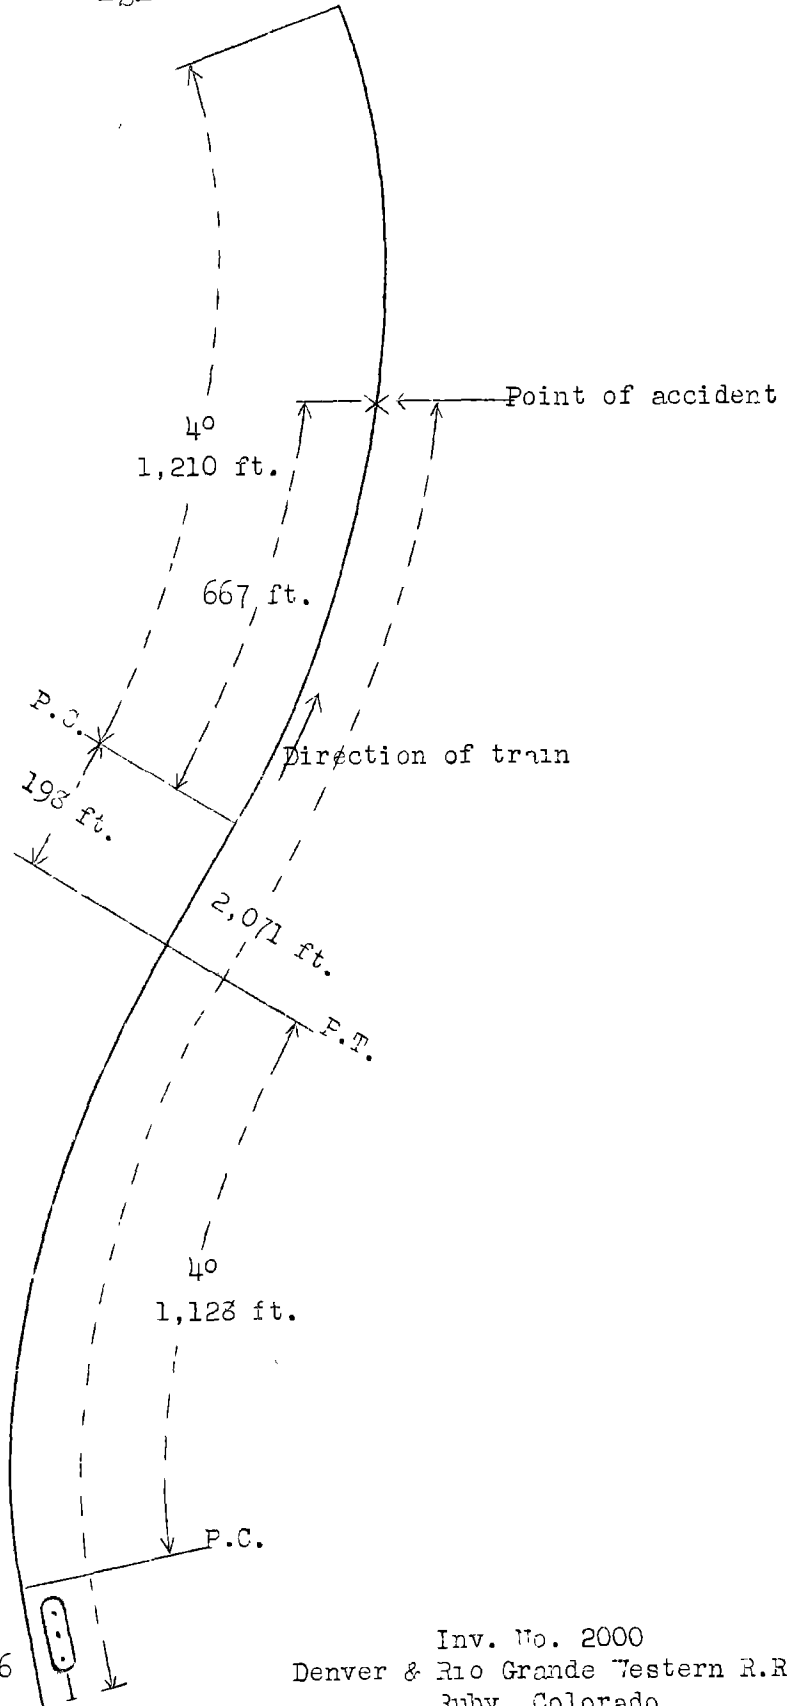
The investigation developed that a rock weighing about 950 pounds became dislodged from a point about 30 feet from and approximately 15 feet above the track, rolled down the slope, and stopped in the center of the track. It seems probable that the fireman observed the rock on the track as soon as it came within his range of vision; he called a warning but it was then too late to avert the accident. After having been struck by the engine the rock appeared to have been pushed ahead for a short distance and then caught in the ties, bunching them and damaging the track sufficiently to result in the derailment of the engine. It further appeared from the evidence that the rock fell because of the disintegration of the underlying shale formation which supported it.

The shale formation seemed to be more or less in progress of disintegration throughout the north side of the cut involved in this accident, and the existence of such a condition results in continual exposure to the danger of similar slides in future. The drainage ditch at the foot of the slope of the cut had become filled up, and the division engineer said a recommendation had been made that ditching be done; ditching of this cut, together with close examination of the slope and the removal of material from various points where danger might develop, should result in providing a safer condition for the operation of trains through this cut.

This accident was caused by a rock slide.

It is recommended that the slope of the cut be examined with a view to eliminating any condition of possible danger which might develop because of the disintegration of the various strata of shale which appear in the surface of the slope, and that provision be made for ditching which the division engineer said had been recommended.
