INVESTIGATION NO. 2969

THE DENVER AND SALT LAKE RAILWAY COMPANY

REPORT IN RE ACCIDENT

AT GORE, COLO., ON

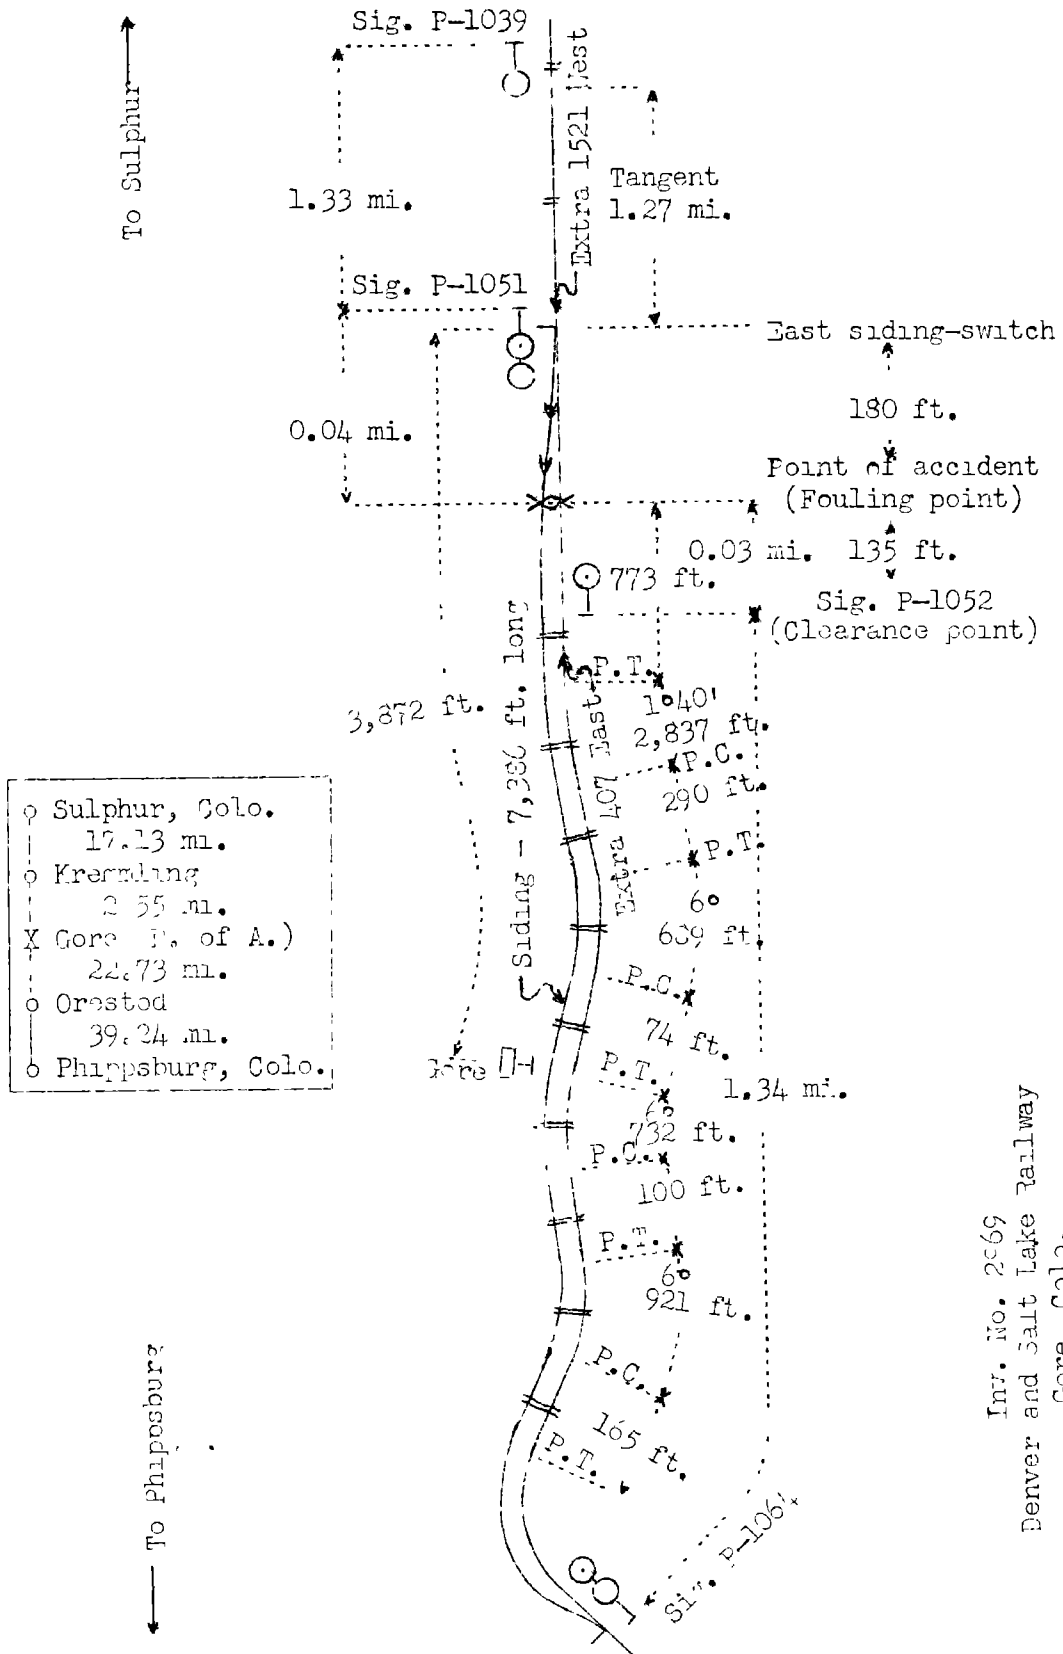
Int. No. 2069
 Denver and Salt Lake Railway
 Gore, Colo.
 January 21, 1946

Signals P-1039 and P-1051, governing west-bound movements, are, respectively, 1.37 miles and 183 feet east of the point of accident. Signals P-1064 and P-1052, governing east-bound movements, are, respectively, 1.37 miles and 135 feet west of the point of accident. Signals P-1039 and P-1052 are of the one-unit color-light type, and signals P-1064 and P-1051 are of the two-unit color-light type. These signals are continuously lighted. The involved aspects and corresponding indications and names of these signals were as follows:

The left side of the first engine of Extra 407 East struck the left side of the engine of Extra 1521 West at the fouling point of the main track and the turnout of the east siding-switch. The first engine and the first auxiliary water car of Extra 407, and the first car of Extra 1521 were derailed. The derailed equipment, the left side of engine 1521 and the second car of Extra 1521 were considerably damaged.
