NATIONAL TRANSPORTATION SAFETY BOARD

RAILROAD ACCIDENT REPORT

DERAILMENT OF AMTRAK PASSENGER TRAIN 8
OPERATING ON THE SOO LINE RAILROAD,
FALL RIVER, WISCONSIN
OCTOBER 9, 1986

NTSB/RAR-87/06

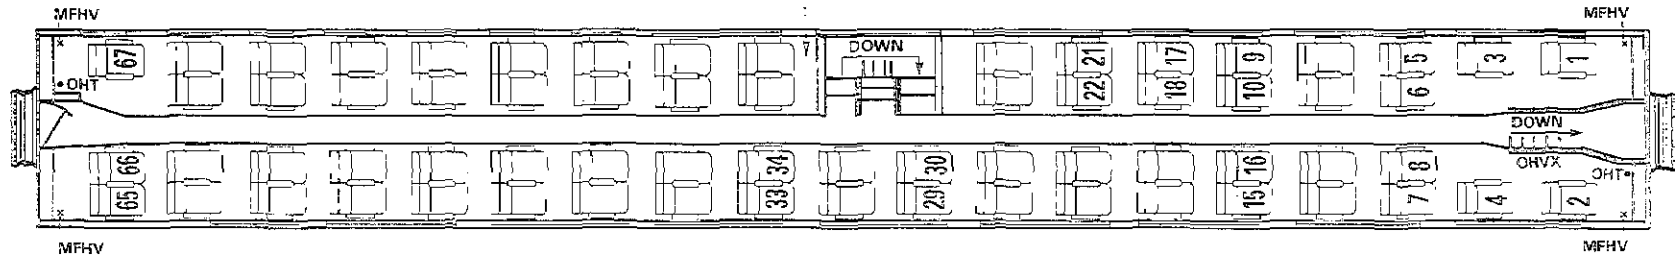
Figure 4.--Diagram of coach/dorm car.

All of the injured train crewmembers were located in the coach/dorm car. On the inside of this car, the left side seat 15-16 was torn from its mounting. The luggage rack above seat 33-34 was displaced upward 4 inches and showed evidence of body contact. At seat 29-30 the window glass was fractured with twisting striations. Seat 21-22 had the right side interior sidewall collapsed approximately 6 inches. Seats 17-18 and 13-14 were bent inboard and partly collapsed. Seats 9-10 and 1-2 were torn free and were lying in the aisle (figure 4).

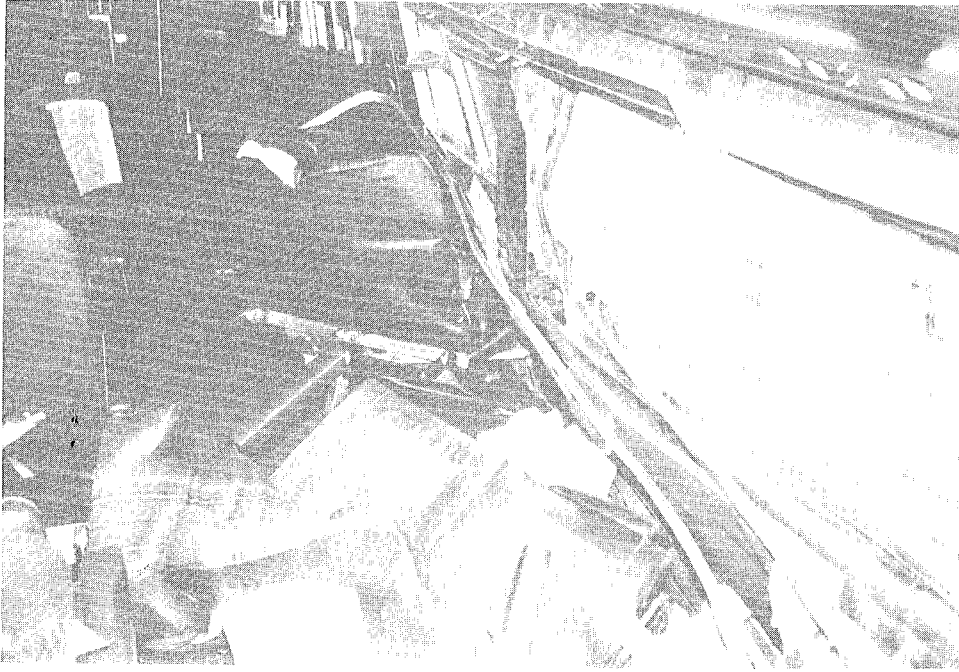
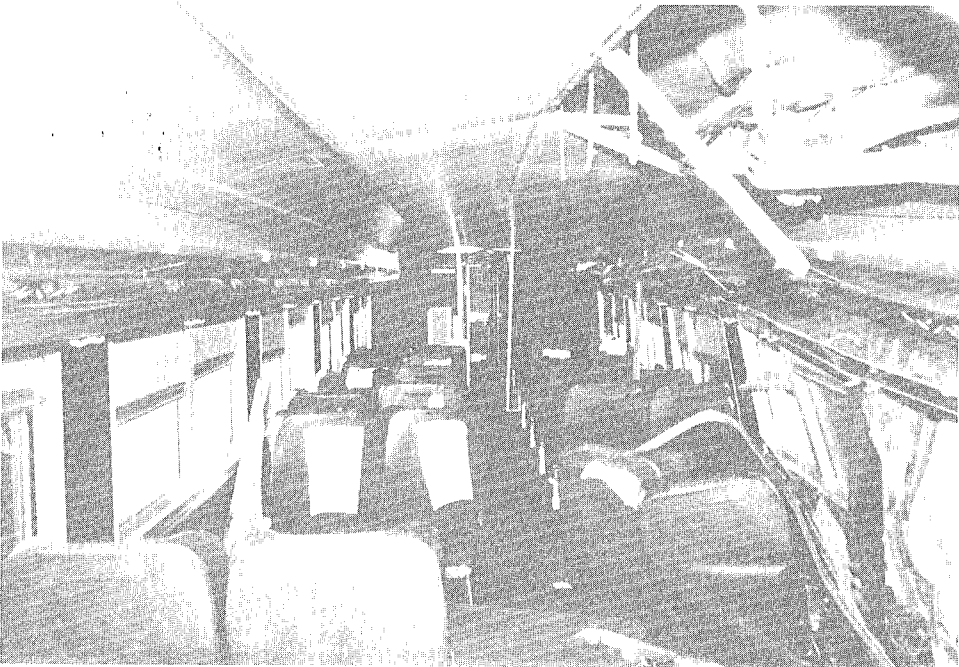
The baggage car, next in line, also overturned. This car was extensively damaged; both ends of the car were crushed. The following car, a coach/dorm car, sustained extensive damage as a result of the collision with other cars during the derailment. This car did not overturn but jackknifed from the train, went over the embankment, and was leaning to one side. The roof of the car was crushed inward about 4 feet, and the side of the car at seat locations 1, 5, 9, and 13 was torn away; the windows were also torn away. At seats 13 and 14 the sidewall was crushed inward about 15 inches, crushing the window seat armrest (figure 4). The window frame was twisted with the outside glass missing, but the inside Lexan window remained in place (figures 5, 6, and 7).

Figure 5.--Foreward end interior of coach/dorm car;
seats 1-2 and 9-10 are in the aisle (top).

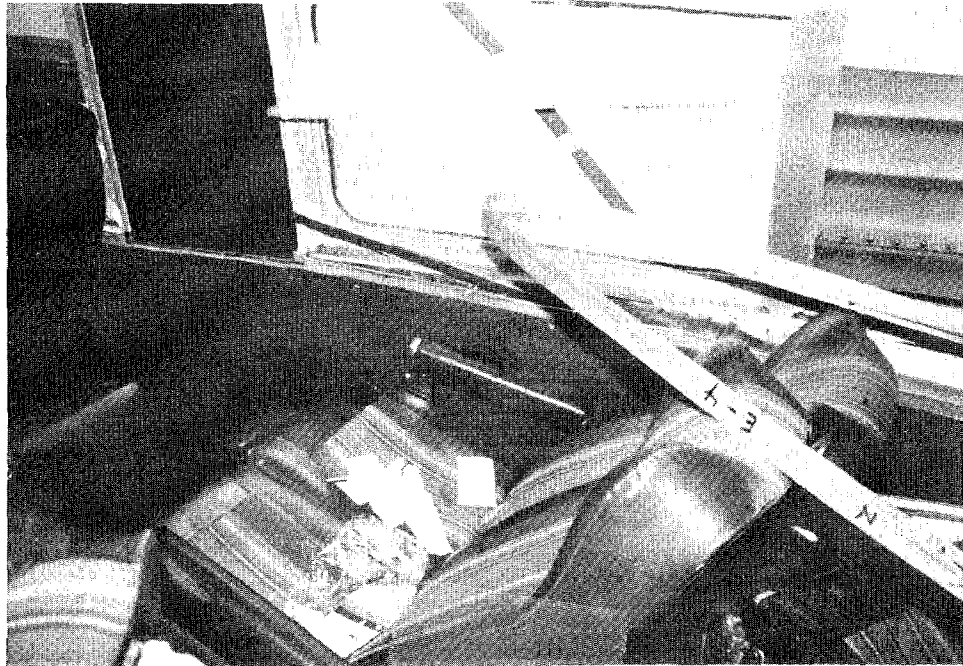
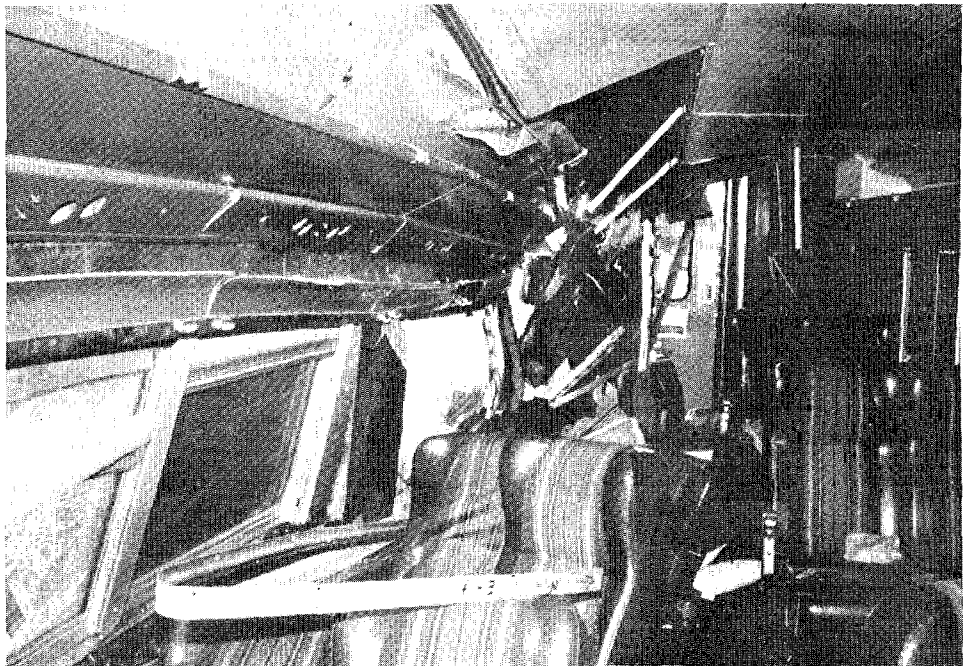
Figure 6.--Rear end interior of coach/dorm car;
bent metal trim strip at seat 29-30.

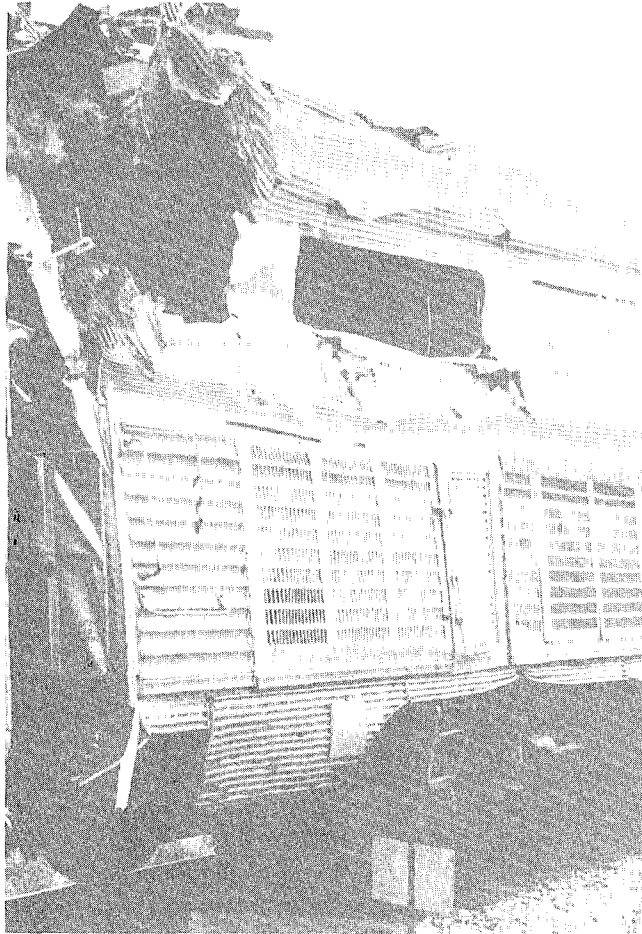
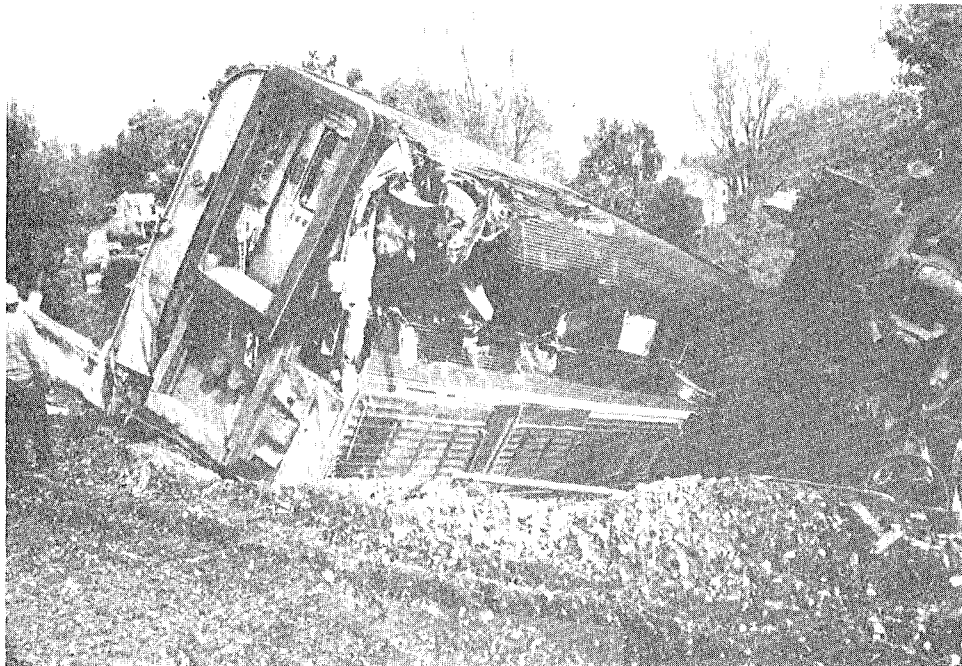
Figure 7.--Dorm/coach car No. 39912 exterior damage.

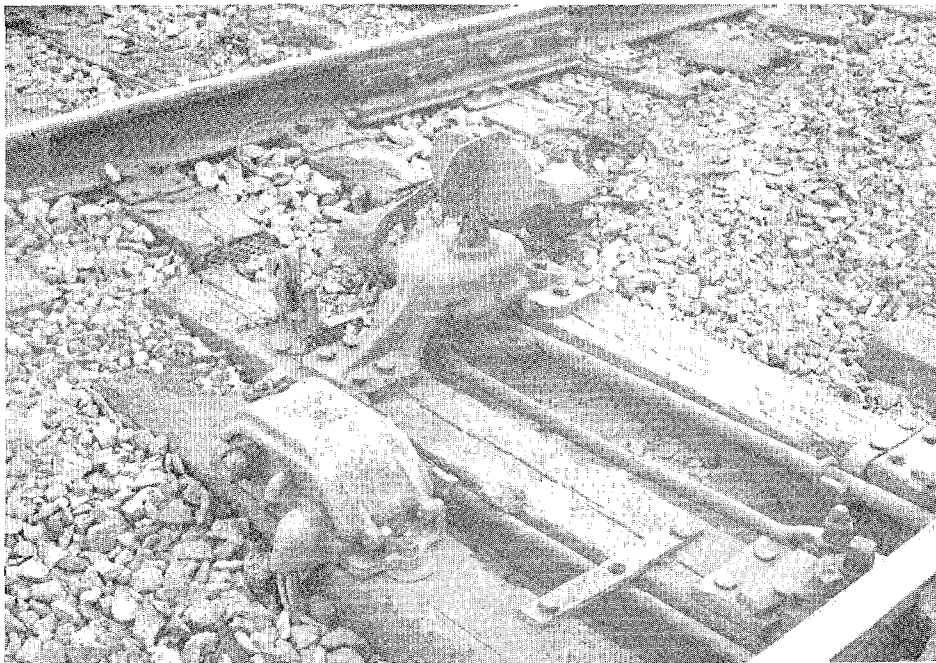
Figure 8.--Low switch stand at Fall River.

When the switchtender lined the switch after train 8 passed the two green signals, the engineer had no way of knowing the condition of the switch until he could see the points of the switch. There was a low switch target on the cross over switch about 102 feet from the center of the grade crossing at Main Street in Fall River. However, because it was low and close to the grade crossing, it could not be seen by the engineer to warn him in sufficient time to bring the train to a stop before entering the switch.
