RAILROAD ACCIDENT INVESTIGATION

REPORT NO 4177

DULUTH, MISSABE AND IRON RANGE RAILWAY COMPANY

JANUARY 30, 1971

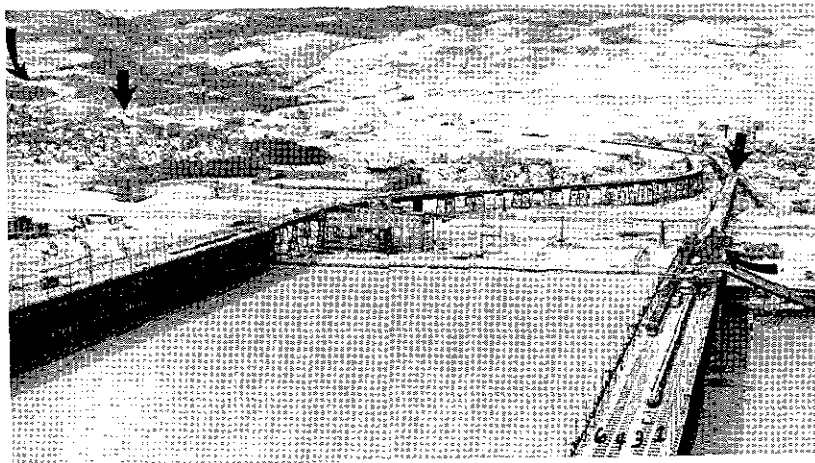
PLATE NO 2

From left to right (arrows), Proctor Hill, Collingwood, east lead track for Ore Dock No. 6, and collision point on track 3 of Ore Dock No. 6.

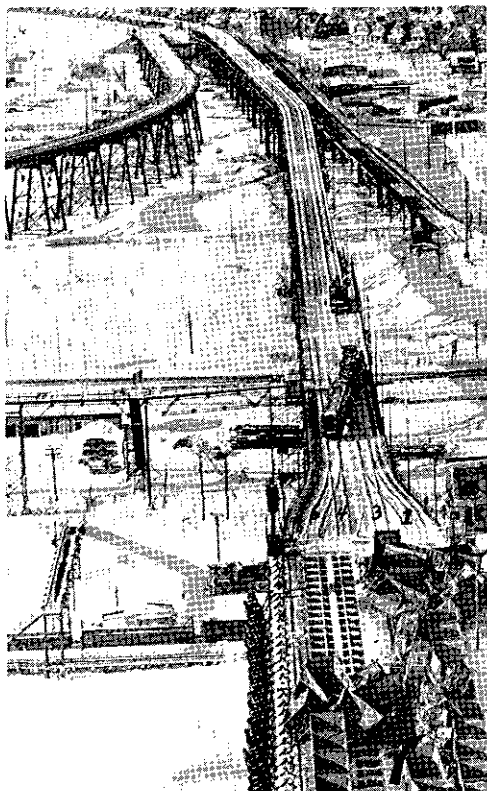
PLATE NO. 3

The derailed cars stopped in various positions, as shown in Plate No 3. The three locomotive units were heavily damaged, with the cab at the front of the first unit being demolished. Of the 22 derailed cars and the 15 cars which were struck but not derailed, 10 were destroyed, 18 heavily damaged, and 9 slightly damaged.

Arrow points to destroyed cab at front of first locomotive unit.
