REPORT OF THE DIRECTOR

ACCIDENT ON THE

ELGIN, JOLIET AND EASTERN

INVESTIGATION NO. 2061

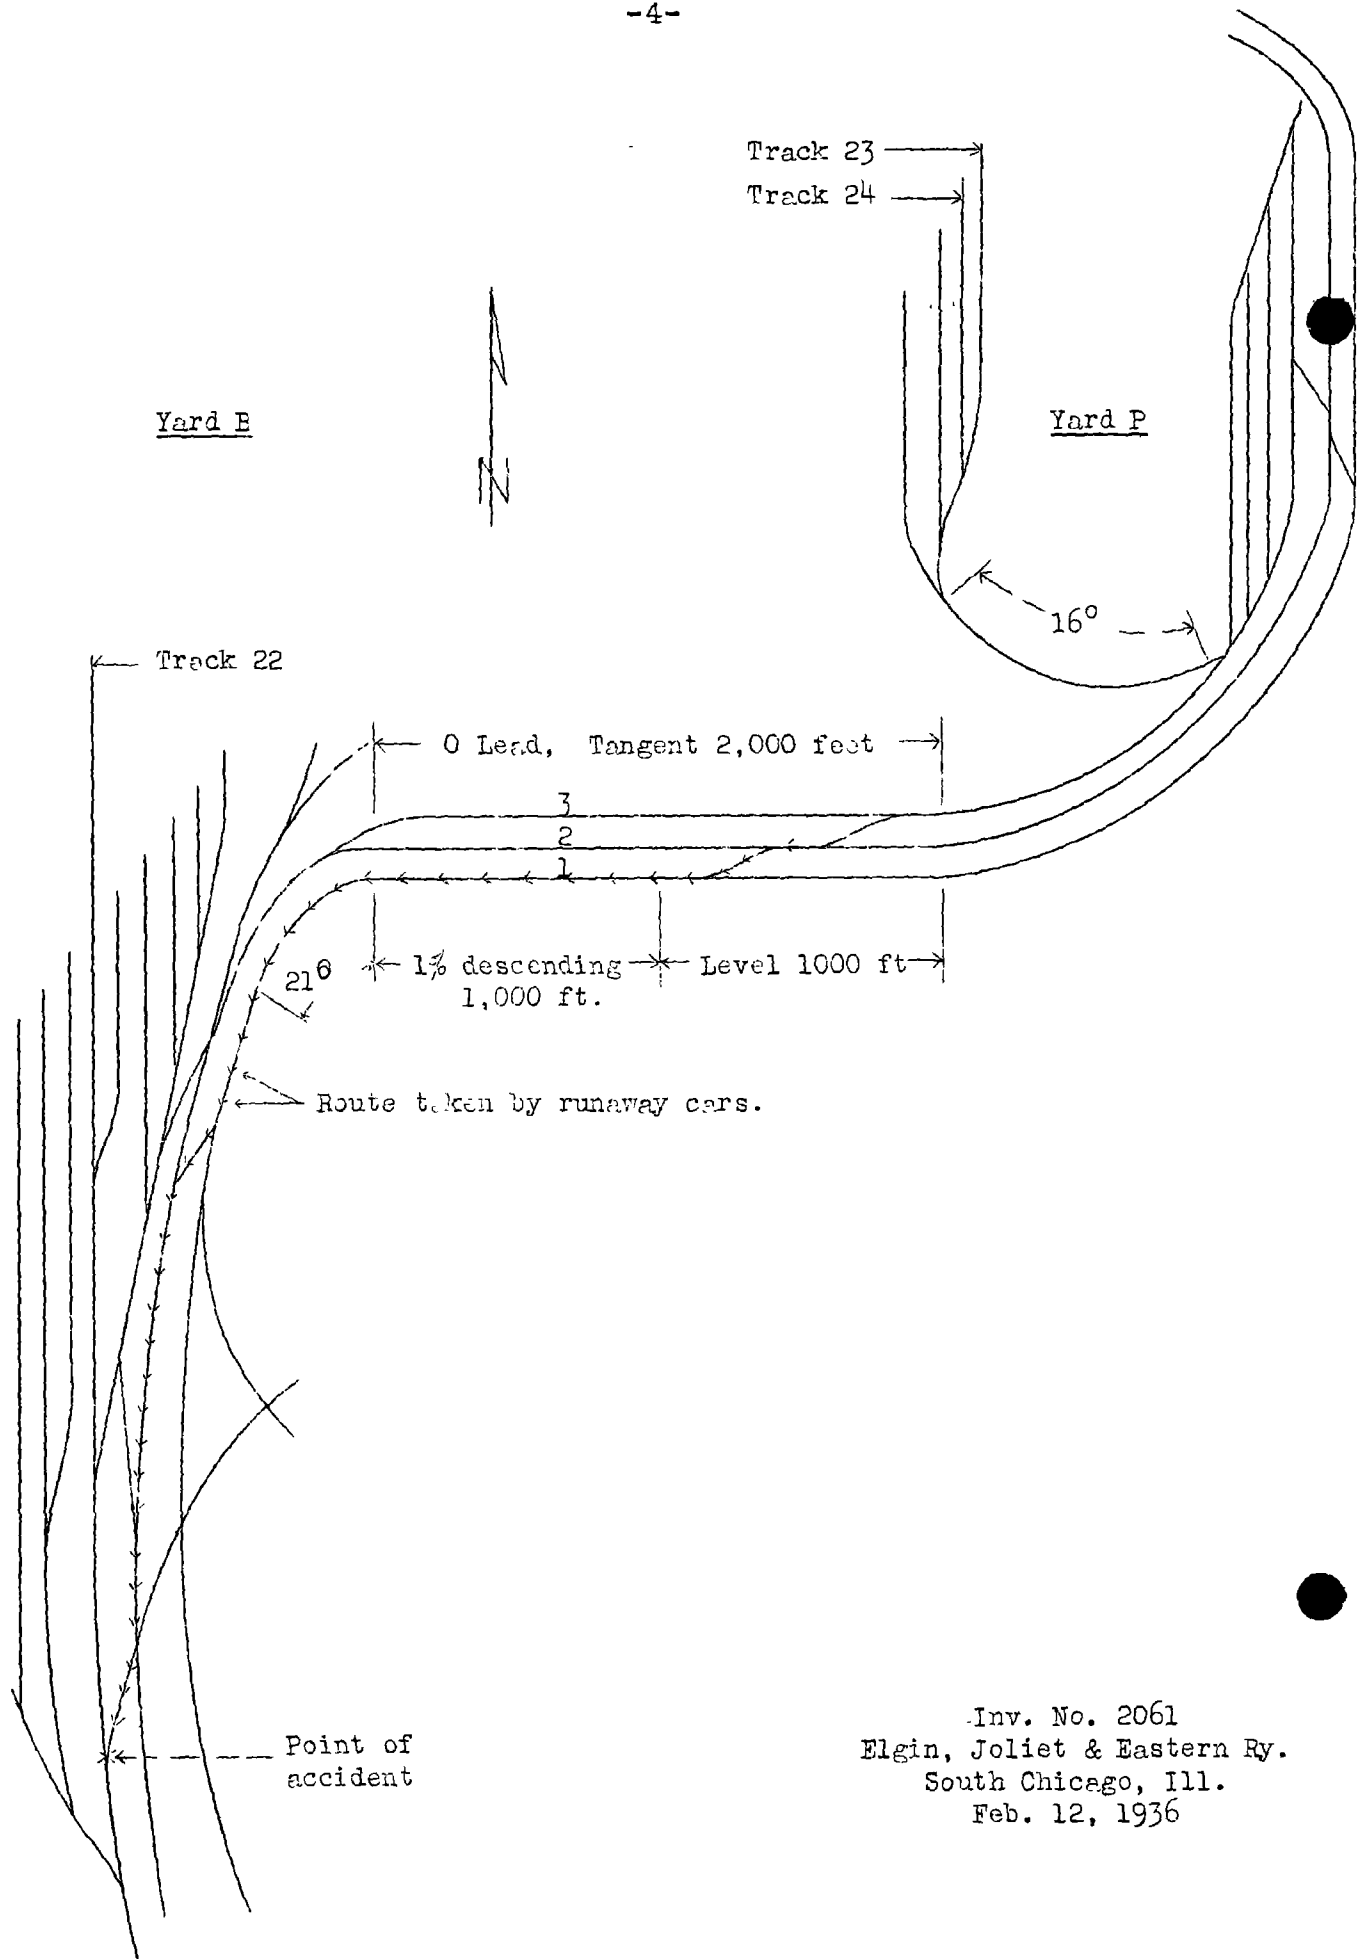
Inv. No. 2061
Elgin, Joliet & Eastern Ry.
South Chicago, Ill.
Feb. 12, 1936

Chief Car Inspector Hilbrich stated that car 30724 is equipped with a Klasing lever-type hand brake and an improved Carmer push-down type uncoupling lever. When applied, the pin lifting arm on the B end should be provided with an offset to clear the clevis and bell crank of the hand brake mechanism; however, on this car this section of the lever had no offset at the time of the accident; the B-1 brake beam, a bottom rod and a spring plank were all bent upward, which allowed an excessive movement of the bell crank and permitted the clevis to engage the pin lifting lever and release the lock block. He had no record of this lever having been changed and it was his opinion the lever had been replaced while the car was on a foreign line; as a repair of this kind is not billed against the car owner he would have no record of the matter. The last record covering inspection of the car prior to the accident showed that it came off the repair track at South Chicago on

Car 30724 is an all-steel, 100,000 capacity gondola built by the E.J. & E. Ry. Co., in 1930 and is equipped, on the B end, with a Klesing lever type hand brake, and with Carner push-down type uncoupling levers on both ends. In designing the pin lifting lever for the B end, on cars of series 30600-30899 of the E.J. & E. Ry., it was foreseen that under some conditions the vertical connection of the Klesing brake might foul the lever, and to eliminate this possibility a 6 inch bend was provided in the lever. However, a pin lifting lever without this offset had been applied to the B end of this car, and a bent brake beam, a bent bottom rod and a bent spring plank were also found on the B end of the car. These latter defects caused an excessive upward movement of the bell crank and clevis, allowing the

clevis at the end of the vertical rod to engage the pin lifting lever and free the lock block of the coupler. Repair track records indicated this car came off the repair track, after undergoing light repairs, in South Chicago Yard on Feb. 4, 1936, and the car records disclosed that the car had not been moved out of the yard between that date and the time of the accident. In view of these facts it appears that the improperly constructed pin lifting lever was on the car when it left the repair track and an adequate inspection at that time should have revealed the condition.

Steps have been taken to curtail the use of push-down type uncoupling devices to the extent that under Rule 3, Sec. C, Par. 9, of the interchange rules adopted by the A.A.R., it is provided that rotating type uncoupling levers similar to the type shown on Plate B of the Safety Appliance specifications, will be required on all cars built new or rebuilt on or after Aug. 1, 1933, in order to render them acceptable from the car owners, and a foot note to this rule contains a recommendation that when cars built prior to August 1, 1933, receive Class 1 general repairs and new couplers are applied, rotating type uncoupling levers should be applied.
