## INTERSTATE COMMERCE COMMISSION

REPORT OF THE DIRECTOR OF THE BUREAU OF SAFETY CONCERNING AN  
ACCIDENT ON THE ERIE RAILROAD NEAR BINGHAMTON, N.Y., ON  
SEPTEMBER 5, 1933.

October 7, 1933.

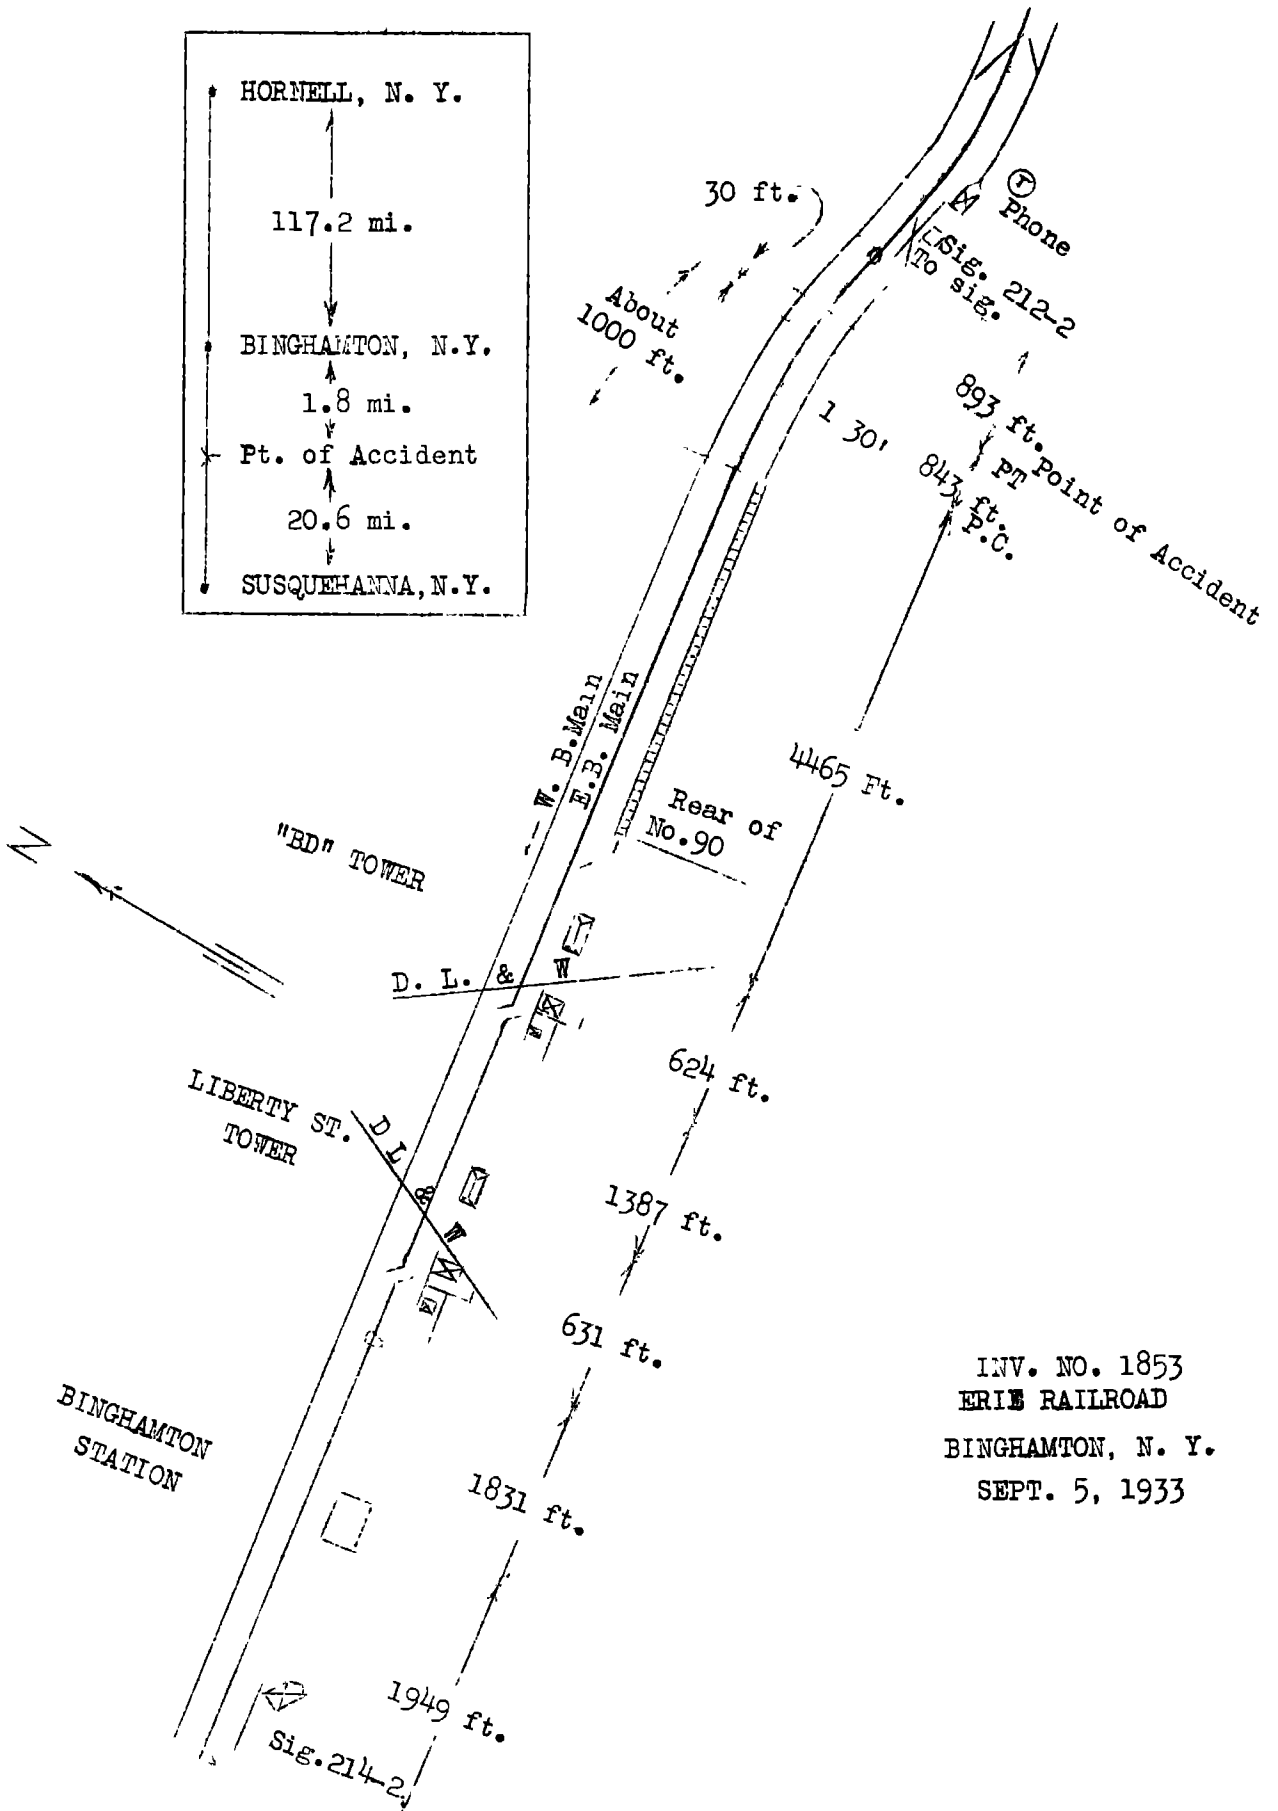
INV. NO. 1853  
 ERIE RAILROAD  
 BINGHAMTON, N. Y.  
 SEPT. 5, 1933

The signals involved, named in order from west to east, were automatic block signal 214.2 and the interlocking home signals at Liberty Street and BD Towers, these signals being located 11,759, 7,980, and 5,962 feet, respectively, west of the point of accident, and automatic block signal 212.2, located 893 feet east of the point of accident. The automatic signals are of the 1-arm, 3-position, upper-quadrant semaphore type, the night indications being red, yellow and green, for stop, approach and proceed, respectively. On the same mast with signal 212.2, and mounted below it, is a 3-position, electrically-operated train-order signal, and the control of the automatic signal is so arranged that its indications will not be more favorable than those displayed by the train-order signal. The interlocking home signals are of the 2-arm semaphore type; the upper arms are of the 3-position,

There is a long siding on the south side of the east-bound track, this siding beginning just east of BD Tower and extending for a considerable distance east of signal 212.2, with a crossover connection with the east-bound track at a point a short distance east of the signal. At the time of the accident, the rear portion of an east-bound freight train, consisting of a caboose and 82 cars, was standing on this track, the head car being probably about 1,000 feet west of the point of accident.
