## INTERSTATE COMMERCE COMMISSION

REPORT OF THE DIRECTOR OF THE BUREAU OF SAFETY CONCERNING AN ACCIDENT WHICH OCCURRED ON THE ERIE RAILROAD AT NORTH TONAWANDA, N. Y., ON MARCH 26, 1932.

May 18, 1932.

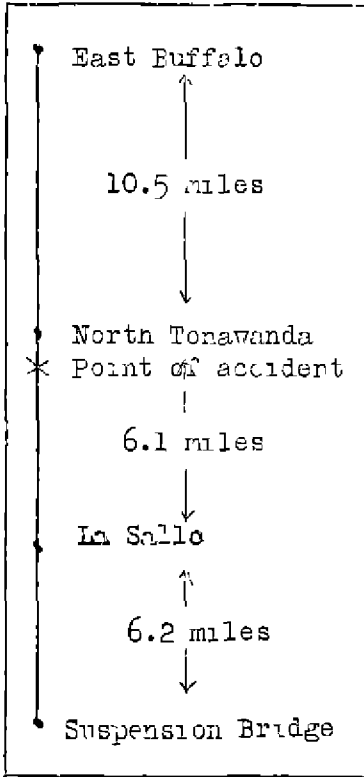
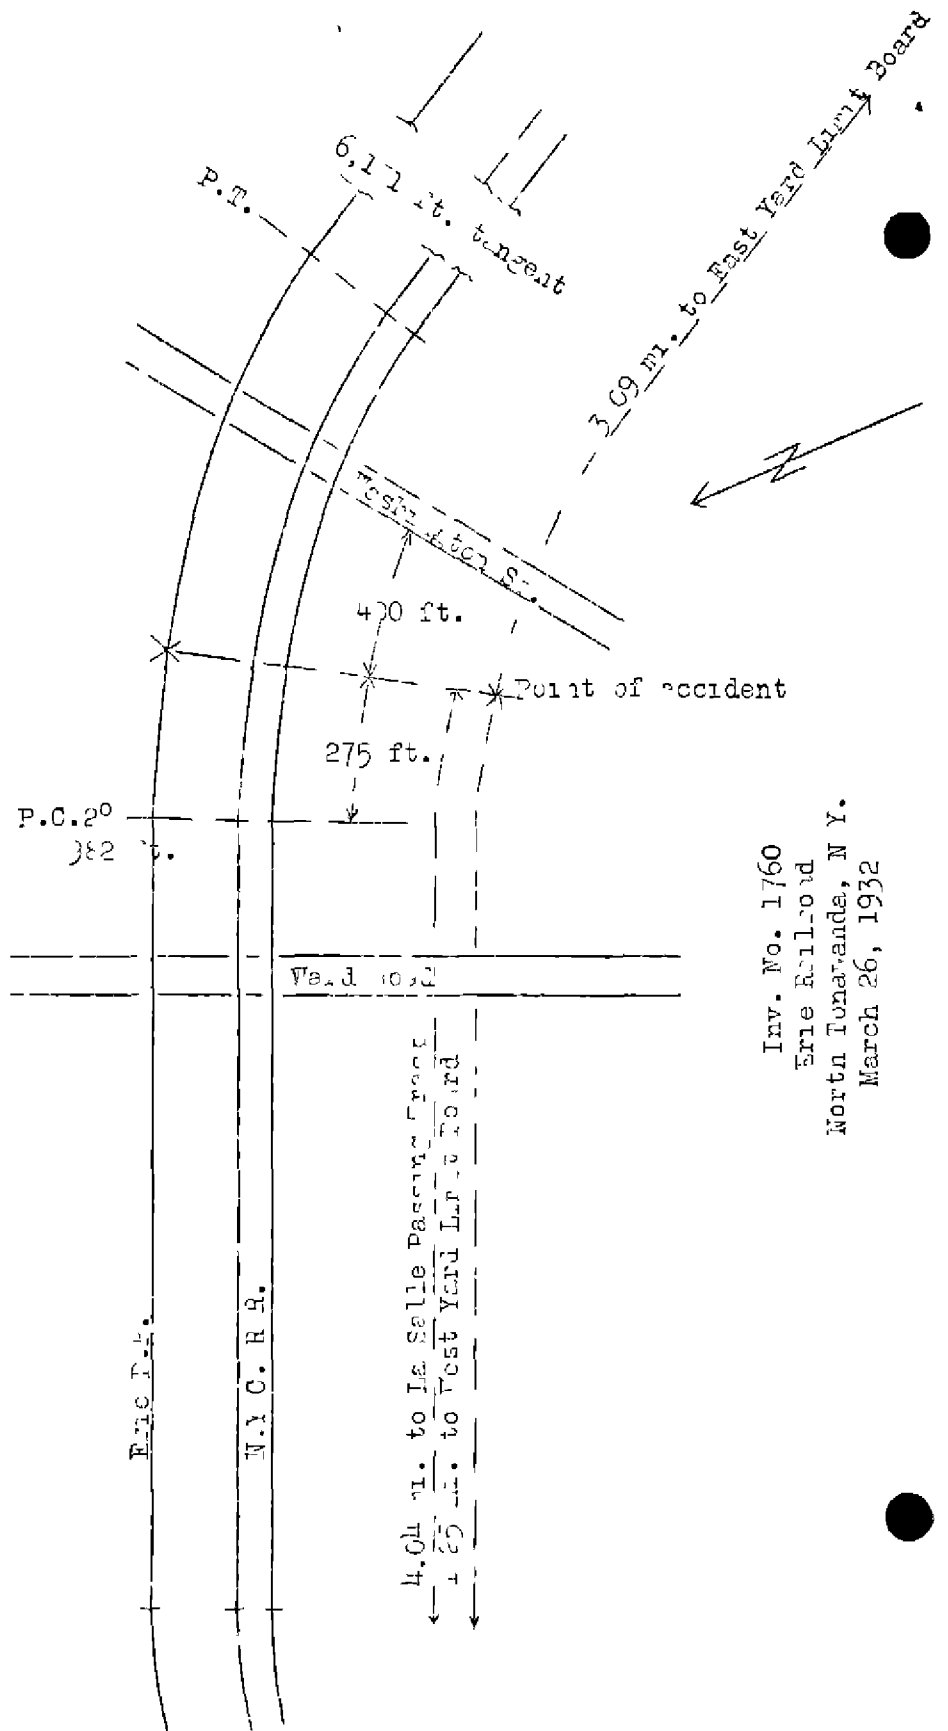
Inv. No. 1760  
 Erie Railroad  
 North Tonawanda, N.Y.  
 March 26, 1932

On March 26, 1932, there was a head-end collision between two freight trains on the Erie Railroad at North Tonawanda, N. Y., which resulted in the injury of four employees.

This accident occurred on the Niagara Falls Branch of the Buffalo Division, extending between Suspension Bridge and East Buffalo, N. Y., a distance of 23.9 miles, in the vicinity of the point of accident this is a single-track line over which trains are operated by time-table, train orders, and a casual block-signal system. The accident occurred within yard limits, at a point 1.25 miles east of the west yard-limit board, approaching this point from the west, the track is tangent for a distance of 1,241 feet, followed by a  $2^{\circ}$  curve to the right 983 feet in length, the accident occurring on this curve at a point about 275 feet from its western end. Approaching from the east the track is tangent for a distance of 6,151 feet, followed by the curve on which the accident occurred. The grade is level.

The tracks of the New York Central Railroad parallel the track of the Erie Railroad on the south in this vicinity, and on account of a line of telegraph poles located between the tracks of these two roads the view across the inside of the curve is considerably obstructed.

Both engines were derailed and considerably damaged, but remained upright, the first two cars in train No. 146 were derailed, while the first car in train No. 187 telescoped the tender of engine 2437. The employees injured were the fireman, conductor and two brakemen of train No. 187.
