# NATIONAL TRANSPORTATION SAFETY BOARD

## RAILROAD/HIGHWAY ACCIDENT REPORT,

GRADE CROSSING COLLISION OF A  
FLORIDA EAST COAST RAILWAY COMPANY  
FREIGHT TRAIN AND AN  
INDIAN RIVER ACADEMY SCHOOLBUS  
PORT ST. LUCIE, FLORIDA  
SEPTEMBER 27, 1984

NTSB/RHR-85/01,

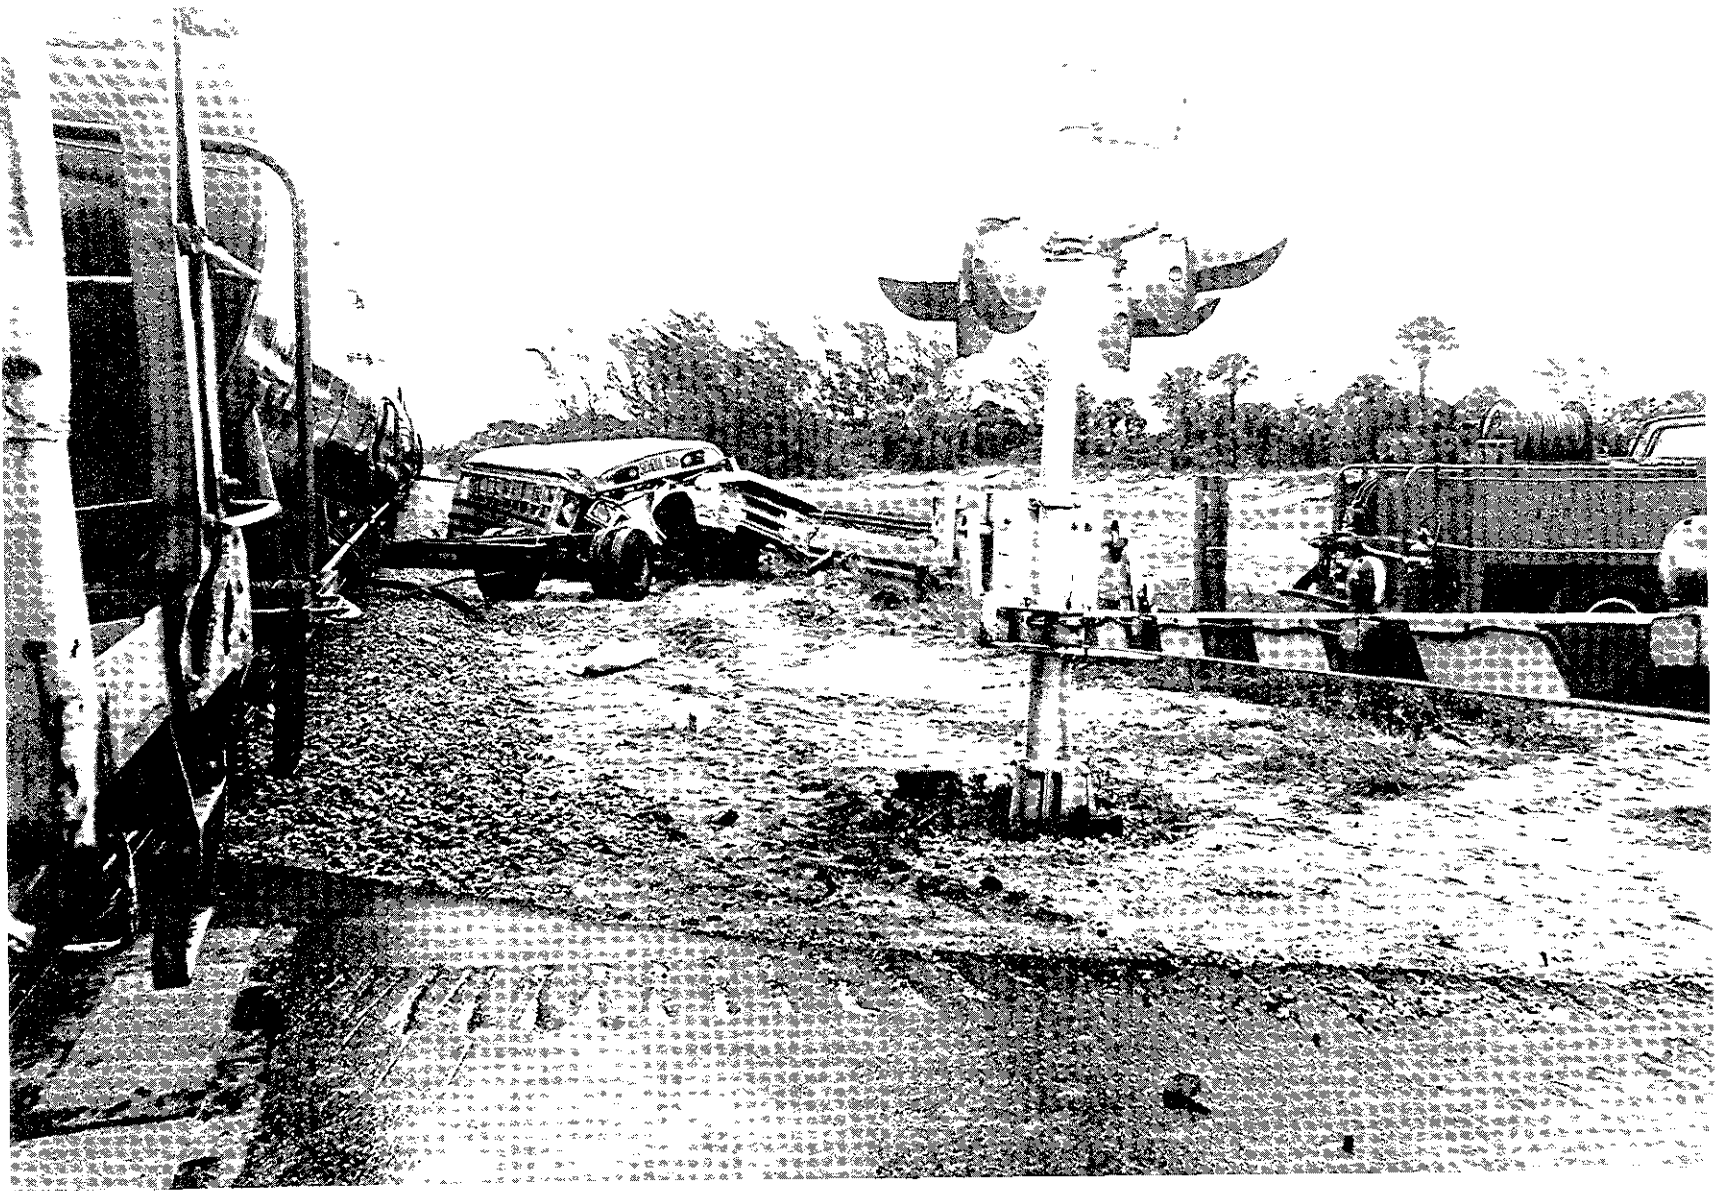
Figure 2.--Schoolbus, train, and warning device at accident site.

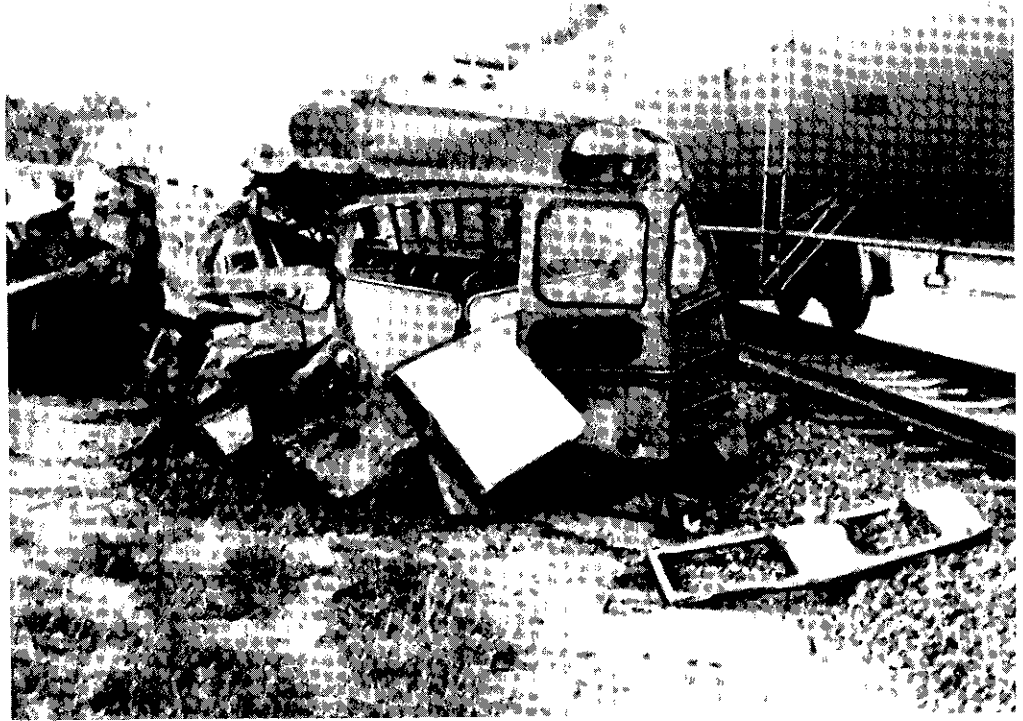
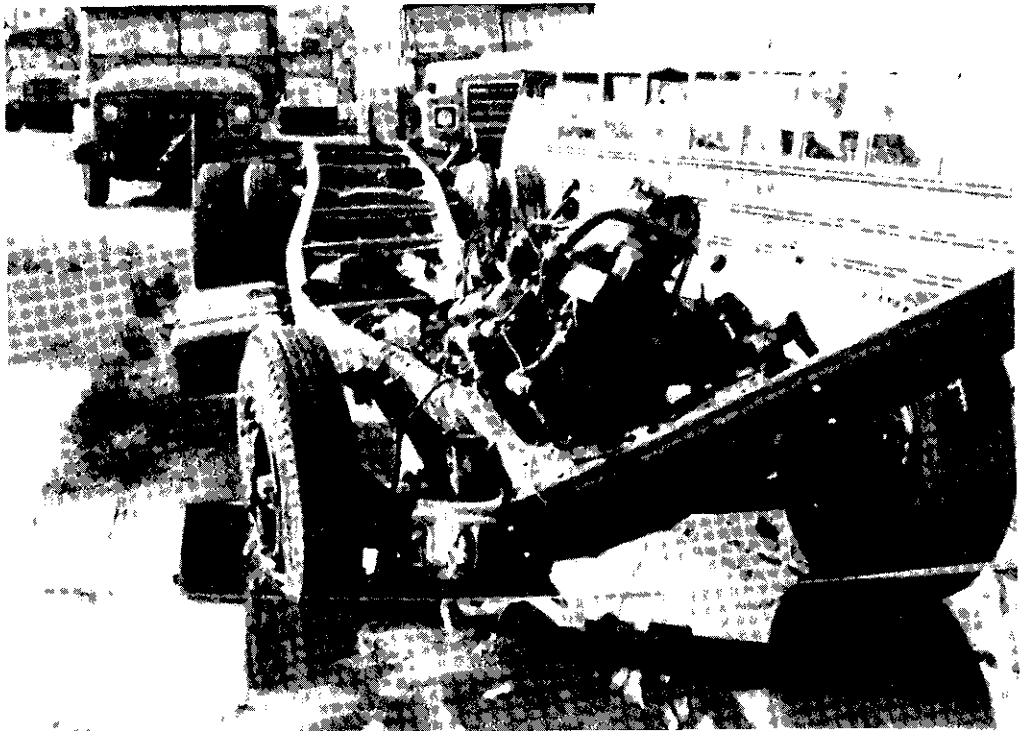
The schoolbus body was separated from the chassis frame at the body mounts. (See figure 3.) The front fenders remained with the body. The engine and transmission remained with the chassis. Damage to the radiator fan was typical of damage that results when the fan is not turning at impact. The transmission gear shift lever, cover, and shift linkage were separated from the transmission assembly.

Deformation on the left side of the body at the point of impact measured 4 feet 2 inches inward. The left sidewall was penetrated and the floor was deformed, leaving an opening into the schoolbus. The driver's seat was forced toward the right and into the area of the front door. Several of the seats in the area of the penetration into the body were dislodged, but most of the seats rearward of the area of penetration remained in place.

Figure 3.--Crash damage to schoolbus body (above) (note emergency door at lower right), and crash damage to schoolbus chassis (below).

There was accident damage to the rear of the schoolbus body. At floor height, deformation to the rear of the body measured 35.75 inches at the rear left, 40.5 inches at the rear center, and 12.5 inches at the rear right. The left portion of the rear wall was separated from the roof, the interior panels above the emergency door were separated from each other, and the panels were separated from the roof rail. Bluish-colored paint transfers were on the schoolbus body near the roof.

The rear emergency door was separated from the schoolbus body at the line of fasteners which connected the door hinge to the door. The factory-equipped operating lever was found near the vertical (open) position. The main door latch was damaged by direct impact, and the outside lever that operated the latch was broken off.

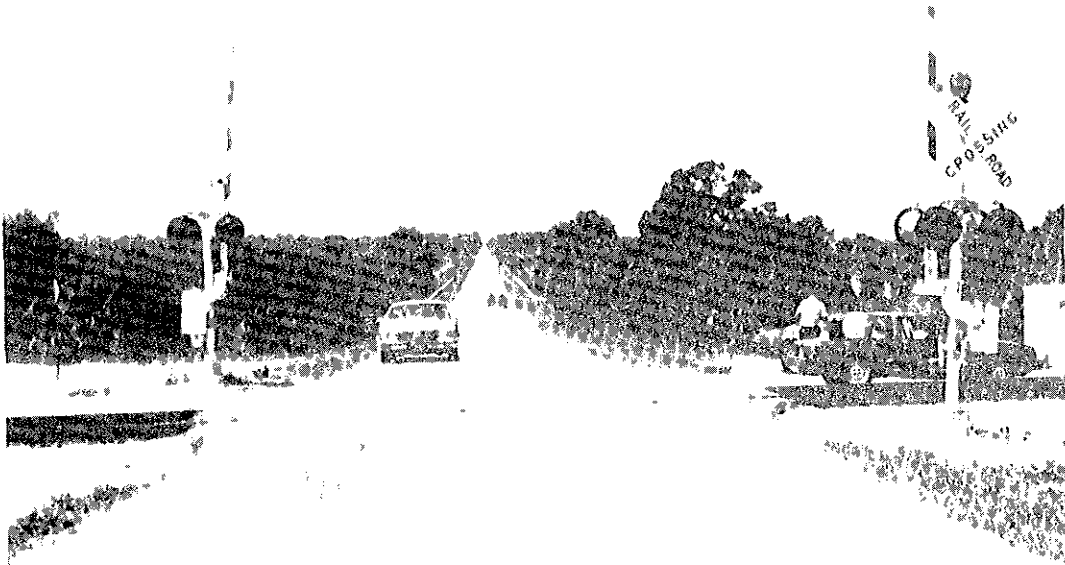
In April 1984, the elevation of the track at the Walton Road crossing was raised, and the pavement on either side of the track was resurfaced. A private contractor employed by the FEC resurfaced the pavement 28 feet east and west of the track. The contractor stated that he did not replace any pavement markings. Consequently, the westbound stop line located 18 feet from the track was covered over with new asphalt; it had not been repainted at the time of the accident. Following communications with Safety Board investigators, the stop line was immediately repainted by St. Lucie County.

Figure 4.--Westbound approach to Walton Road grade crossing.

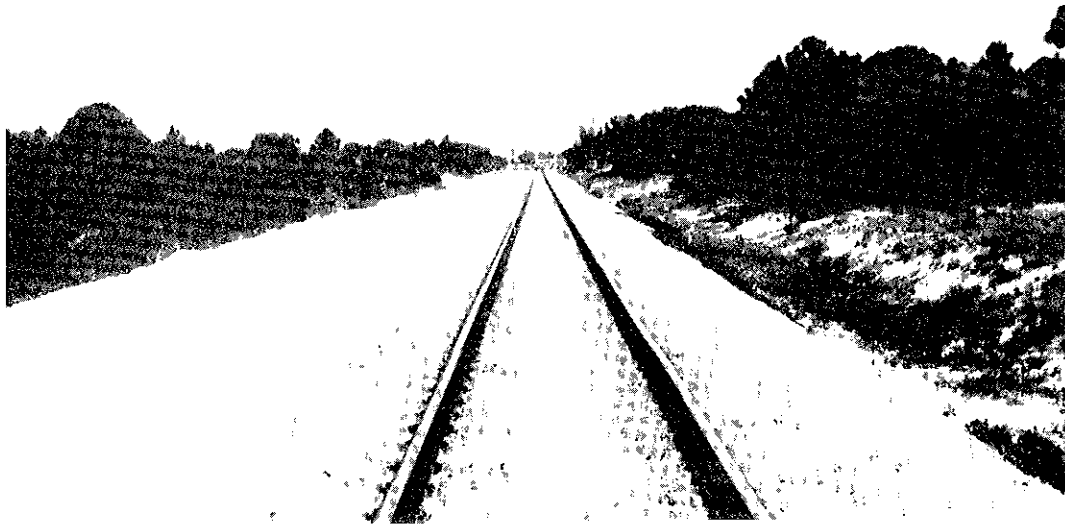
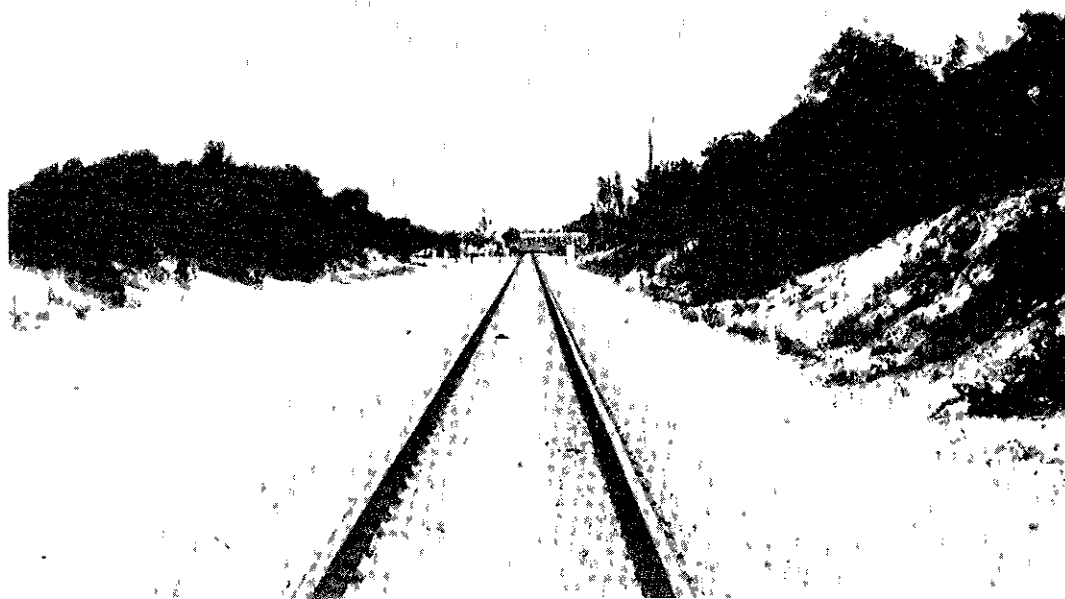
Figure 7.--Northbound approach at 1,732 feet to Walton Road crossing (above), and northbound approach at 732 feet (below).
