REPORT NO. 3506
FLORIDA EAST COAST RAILWAY COMPANY
IN RE ACCIDENT
NEAR OAK HILL, FLA., ON
FEBRUARY 11, 1953

Accident near Oak Hill, Fla., on February 11, 1953, caused
by a broken rail.

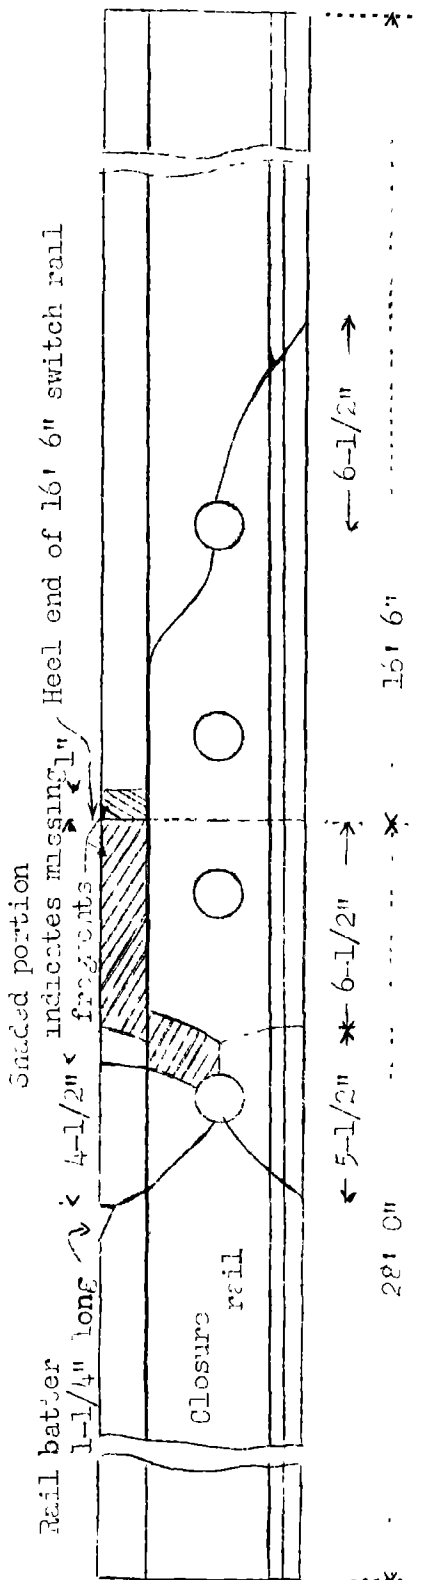
Sketch showing broken rail- east side of track

Examination of the turnout disclosed that the closure rail connected to the east switch rail was broken. This rail was manufactured by the Tennessee Coal, Iron & Railroad Company in June, 1942. It bore heat No. 856540B. The leaving end of this rail between the second bolt hole and the end of the rail was broken into a number of pieces, four of which were recovered. Fractures extended from the second bolt hole downward through the base at points 6-1/2 inches and 12 inches south of the end of the rail and upward through the head at points 6 inches, 7-1/2 inches, and 12 inches south of the end of the rail. The head of the rail south of two of the breaks was battered. This indicated that several wheels of a south-bound train had passed over the rail after a portion of the head became dislodged. A portion of the head of the switch rail 1 inch in length was broken out of the heel. This piece was not recovered. A fracture in the switch rail extended downward from the point where the portion of the head was broken out, through the second bolt hole, and through the base at a point 15 inches north of the end of the rail. All of the breaks in both rails appeared to be new. Both bolts at the leaving end of the closure rail and the bolt through the first bolt hole of the switch rail were broken.

The breaks in the closure rail occurred between the joint bars and over the heel plate, and did not break the track circuit. As a result, the operation of the automatic block-signal system was not affected.
