INVESTIGATION NO. 2782
THE FLORIDA EAST COAST RAILWAY COMPANY
REPORT IN RE ACCIDENT
AT POMPANO, FLA., ON
MARCH 5, 1944

SUMMARY

Accident at Pompano, Fla., on March 5, 1944, caused by
a crossover switch being opened immediately in
front of an approaching engine when a train was
passing on adjoining track.

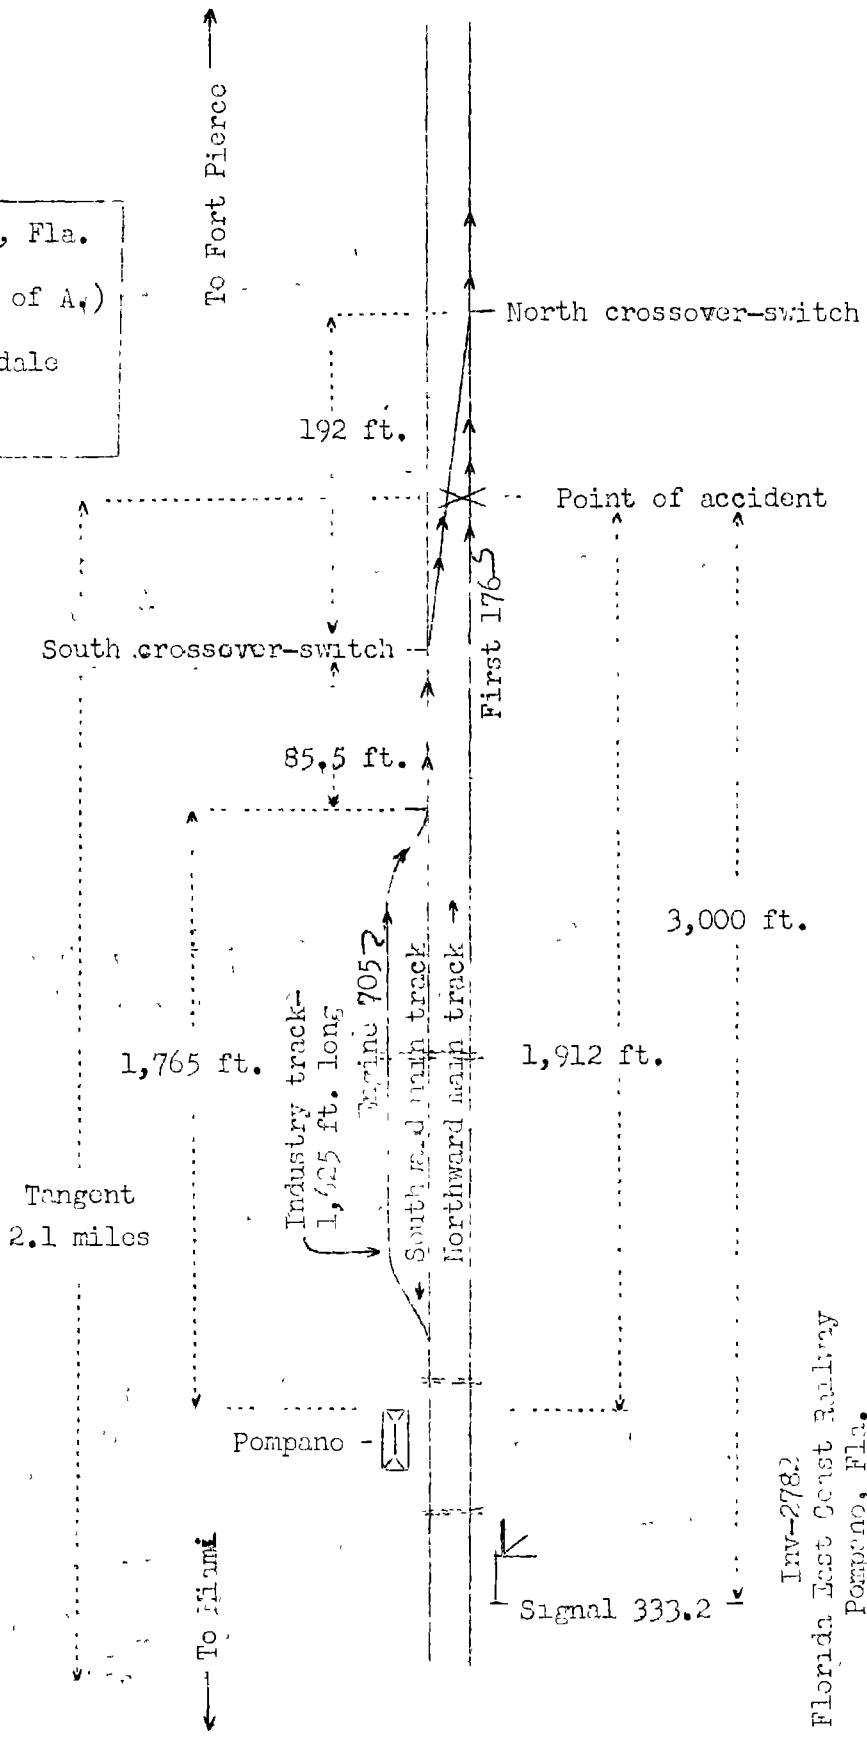
Inv-2782
 Florida East Coast Railway
 Pompano, Fla.
 March 5, 1943

The switch-stand for the south switch of the crossover was on the west side of the southward main track, and was of the hand-throw low-stand type. No light or target was provided.

Engine 705, of Extra 705 North, a north-bound freight train, was engaged in switching operations at Pompano. About 9:06 p. m., after this engine had moved a cut of 13 cars northward from the industry track to the southward main track, it entered the crossover at the south switch, and while moving at an estimated speed of 5 miles per hour it struck First 176.

The rear portion of the left side of the sixth car of First 176 was slightly damaged. The seventh and eighth cars were derailed and stopped, badly damaged, in line with the main tracks and leaning at an angle of about 45 degrees to the east, with the front end of the seventh car about 135 feet north of the point of accident. The front truck of the ninth car was derailed. Engine 705 was derailed and stopped, badly damaged, upright and in line with the crossover.
