REPORT NO. 3749

FLORIDA EAST COAST RAILWAY COMPANY

IN RE ACCIDENT

Accident at Daytona Beach, Fla., on March 16, 1957, caused
by a false flange on a slid-flat driving wheel resulting
from a seized traction-motor armature bearing.

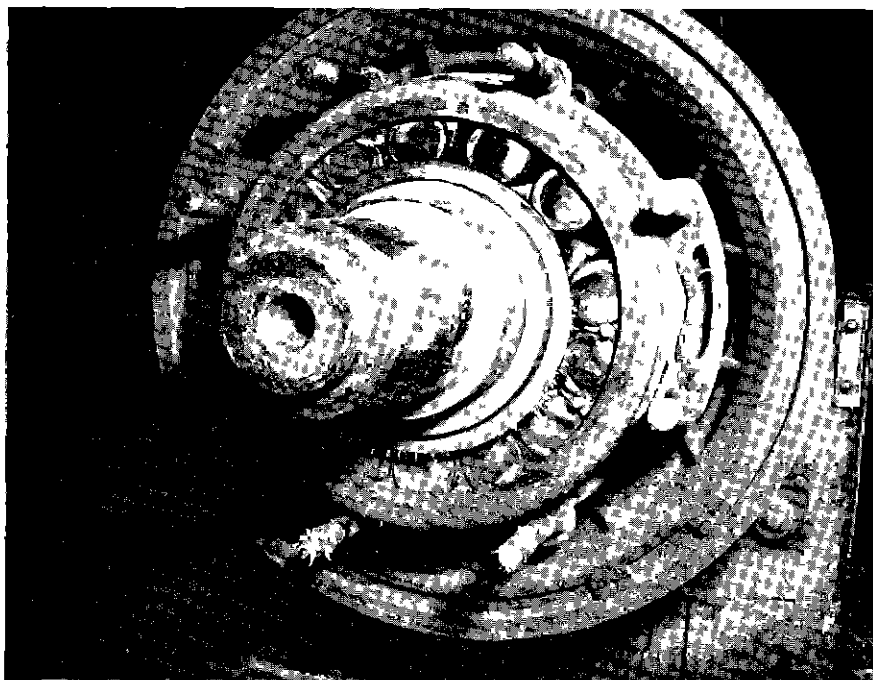
Examination of the No. 4 traction motor after it was disassembled at Miami, Fla., disclosed that the armature bearing at the pinion end had seized. The roller-bearing assembly at that end was discolored from heating. The heads of nine of the 14 roller-bearing cage rivets were sheared at the outer retainer ring. Six of the 14 roller bearings had 3/8-inch to 1/2-inch flat spots extending the length of the bearing.

Five other roller bearings had smaller flat spots. The inside bearing surface of the outer race and the outside bearing surface of the inner race bore indentations where the roller bearings had been embedded. Marks on the journal and on the inner bearing surface of the inner race indicated that the race had turned on the journal. An oil thrower and the inner race were fused to the armature shaft.

Traction-motor armature bearing, pinion end, after removing housing.

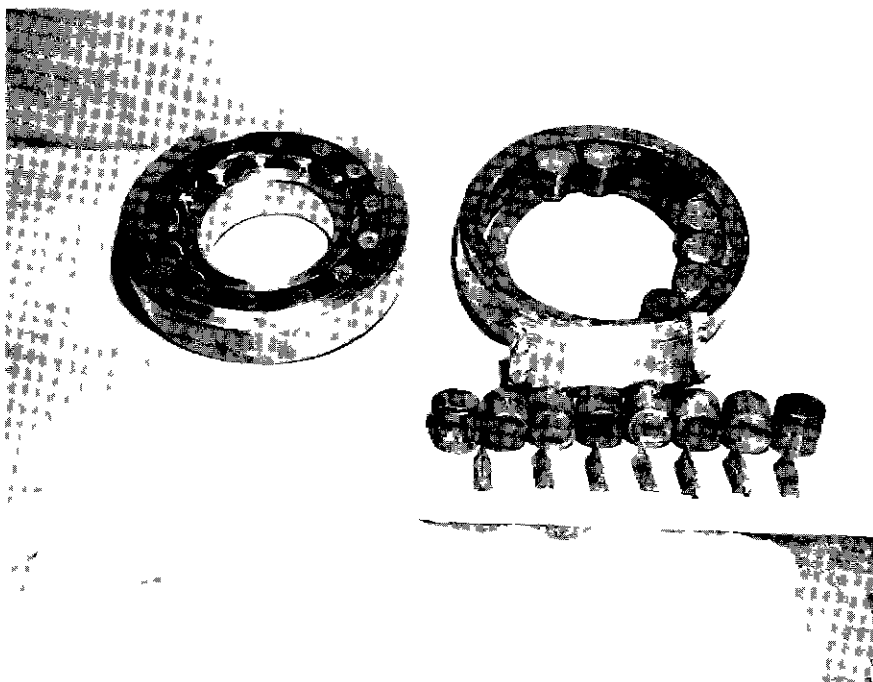
Races, rollers, and cage compared with new bearing of same type.
