INTERSTATE COMMERCE COMMISSION
WASHINGTON

REPORT OF THE DIRECTOR
BUREAU OF SAFETY

ACCIDENT ON THE
FORT DODGE, DES MOINES & SOUTHERN R.R.

INVESTIGATION NO. 2066

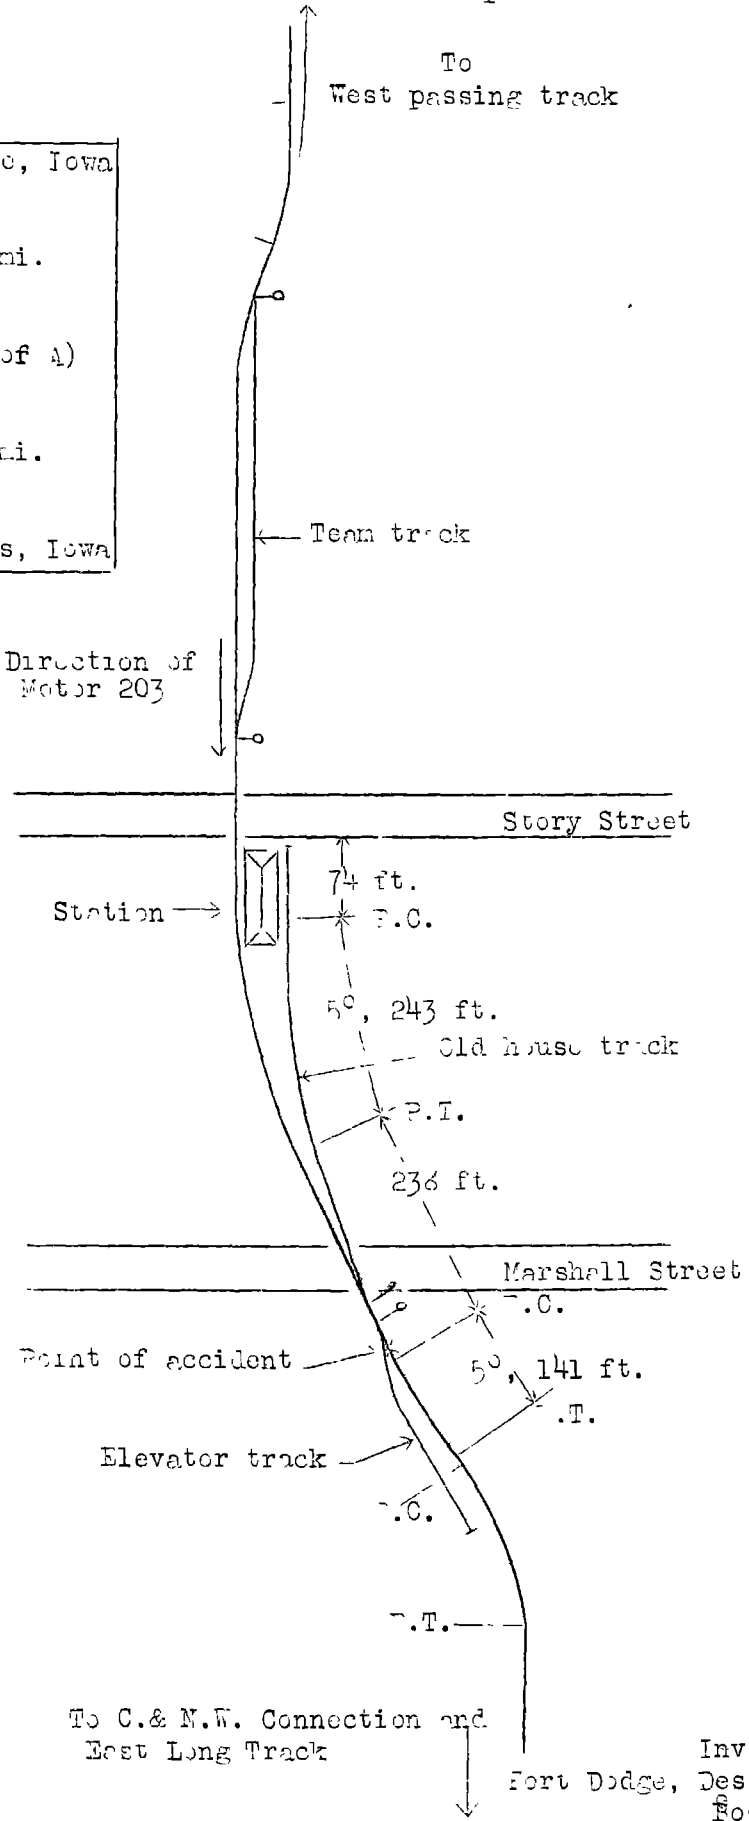
Inv. No. 2066
Fort Dodge, Des Moines & Southern RR.
Boone, Iowa
May 20, 1936

The north switch of the east long track is located 3,499 feet south of Story Street, while the south switch of the west passing track is located 4,348 feet north of Story Street; the north switch of the team track is located 1,053 feet north of Story Street. There is a C. & N.W. transfer connection located several hundred feet south of the elevator track.

To C. & N.W. Connection and
East Long Track
