INTERSTATE COMMERCE COMMISSION  
WASHINGTON

ACCIDENT ON THE  
FORT WORTH & DENVER CITY RAILWAY

SAMNORWOOD, TEX.

INVESTIGATION NO. 2277

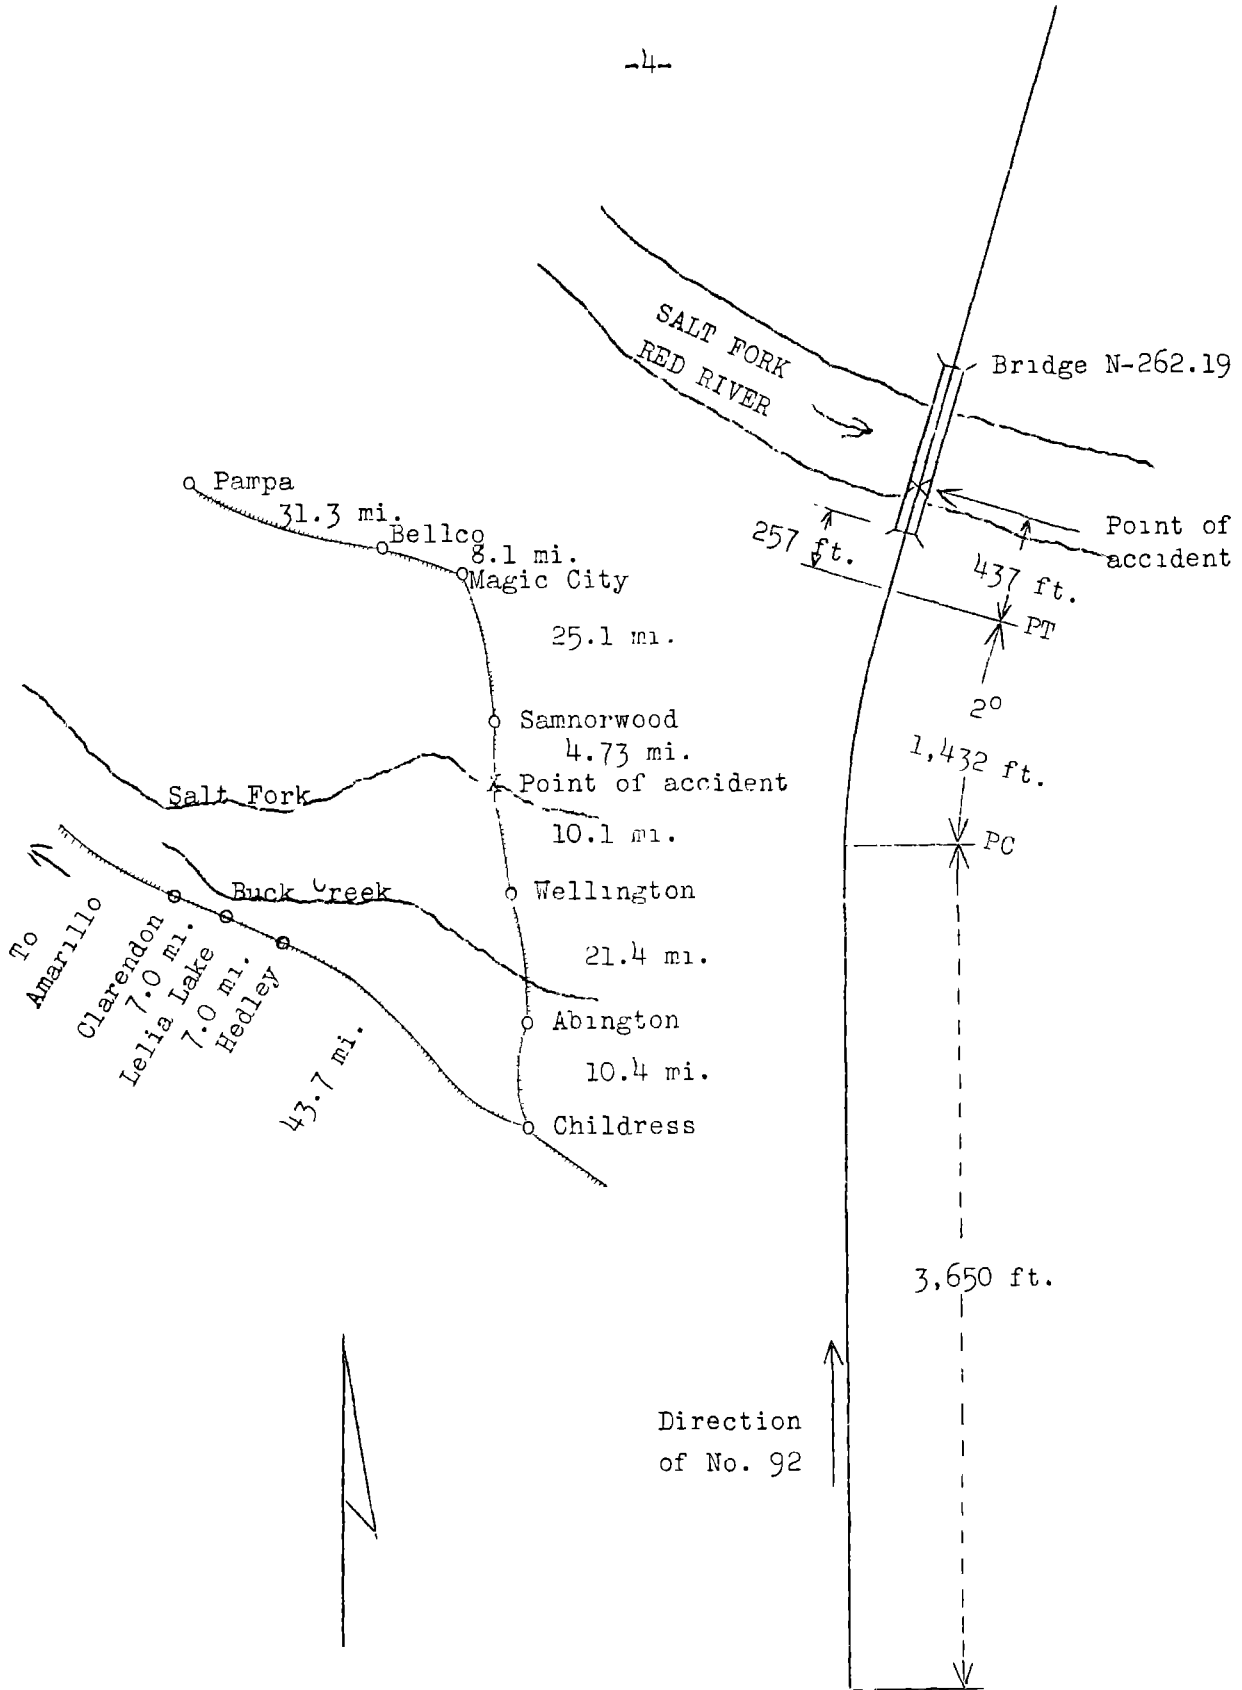
Inv. No. 2277  
 F.W. & D.C. Ry.  
 Samnorwood, Texas  
 June 16, 1938

Inspection of the remaining portion of bridge N-262.19 by the Commission's inspectors indicated that it was in good condition prior to the night of the accident. In addition to the damage heretofore described, the batter piling at the twentieth bent from the south side was broken off at a point approximately 17 feet above the creek bed. The maximum height of the water during the flood was apparently 14 feet. One bent was found about 2 miles down stream; all 7 of the piles remained bolted together and were broken off about 50 feet below the cap. Other pieces of piling which had been broken off at both ends were also found.

The investigation developed that about 11 p.m. June 15, a rain of cloudburst proportions fell within the watershed area of Salt Fork but some distance above bridge N-262.19. As a result Salt Fork was flooded and about 400 feet of a highway bridge located 7 miles upstream from bridge N-262.19 was washed out. The current in Salt Fork is swift and apparently the wreckage of this highway bridge drifted down and struck bridge N-262.19 with such force that it broke the piling and shoved the bridge out of line, weakening it to such an extent that it collapsed under the engine of No. 92. There was no indication that scouring of the creek bed was in

This accident was caused by the collapse of bridge N-262.19, due to its having been broken and weakened by the drifting wreckage of a highway bridge located about 7 miles upstream which had been washed out by flood water.

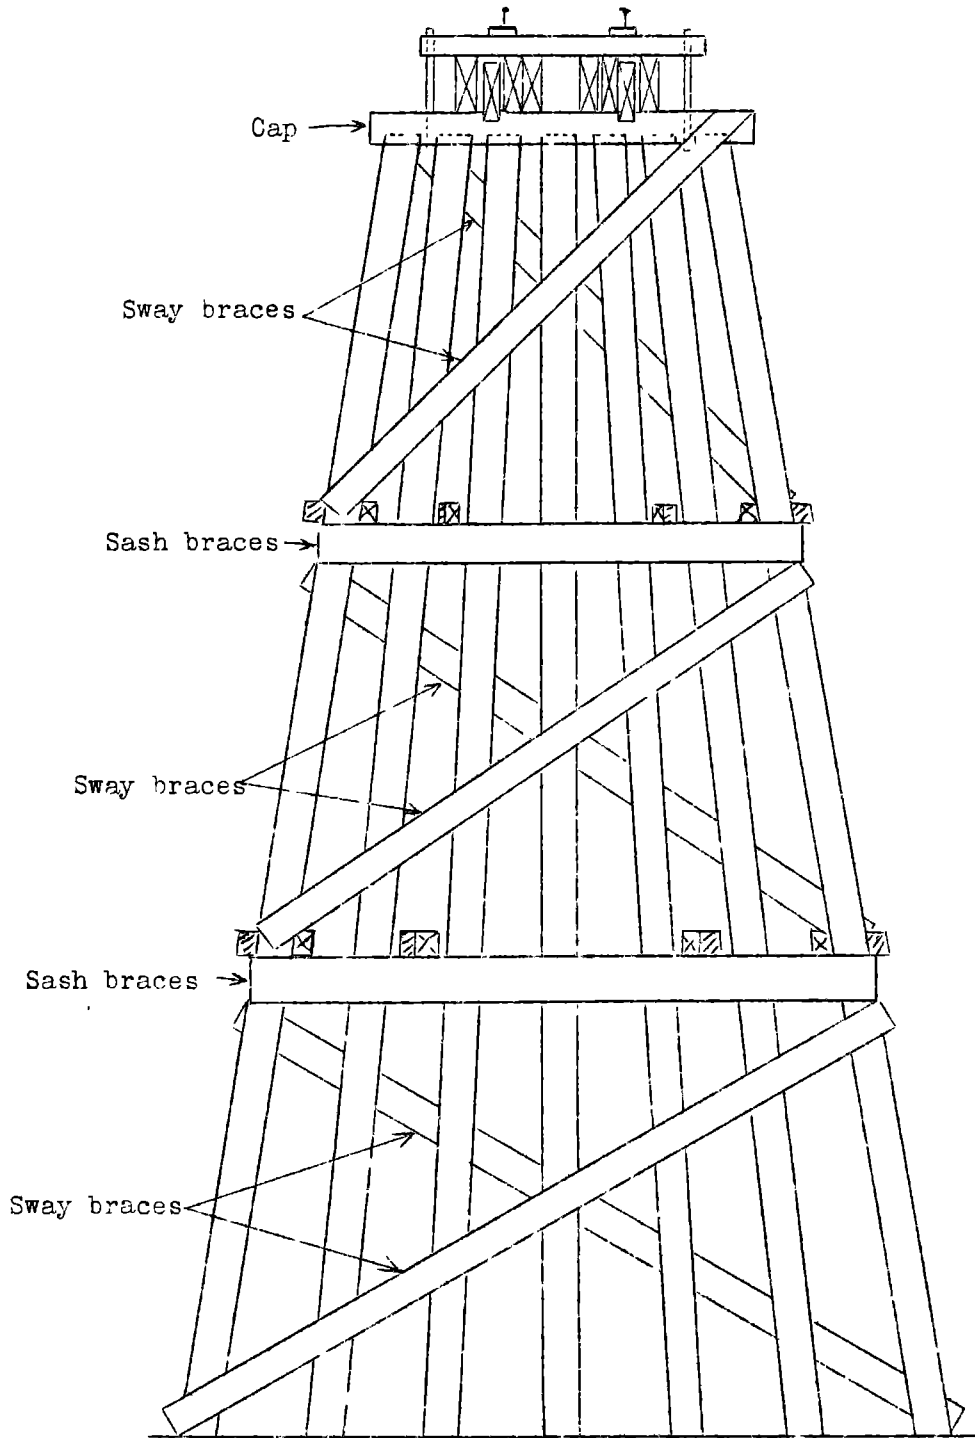
TYPICAL BENT

Bridge N-262.19 is an open-deck, 46-span, pile trestle, 920 feet in length, built in 1932; all material is creosoted. Each bent consists of 7 yellow pine piles varying in length from 70 to 85 feet; the tip ends vary from 8 to 10 inches, and the butt ends from 14 to 16 inches, in diameter. The bents are located 20 feet apart and are from 52 to 55 feet in height above the river bed. The bent caps are of the built-up type, composed of two pieces, each 8 by 16 inches by 16 feet; there are three 9 by 24 inch stringers per rail. The ties are 8 by 8 inches by 10 feet, and are spaced 14 inches center to center. On each chord an 8 by 16 inch block, 7 feet long, dapped 3 inches fits down over the cap, and through each block there are four bolts, two on each side of cap. The tie above each bent-cap is fastened to the cap with a 1 inch bolt. Each bent is provided with three sets of 4 by 10 inch sway braces, and between each set of sway braces there are 4 by 10 inch sash braces on each side of the bent, located 17 feet and 33 feet, respectively, below the cap. At the same distances below the caps four 6 by 8 inch braces run parallel to the track for the entire length of the bridge, one on each side bolted to the outer piles

and one each between the second and third pile from each side. The bridge is also tower-braced, every fourth panel being braced with cross braces parallel to the track on the outside of the piling. The result is that on each side of the structure there are 3 sets of cross braces tying two bents together and the next bent has no longitudinal cross-bracing. Quick sand in the bed of the creek varies from about 9 to 12 feet in depth and is underlain with clay strata of various kinds and thicknesses. Penetration of the piling into the clay varies from 12 to 14 feet. The maximum speed allowed for freight trains over this bridge is 20 miles per hour.
