REPORT NO. 3375  
FORT WORTH AND DENVER CITY RAILWAY COMPANY  
IN RE ACCIDENT  
AT QUANAH, TEX., ON  
OCTOBER 25, 1950

Date: October 25, 1950

Kind of accident: Rear-end collision

Accident at Quanah, Tex., on October 25, 1950, caused by  
an open switch.

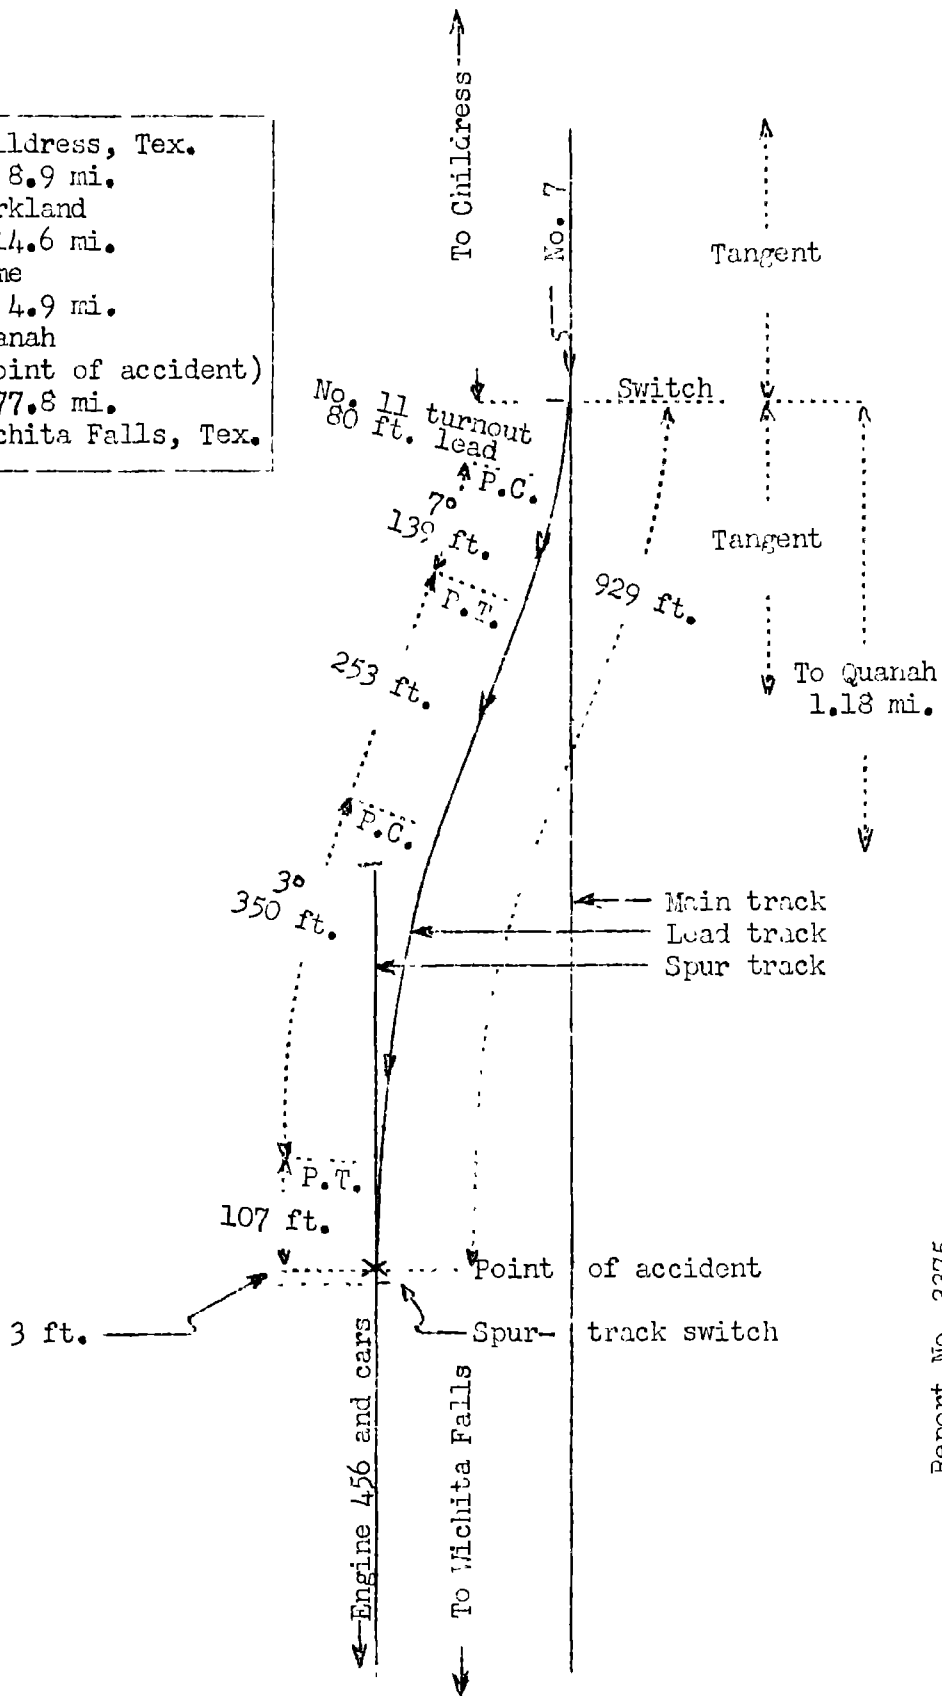
Report No. 3375  
 Fort Worth and Denver City Railway  
 Quanah, Tex.  
 October 25, 1950

This accident occurred on that part of the Wichita Falls Division extending between Childress and Wichita Falls, Tex., 106.2 miles, a single-track line, over which trains are operated by timetable and train orders. There is no block system in use. At Quanah, 28.4 miles south of Childress, a lead track diverges from the main track on the west. The north switch of the lead track, which is facing-point for south-bound movements, is located 1.18 miles north of Quanah station. From the north on the lead track there are, in succession, a No. 11 turnout lead 80 feet in length, a 7° curve to the right 139 feet, a tangent 253 feet, a 3° curve to the left 350 feet and then a tangent 107 feet to the point of accident and a considerable distance southward. South of the point of accident the lead track parallels the main track. A spur track connects with the lead track at a point 932 feet south of the north lead-track switch. The spur track extends northward and is parallel to the main track. The Fort Worth and Denver City Railway Company and the Quanah, Acme & Pacific Railway Company jointly use the lead track and the spur track for switching operations. The accident occurred on the lead track at a point 929 feet south of the north lead-track switch. The main track is tangent a considerable distance north of the north lead-track switch. In the vicinity of the point of accident the grade for south-bound movements is 0.33 percent descending.

The switch stand at the north switch of the lead track is of the intermediate-stand hand-throw type, and is located 9 feet 6 inches west of the center-line of the main track. It is equipped with a round red target 17-5/8 inches in diameter. It also is equipped with reflector lenses 4-3/4 inches in diameter. The center of the target and the centers of the reflector lenses are, respectively, 5 feet 4 inches and 6 feet 8 inches above the level of the tops of the ties. When the switch is lined for movement from the main track to the lead track the switch target is at right angles to the main track.
