INTERSTATE COMMERCE COMMISSION
WASHINGTON

REPORT OF THE DIRECTOR
BUREAU OF SAFETY

ACCIDENT ON THE
GRAND CENTRAL TERMINAL RAILROAD

INVESTIGATION NO. 2312

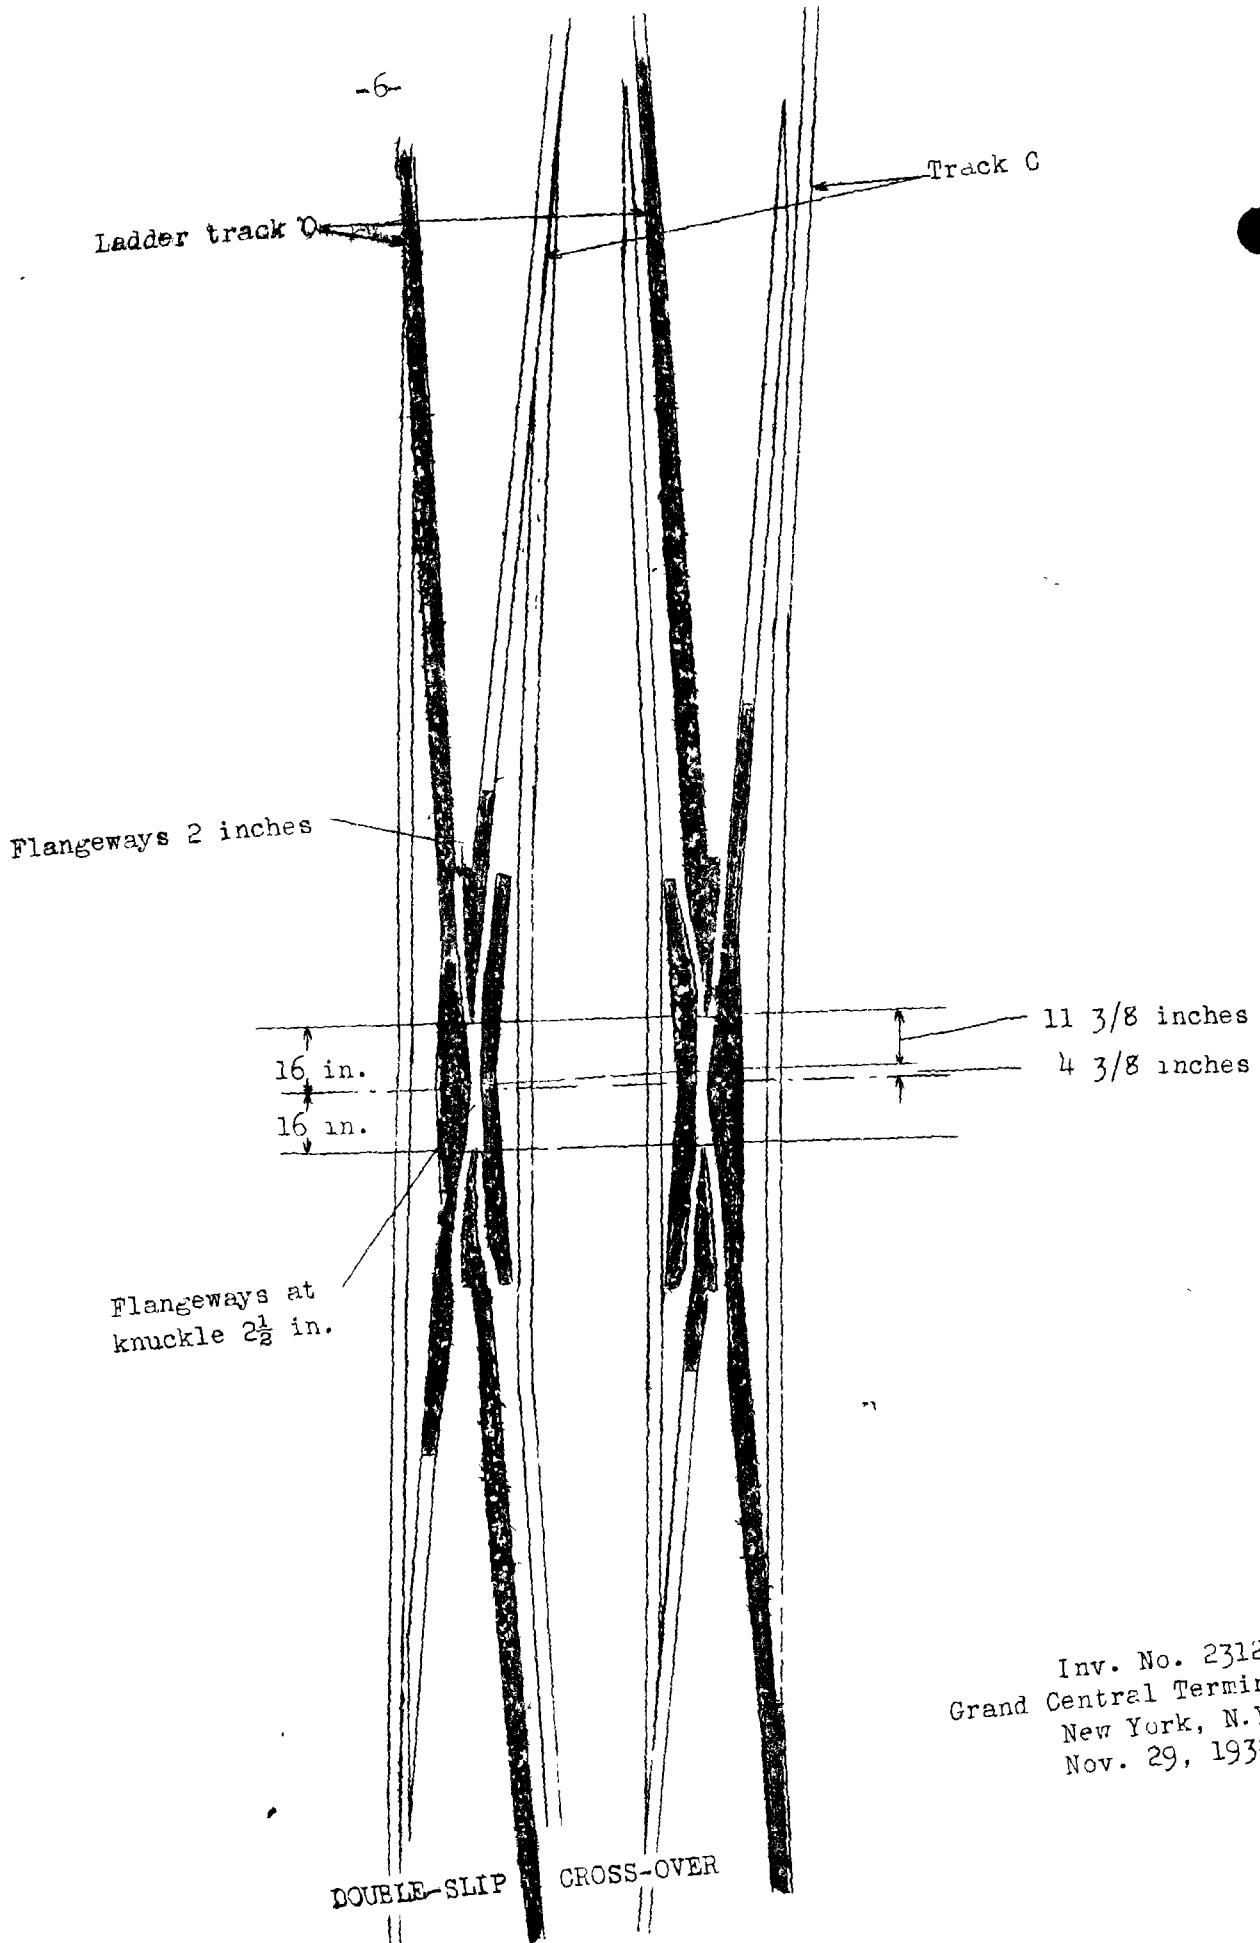
Inv. No. 2312
Grand Central Terminal R.R
New York, N.Y.
Nov. 29, 1938.

Point of accident

No. 6 $\frac{1}{2}$ switch frogs with stationary points are in use at the point of derailment. There is an open space of 16 inches between the point and the guard knuckle of the frog or 32 inches between the points. The flange-ways have a width of two inches and are 2 $\frac{1}{2}$ inches wide at the knuckle with a depth of 1 $\frac{15}{16}$ inches from top of rail to bed of frog. The diagonal formed by the intersection of tracks O and C places one frog 4- $\frac{3}{8}$ inches in advance of the other, thereby reducing the open space to 11- $\frac{5}{8}$ inches for a pair of wheels.

According to the evidence locomotives of the type involved in the accident had successfully passed over the crossing involved for a period of more than 7 months. Engine 0364 had a wheel base 66 feet long. The rear of this engine was on a more than 15-degree curve to the right when the forward wheels were entering the crossing. Apparently the position of the rear of the engine at this instant caused the right front wheel of the guide truck to crowd to the right to the extent that, instead of passing on the inside, it mounted the point. Apparently the weight of the engine was thrown toward the left rail and with the rear end on the curve the cab remained in position to take much of the weight off the right side of the front end; when the rear end came into the tangent and the engine assumed normal position, the weight returned to the right side forcing the right wheels across the east rail where they dropped and moved upon the ties for 34 feet, finally stopping 18 inches from the rail.

It is believed that this accident was caused by the leading guide truck wheel of an electric engine mounting the point of a double-slip frog that did not provide sufficient protection through the space between the knuckle and the point of frog for a locomotive of this design with the rear unit conforming to the angles set up by a sharp curve when the front unit was passing through a frog on tangent track.
