REPORT NO. 3534

GRAND TRUNK WESTERN RAILROAD COMPANY
AND
THE NEW YORK CENTRAL RAILROAD COMPANY

IN RE ACCIDENT

NEAR JACKSON, MICH., ON

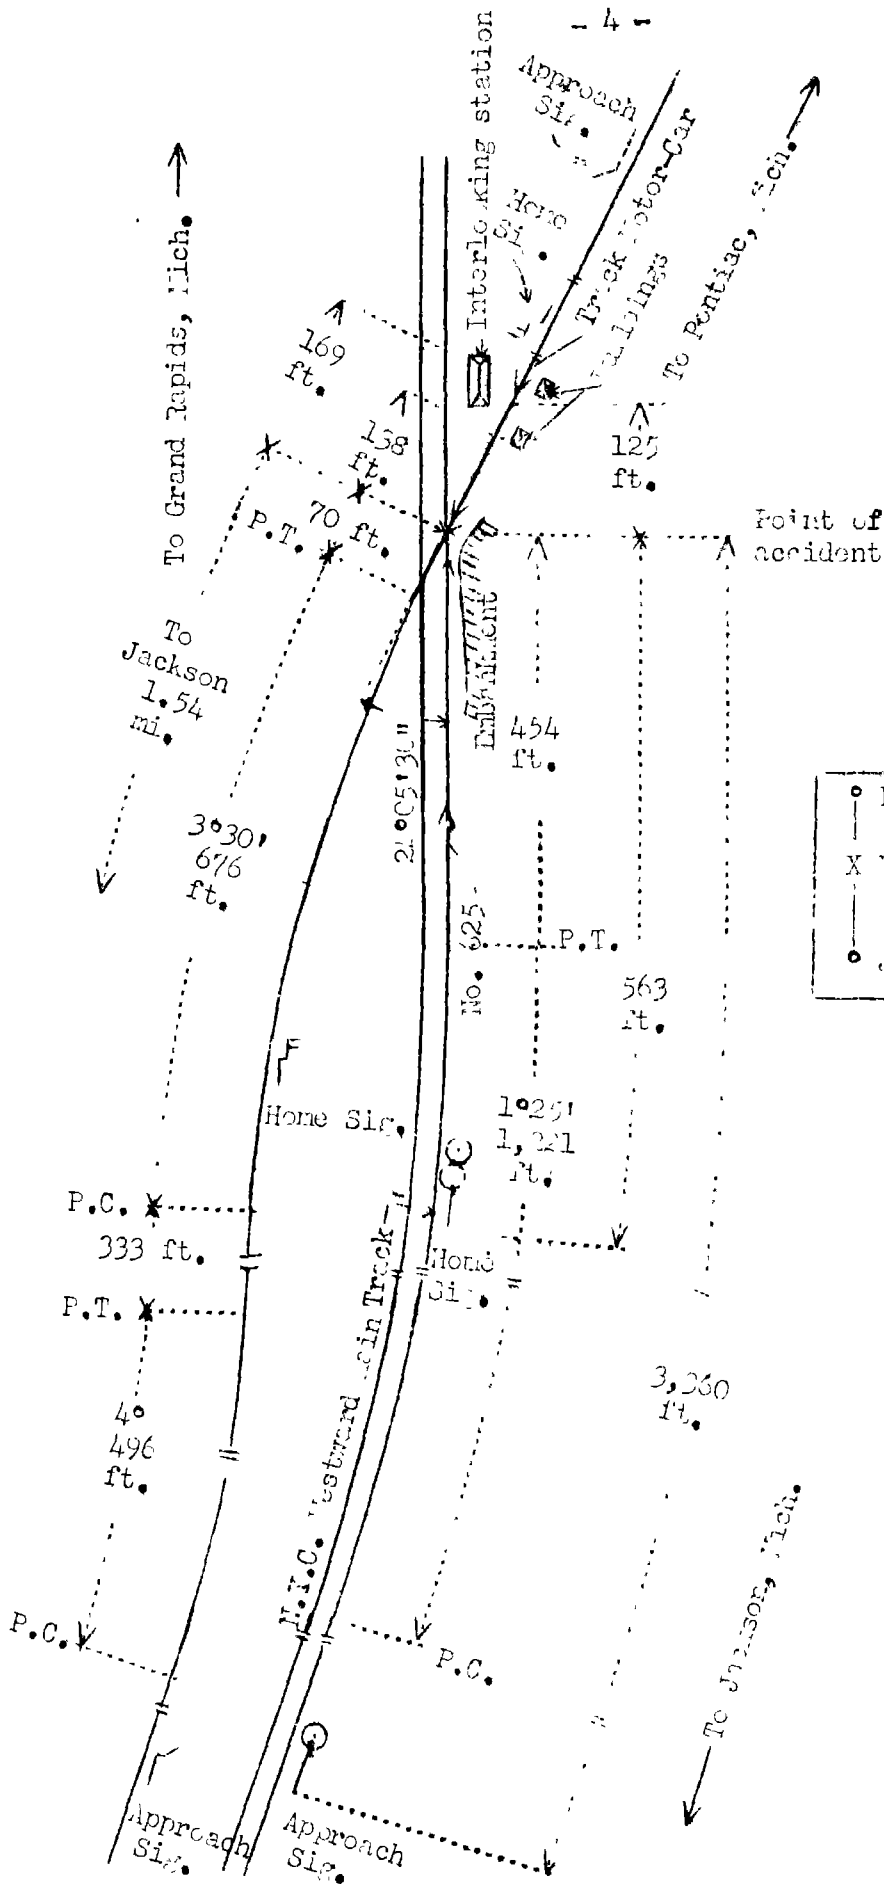
Report No. 3534
 Grand Trunk Western Railroad
 near Jackson, Mich.
 Sept. 14, 1953.

This accident occurred at the intersection of the Grand Trunk Western Railroad, hereinafter referred to as the G.T.W., and the New York Central Railroad, hereinafter referred to as the N.Y.C., near Jackson, Mich. An interlocking station at the intersection is designated by the G.T.W. as M.C.R.R. Crossing. This designation is used in this report. The crossing is located on that part of the Detroit Division of the G.T.W. extending between Jackson and Pontiac, Mich., 71.46 miles, and on that part of the Michigan Division of the N.Y.C. extending between Jackson and Grand Rapids, Mich., 94.47 miles. In the vicinity of the point of accident the G.T.W. extends from southwest to northeast. The N.Y.C. extends from southeast to northwest and crosses the G.T.W. at an angle of $24^{\circ}05'30''$. Timetable directions on both lines are east and west, and these directions are used in this report. M.C.R.R. Crossing is 1.54 miles east of Jackson on the G.T.W. and 1.47 miles west of that station on the N.Y.C. In this vicinity the G.T.W. is a single-track line, over which trains are operated by timetable and train orders. There is no block system in use. From the west there are, in succession, a 4° curve to the left 496 feet in length, a tangent 333 feet, a $3^{\circ}30'$ curve to the right 676 feet, and a tangent 70 feet to the point of accident and a considerable distance eastward. At the point of accident the grade is 0.58 percent descending westward. In the vicinity of the point of accident, the N.Y.C. is a double-track line, over which trains moving with the current of traffic are operated by signal indications. From the east there are, in succession, a $1^{\circ}25'$ curve to the left 1,221 feet in length and a tangent 454 feet to the point of accident and 38 feet westward. The grade is practically level. An embankment which rises to a height of approximately 6 feet above the level of the tops of the rails parallels the westward main track on the north immediately east of the crossing.

The investigation disclosed that an embankment, buildings and vegetation adjacent to the tracks in the southeast angle of the intersection materially restrict the view which the operator of a west-bound G.T.W. track motor-car approaching M.C.R.R. Crossing has of the N.Y.C. tracks south of the crossing. From points on the G.T.W. track 150 feet, 100 feet, and 75 feet immediately east of the crossing, the N.Y.C. tracks south of the crossing are visible for distances of 100 feet, 250 feet, and 1,100 feet, respectively.
