ACCIDENT ON THE
GRAND TRUNK WESTERN RAILROAD

LANSING, MICH.

JUNE 9, 1937

INVESTIGATION NO. 2180

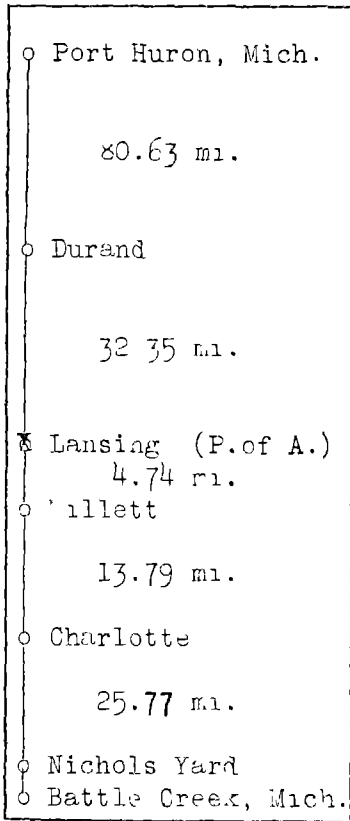
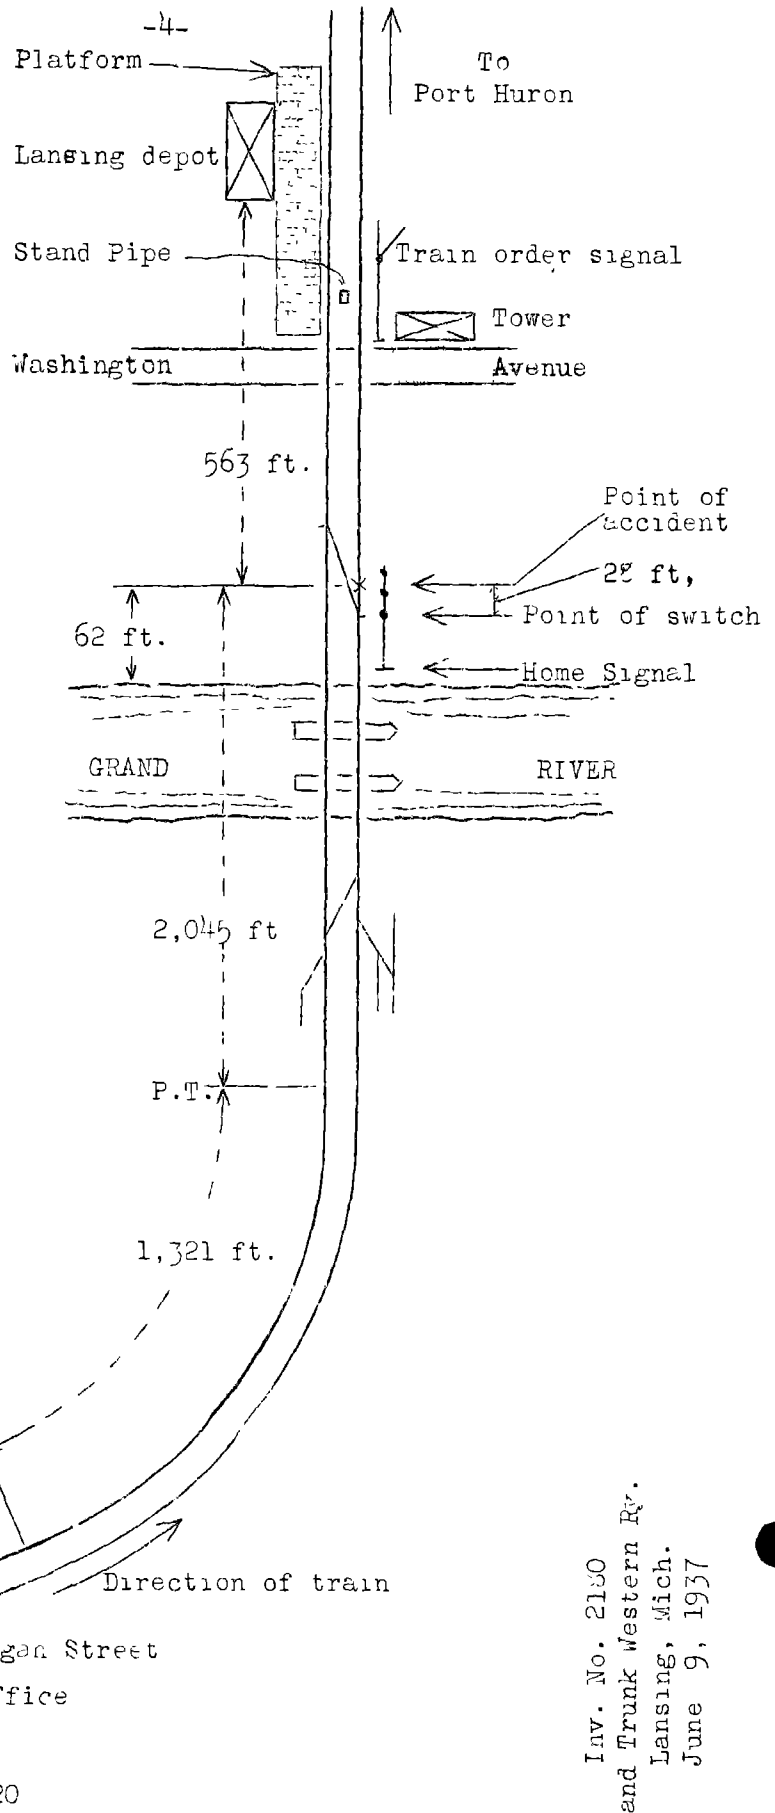
Inv. No. 2150
 Grand Trunk Western Ry.
 Lansing, Mich.
 June 9, 1937

Engine 6301, its tender and the first 27 cars in the train remained on the track as did the 2 rear cars and caboose; the rear truck of the 28th car was derailed, but it remained coupled to the forward portion of the train, and stopped 1,050 feet east of the totally derailed cars. The twenty-ninth to fortieth cars, inclusive, were derailed and stopped in various positions on and across both main tracks and the cross-over, all within a distance of 450 feet; the body of the twenty-ninth car, S.F.R.D. 14559, was torn from its trucks and lay on its side across the westward main track and the station platform. During the course of derailment the signal tower located about 6 feet south of the tracks and about 10 feet east of the sidewalk of Washington Avenue was struck and practically demolished. The eastward main track was considerably damaged for a distance of 340 feet. The employee injured was the operator in the tower.
