INVESTIGATION NO. 2954
GRAND TRUNK WESTERN RAILROAD COMPANY
REPORT IN RE ACCIDENT
AT SMITH'S CREEK, MICH., ON
DECEMBER 7, 1945

Railroad: Grand Trunk Western

Location: Smith's Creek, Mich.

Kind of accident: Rear-end collision

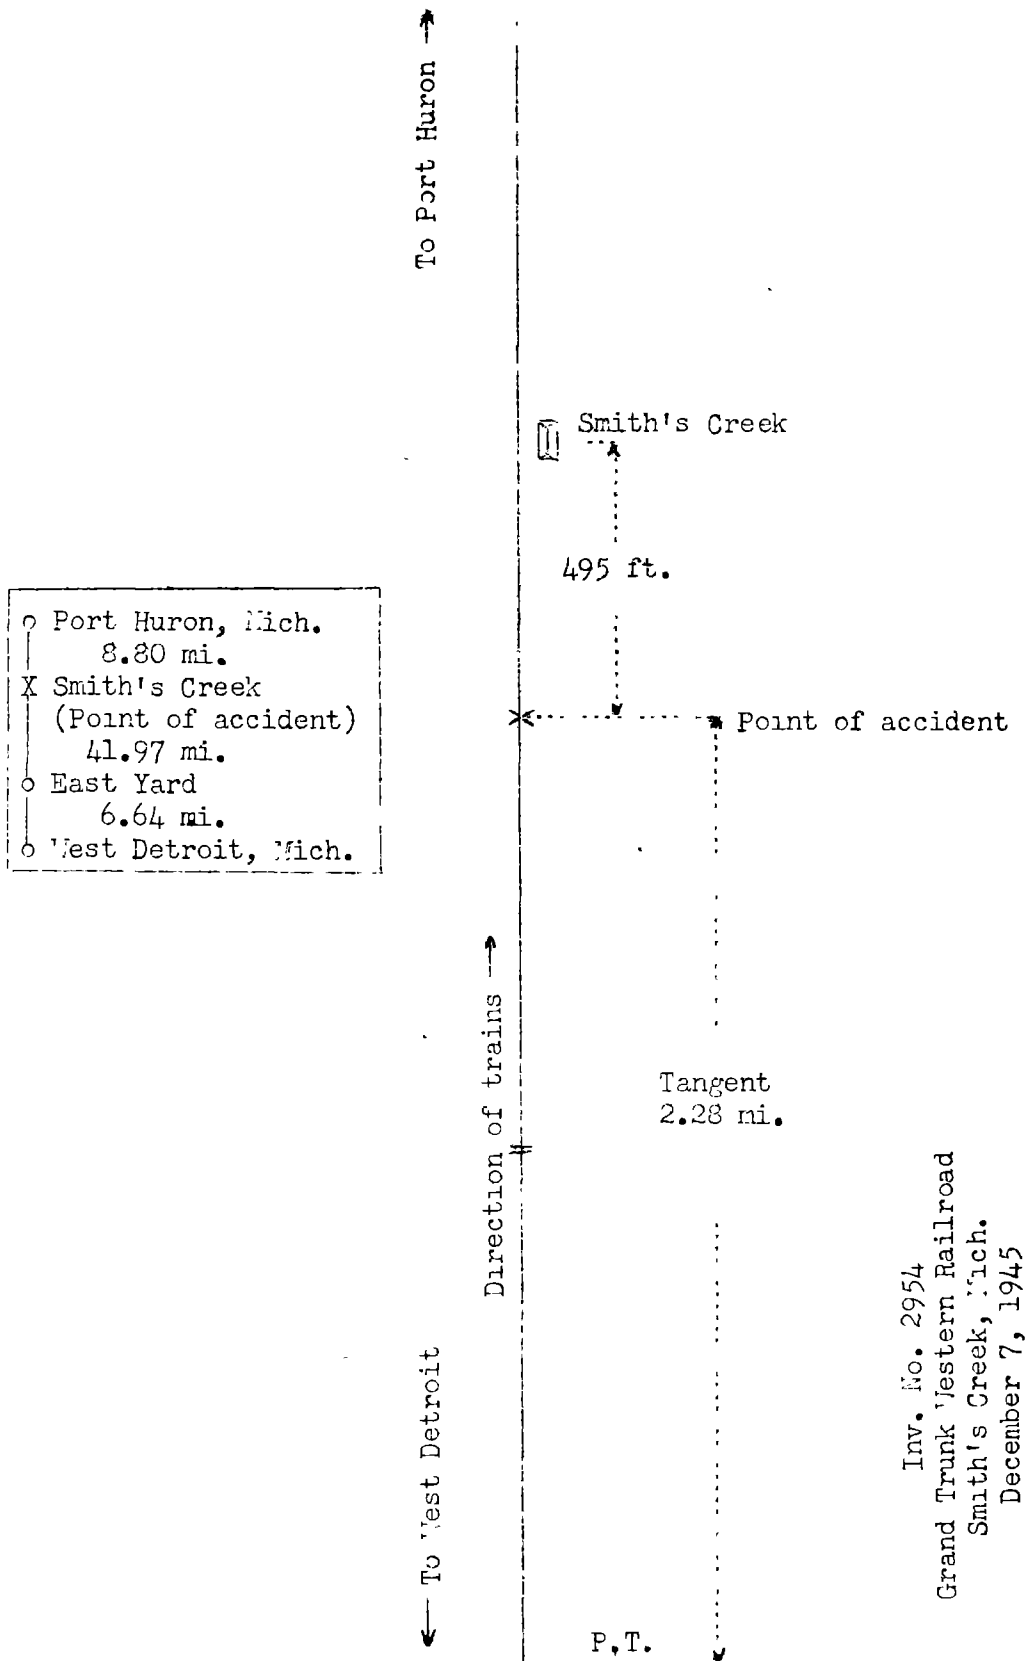
Inv. No. 2954
Grand Trunk Western Railroad
Smith's Creek, Mich.
December 7, 1945

This accident occurred on that part of the Detroit Division extending between West Detroit and Port Huron, Mich., 57.41 miles, a single-track line in the vicinity of the point of accident, over which trains are operated by timetable and train orders. There is no block system in use. The accident occurred 48.61 miles east of West Detroit, at a point 495 feet west of the station at Smith's Creek. The main track is tangent throughout a distance of 2.28 miles west of this point and a considerable distance eastward. The grade for east-bound trains varies between 0.22 percent and 0.41 percent descending throughout a distance of about 1.25 miles, then it is 0.15 percent ascending 400 feet, and 0.10 percent ascending 524 feet to the point of accident and 276 feet eastward.
